Whole-body vibration on construction, mining and quarrying machines

Evaluation of emission and estimated
exposure levels

Prepared by **Silsoe Research Institute**
for the Health and Safety Executive 2005

RESEARCH REPORT 400

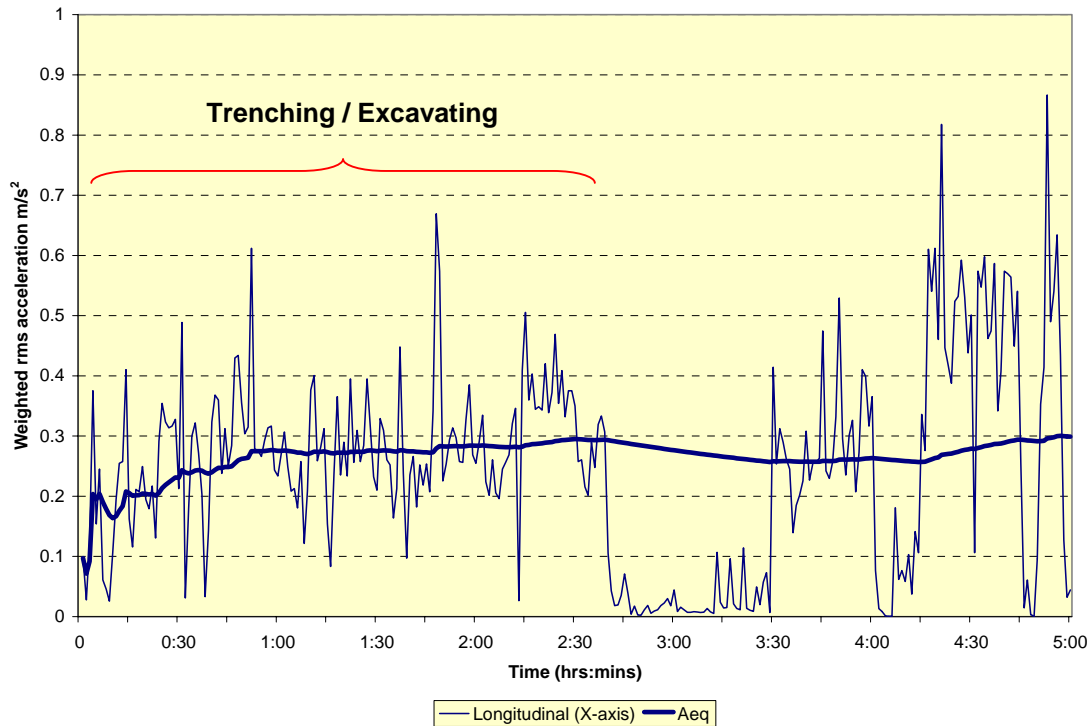
Figure A1.1.2 JCB 4CX backhoe loader:- time history of weighted 1-minute rms seat accelerations (X-axis) and equivalent continuous rms acceleration (Aeq) – entire measurement period

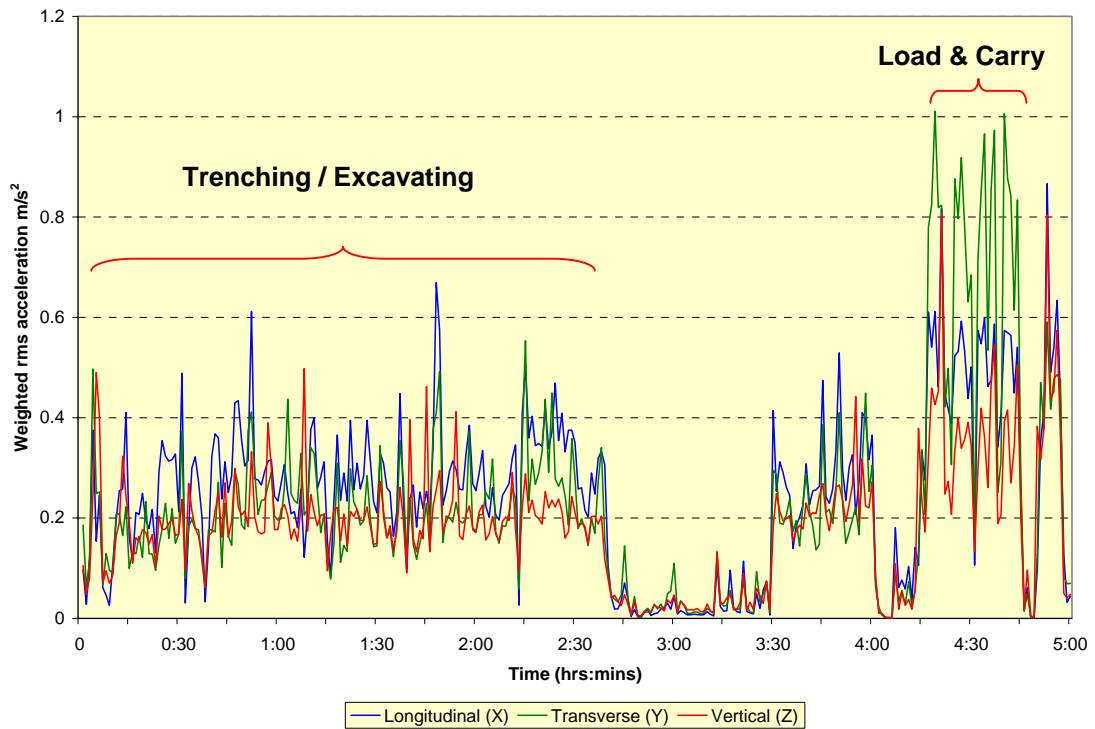
Figure A1.1.3 JCB 4CX backhoe loader:- time histories of weighted 1-minute rms seat accelerations (X, Y and Z-axes) – entire measurement period

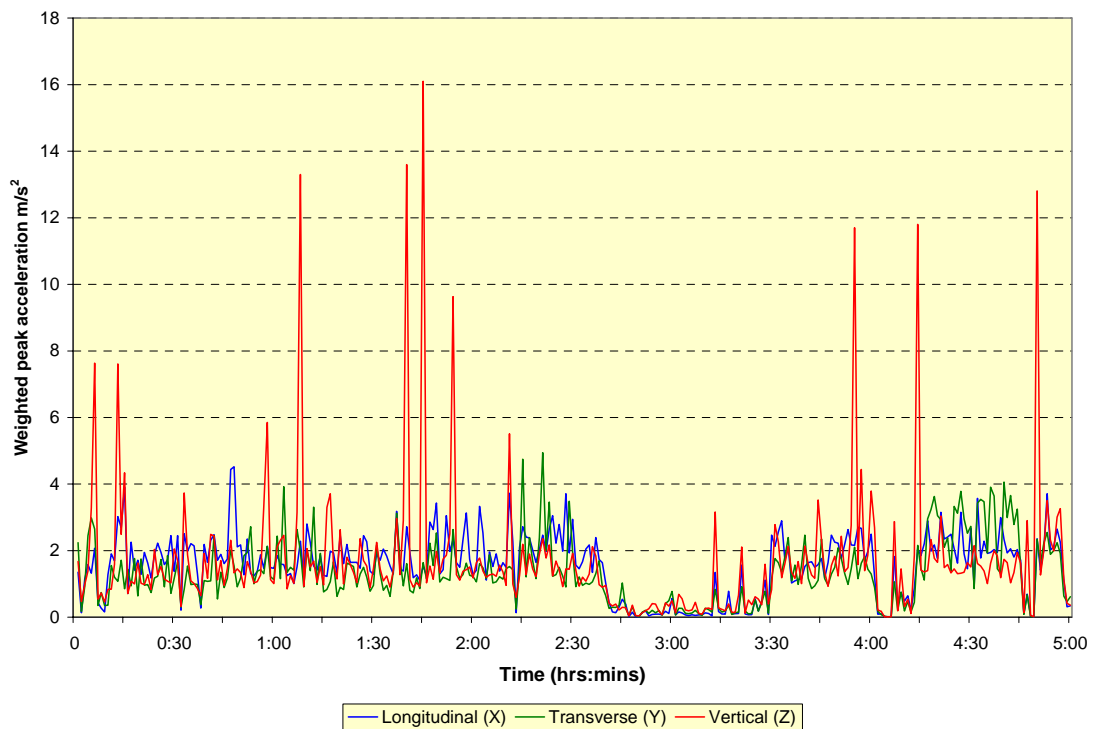
Figure A1.1.4 JCB 4CX backhoe loader:- time histories of weighted 1-minute peak seat accelerations (X, Y and Z-axes) – entire measurement period

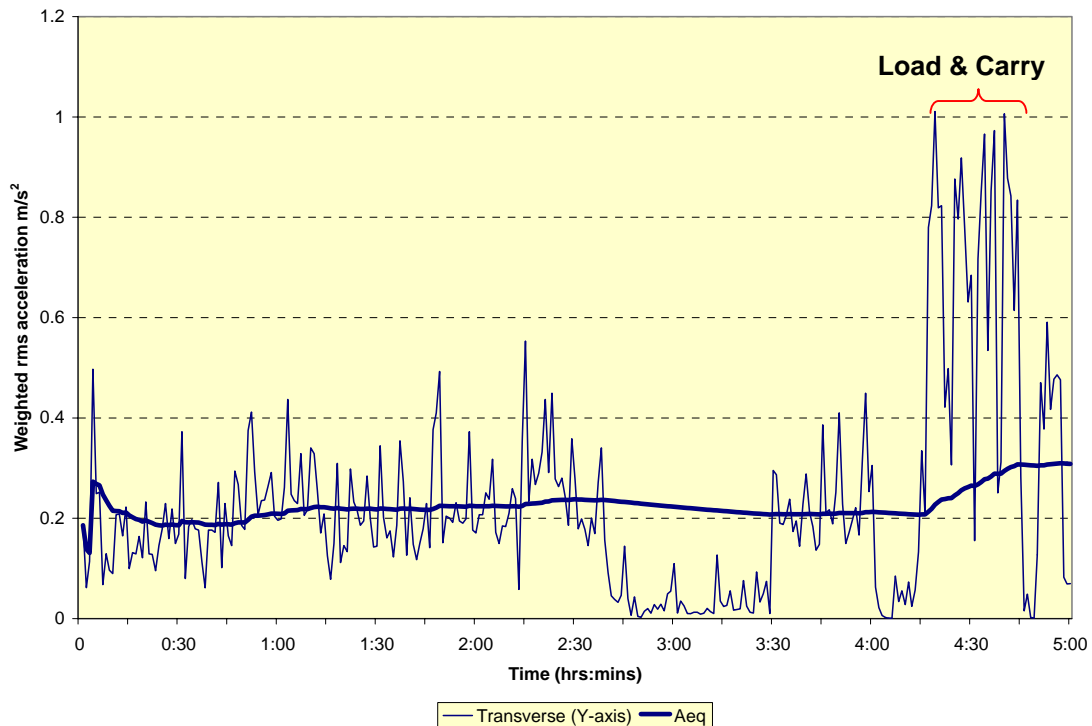
Figure A1.1.6 JCB 4CX backhoe loader:- time history of weighted 1-minute rms seat accelerations (Y-axis) and equivalent continuous rms acceleration (Aeq) – entire measurement period

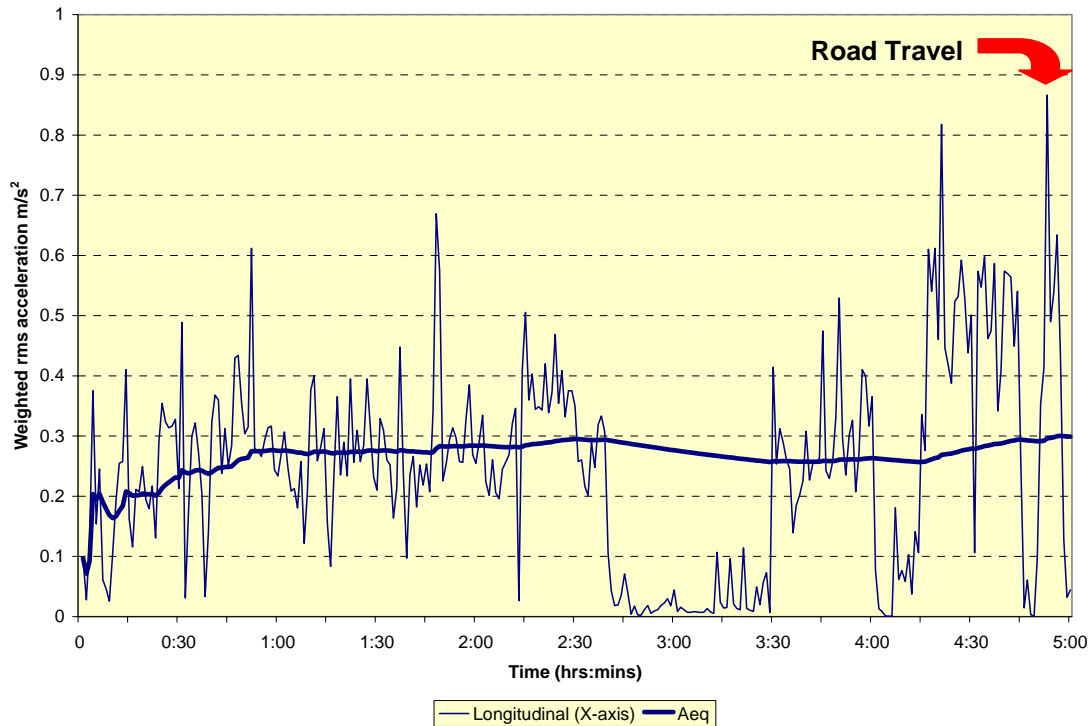
Figure A1.1.11 JCB 4CX backhoe loader:- time history of weighted 1-minute rms seat accelerations (X-axis) and equivalent continuous rms acceleration (Aeq) – entire measurement period

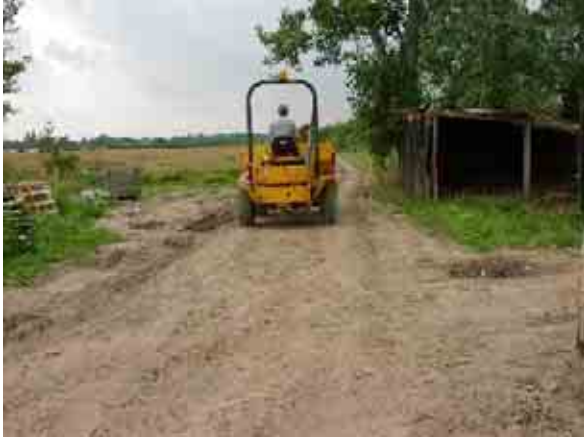
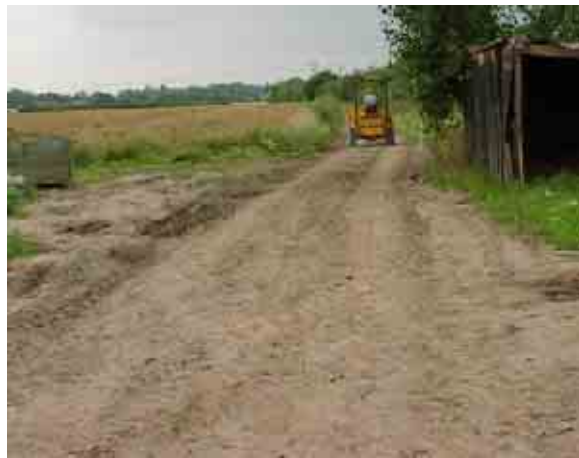
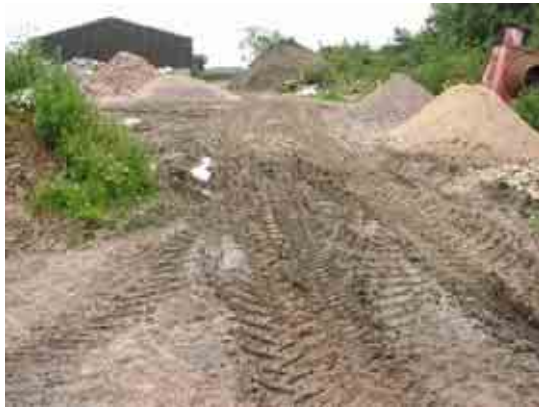
Figure A1.2.2 Thwaites 3-tonne articulated site dumper undertaking 'soil transport'

Full details of this machine, operating application(s) and resulting WBV levels are presented in Appendix 1.2. When used for somewhat sedate 'Spoil Removal' (shuttle dumping) (see Appendix 1.2.2), this machine showed low magnitudes of whole-body vibration (WBV), arguably within the capacity of the primitive seat suspension. When used for Soil Transport over a moderately-rough roadway, much higher magnitudes were found (see Appendix 1.2.3). A suitable suspended seat could reduce the vertical (Z-axis) vibration component, whose energy is centred at about 2.5 Hz, but the transverse (Y-axis) component would then become the largest. Risk would best be minimised by operator training in 'Best Practice', particularly by encouraging drivers not to be too enthusiastic when driving over longer distances of typical off-road tracks.

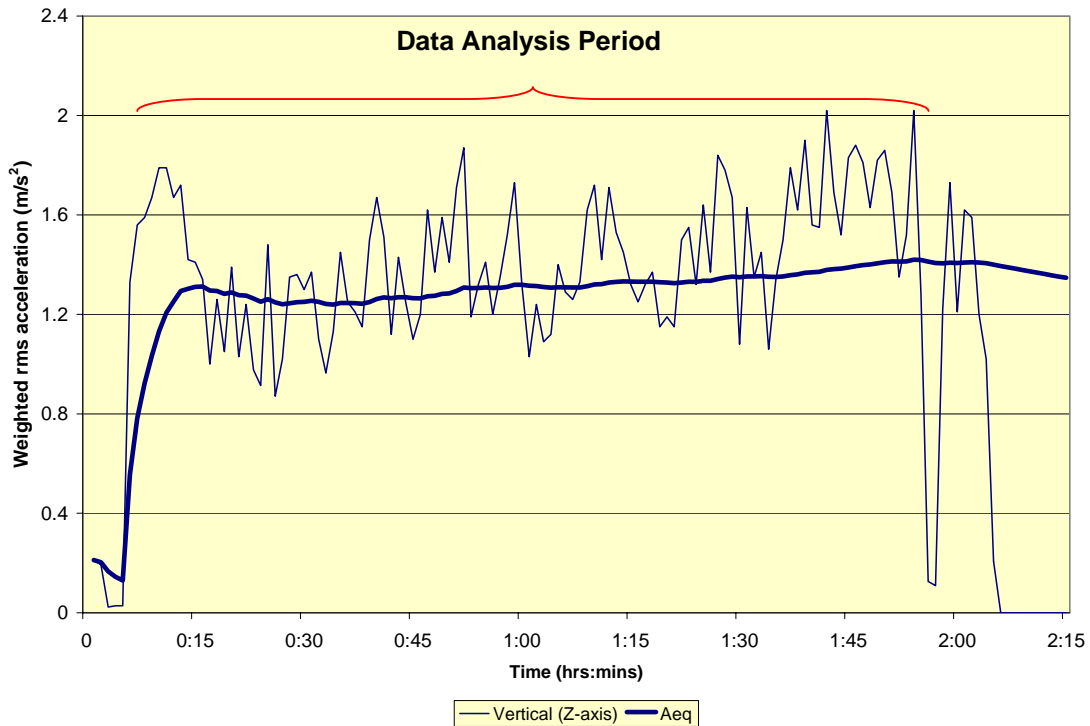
Figure A1.4.2 Komatsu Dozer:- time history of weighted 1-minute rms seat accelerations (Z-axis) and equivalent continuous rms acceleration (Aeq)

Full details of this machine, operating application and resulting WBV levels are presented in Appendix 1.4. In ‘as found’ condition, this machine exhibited the highest WBV levels encountered in the study, passing the ELV in little more than half a day. This was dominated by the vertical (Z-axis) vibration component, as a result of a very badly maintained (and largely dysfunctional) suspension seat.

The vibration encountered had most of its energy at frequencies above 5 Hz; primarily a result of the characteristic vibration frequency spectrum generated by the dozer’s track undercarriage (soil conditions being soft / moderate). However, the SEAT value in this instance was 1.16. This application or rather the frequency distribution of vertical (Z) axis vibration energy, places a significant demand upon a suspension seat, albeit one well within its capabilities if properly maintained and replaced at the end of its service life (~ 4000 hrs). This had not occurred in this application, the dozer having reached 8600 operating hours with the original seat. An appropriate seat for such a machine, properly maintained, should have a SEAT value of about 0.6, which would reduce the operator’s WBV exposure to a much more moderate level.

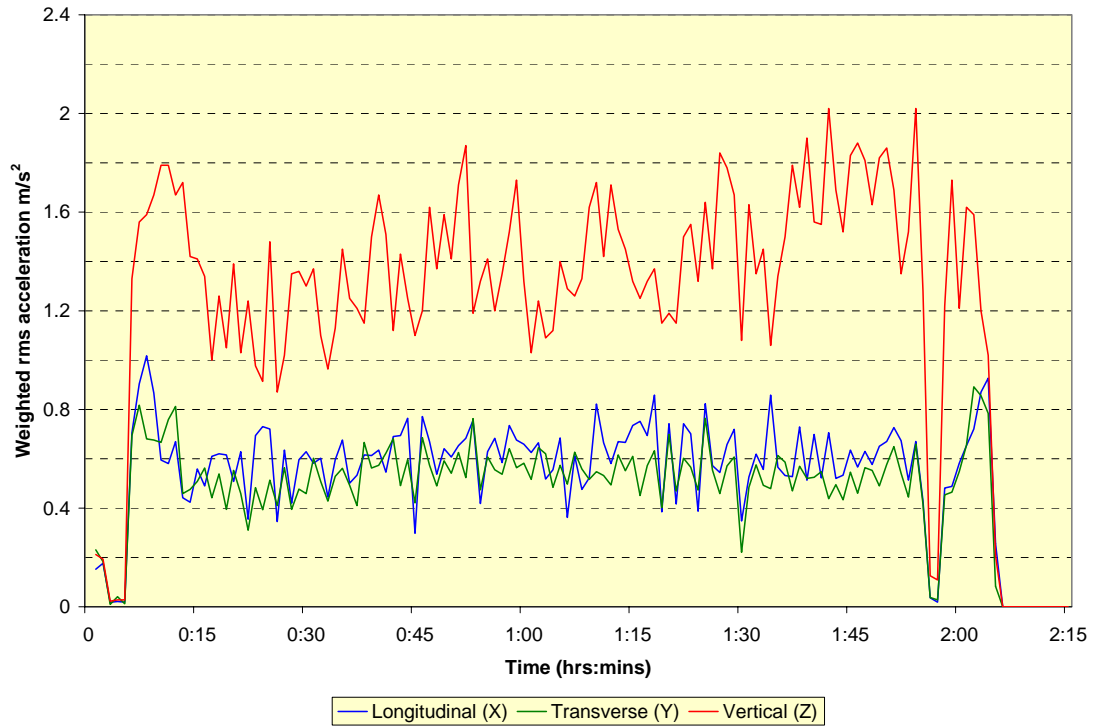
Figure A1.4.3 Komatsu Dozer:- time histories of weighted 1-minute rms seat accelerations (X, Y and Z-axes)

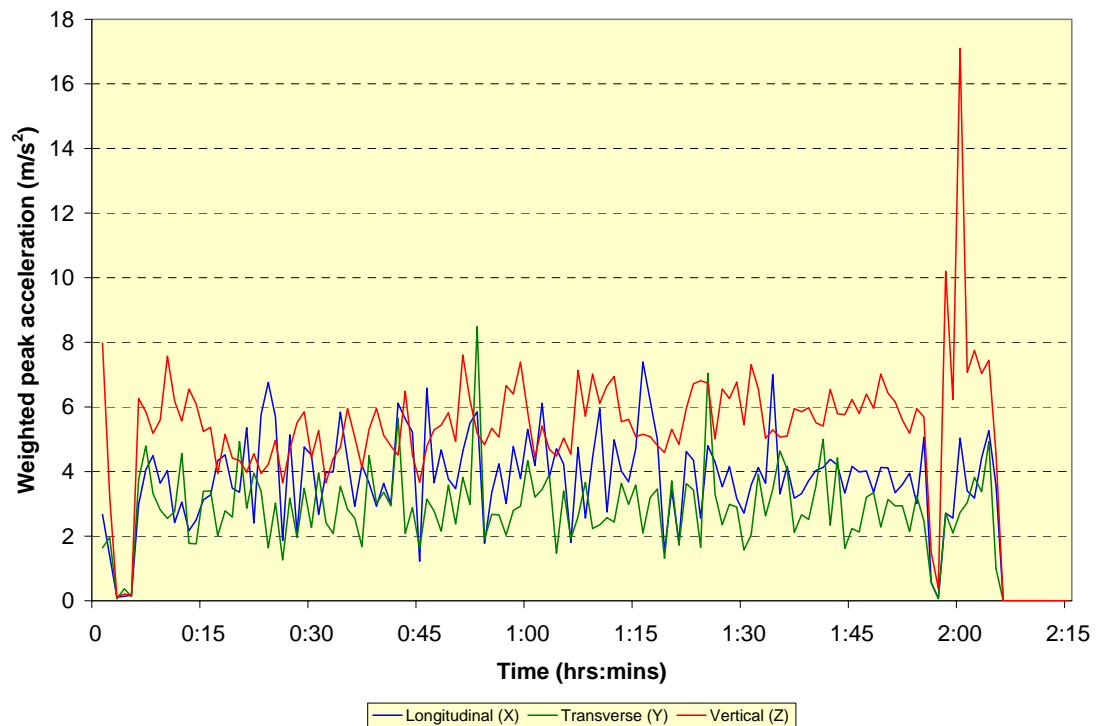
Figure A1.4.4 Komatsu Dozer:- time histories of weighted 1-minute peak seat accelerations (X, Y and Z-axes)

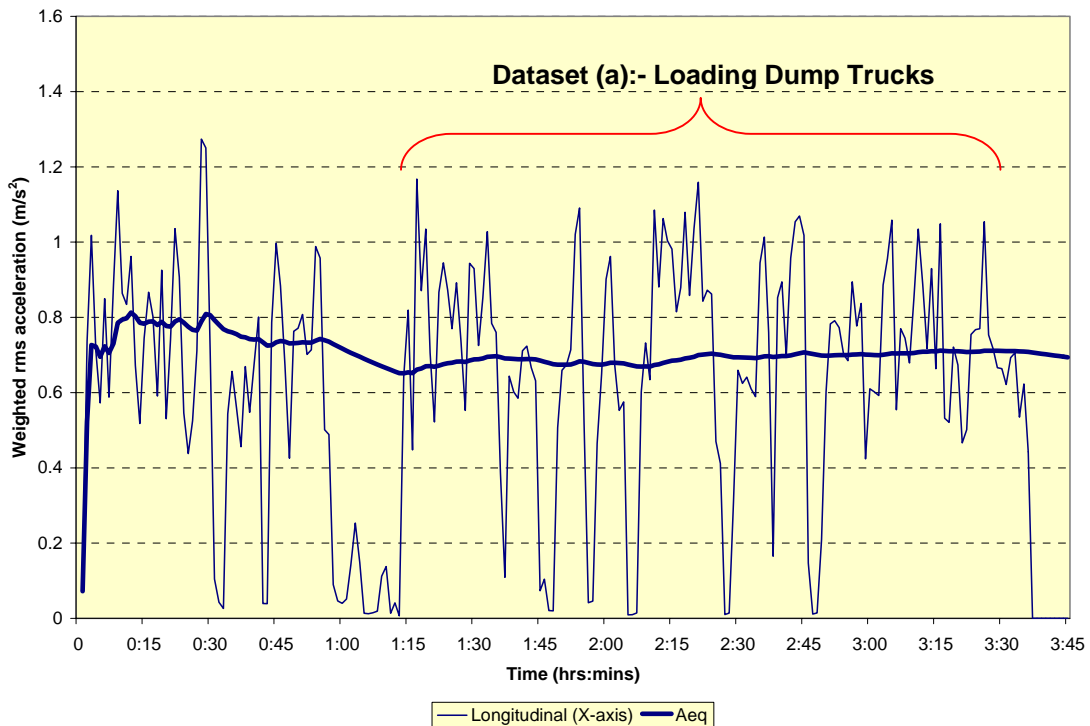
Figure A1.5.2 Liebherr Face Shovel:- time history of weighted 1-minute rms seat accelerations (X-axis) and equivalent continuous rms acceleration (Aeq) – entire recording period

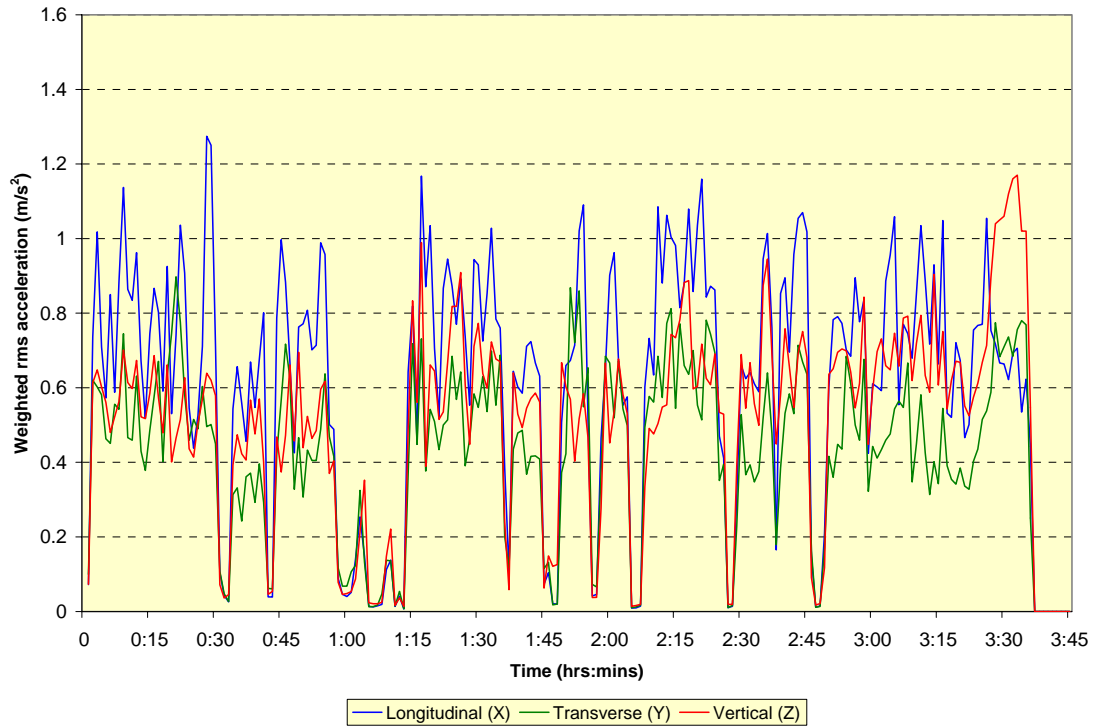
Figure A1.5.3 Liebherr Face Shovel:- time histories of weighted 1-minute rms seat accelerations (X, Y and Z-axes) – entire recording period

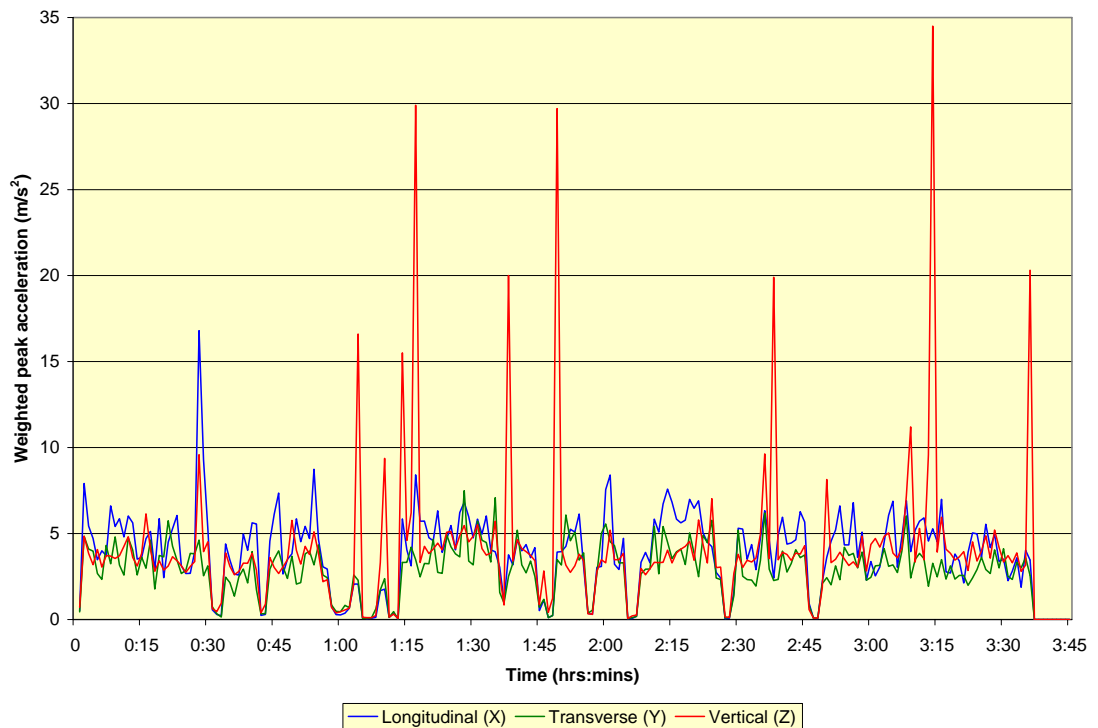
Figure A1.5.4 Liebherr Face Shovel:- time histories of weighted 1-minute peak seat accelerations (X, Y and Z-axes) – entire recording period

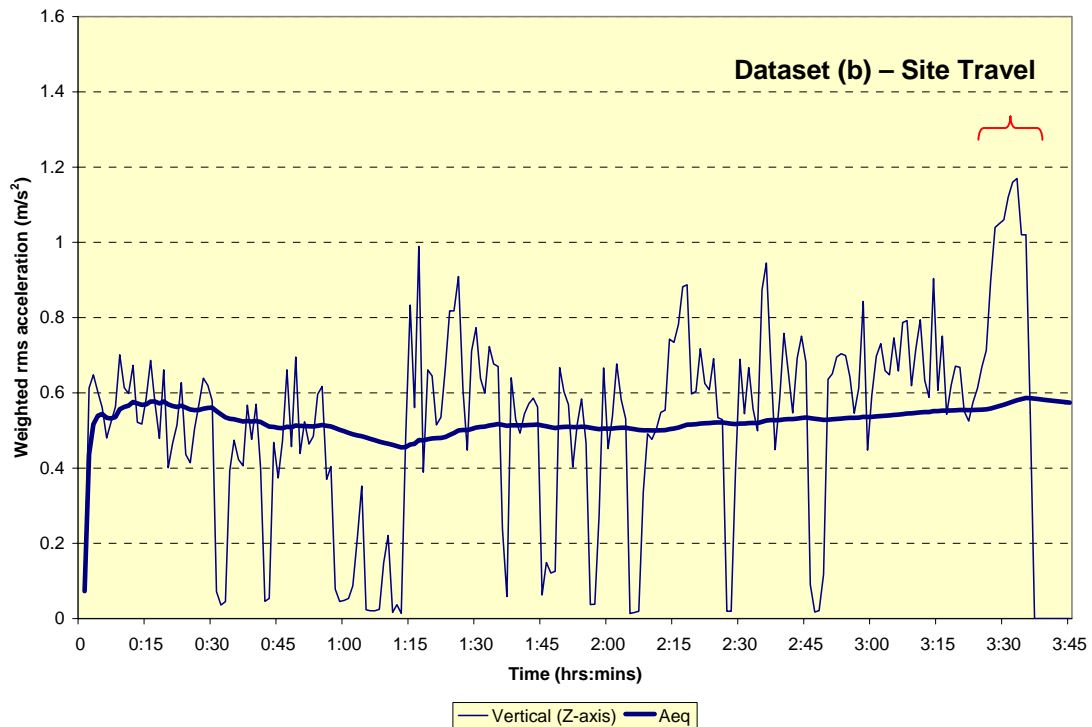
Figure A1.5.9 Liebherr Face Shovel:- time history of weighted 1-minute rms seat accelerations (Z-axis) and equivalent continuous rms acceleration (Aeq):- entire recording period

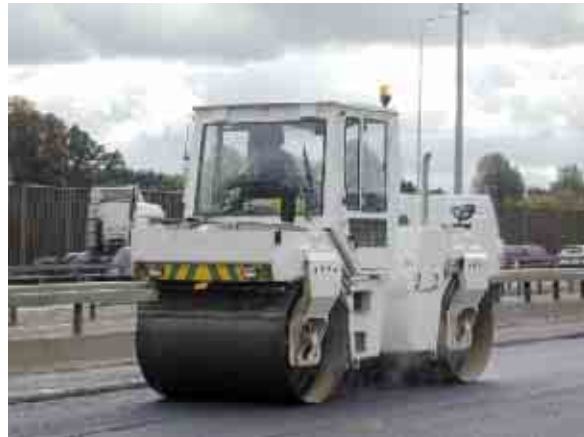
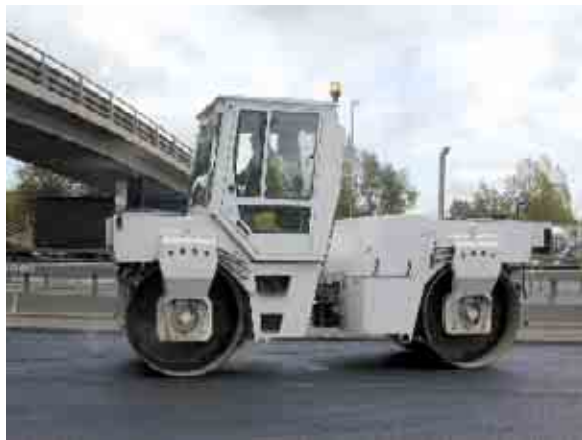
Figure A1.6.1 Bomag BW161 AD2 10-tonne articulated twin-drum vibrating roller compacting freshly-laid hot asphalt on M25

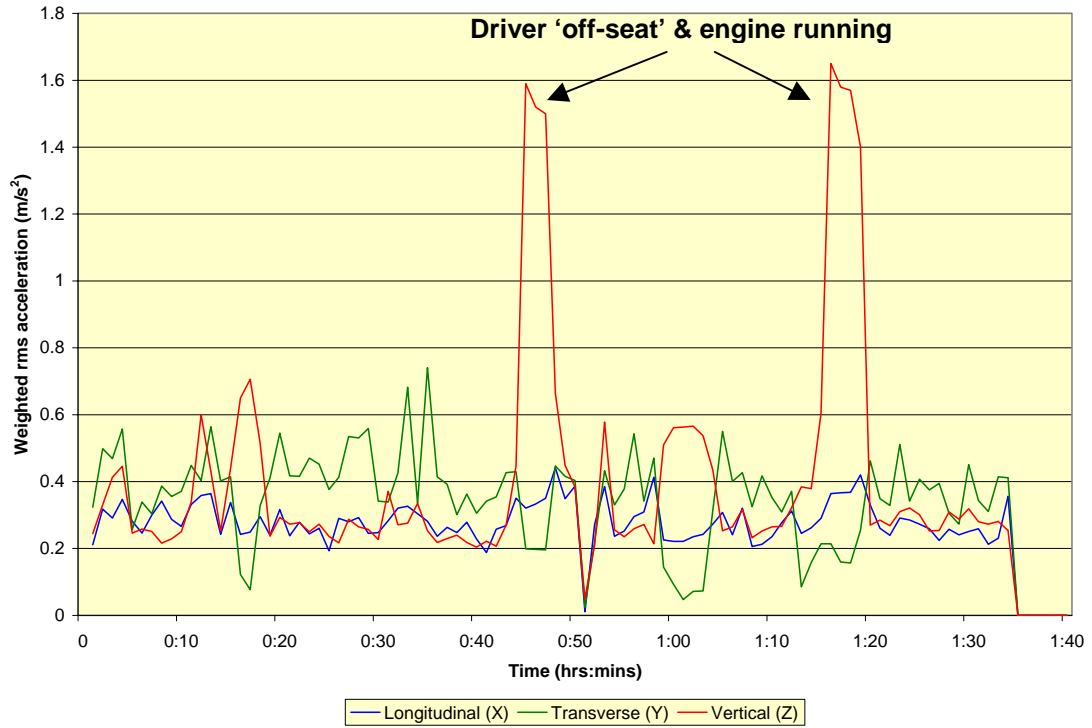
Figure A1.6.3 Bomag BW161 10-tonne twin drum vibrating roller:- time histories of weighted 1-minute rms seat accelerations (X, Y and Z-axes)

- Periods of machine idleness (at engine tickover) and/or operator absence from the driver's seat appear to cause higher Z-axis WBV values;
- Datasets derived from periods when the driver is "on-seat" generate significantly lower Z-axis WBV levels than those relating to the entire measurement period (particularly for "seat" WBV values);
- High Z-axis rms seat acceleration values (see Figure A1.6.3) appear to coincide with the periods when the driver is "off-seat" (see Figure A1.6.4).

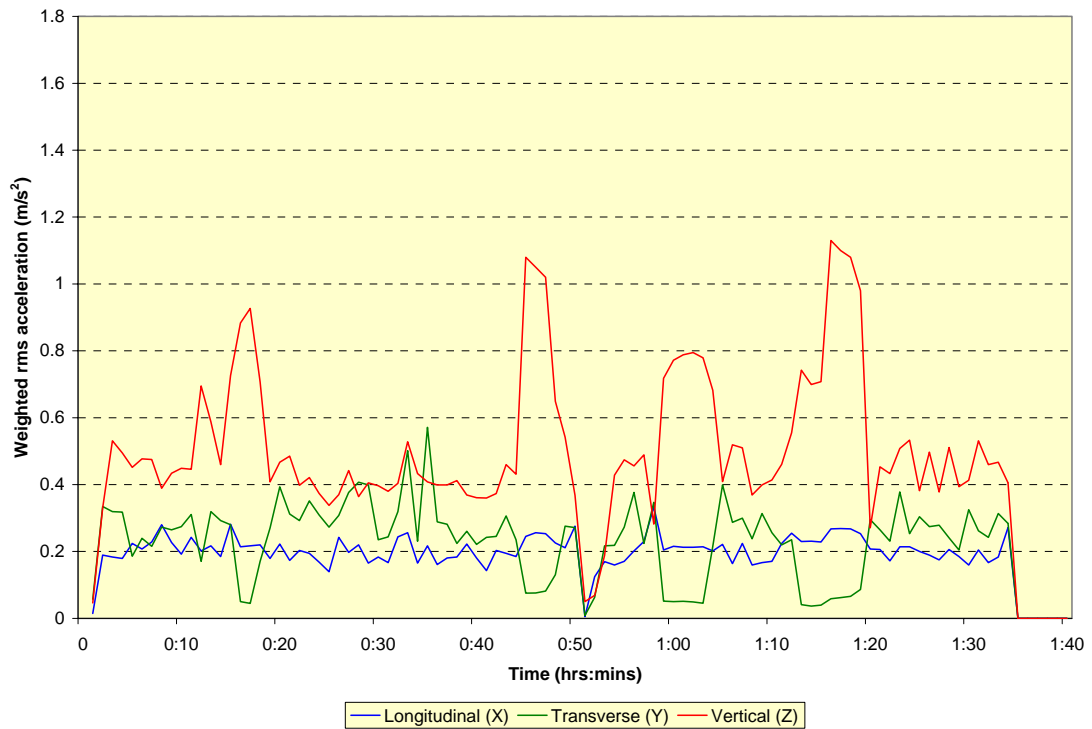
Figure A1.6.5 Bomag BW161 10-tonne twin drum vibrating roller:- time histories of weighted 1-minute rms floor accelerations (X, Y and Z-axes)

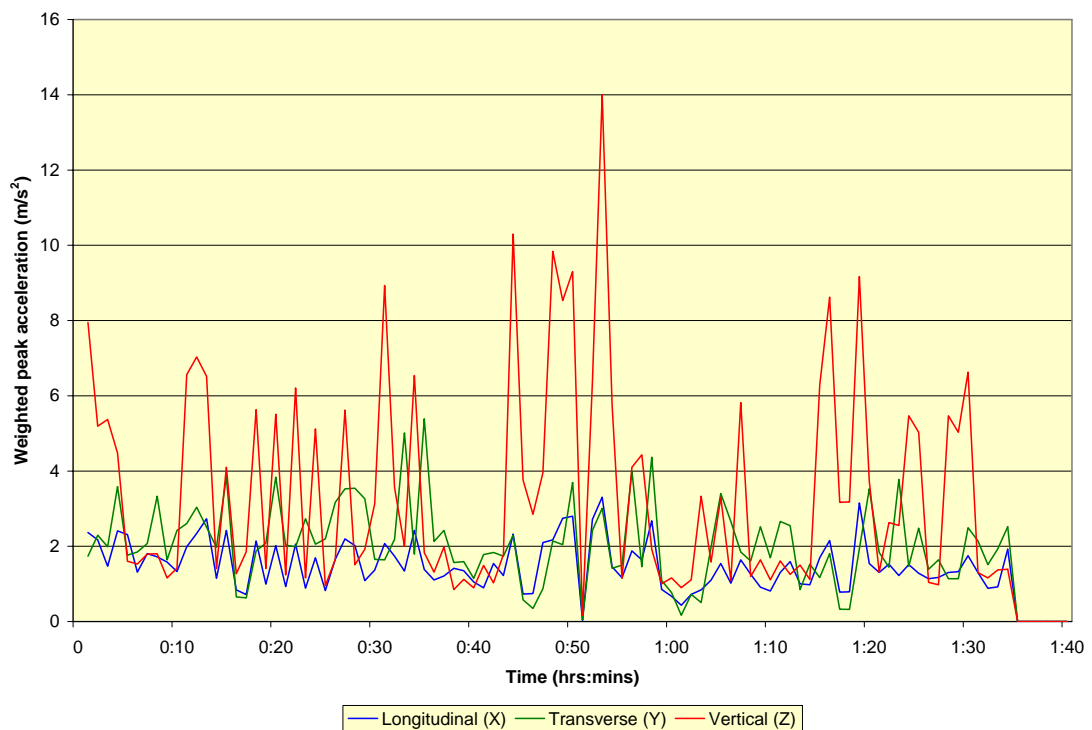
Figure A1.6.6 Bomag BW161 10-tonne twin drum vibrating roller:- time histories of weighted 1-minute peak seat accelerations (X, Y and Z-axes)

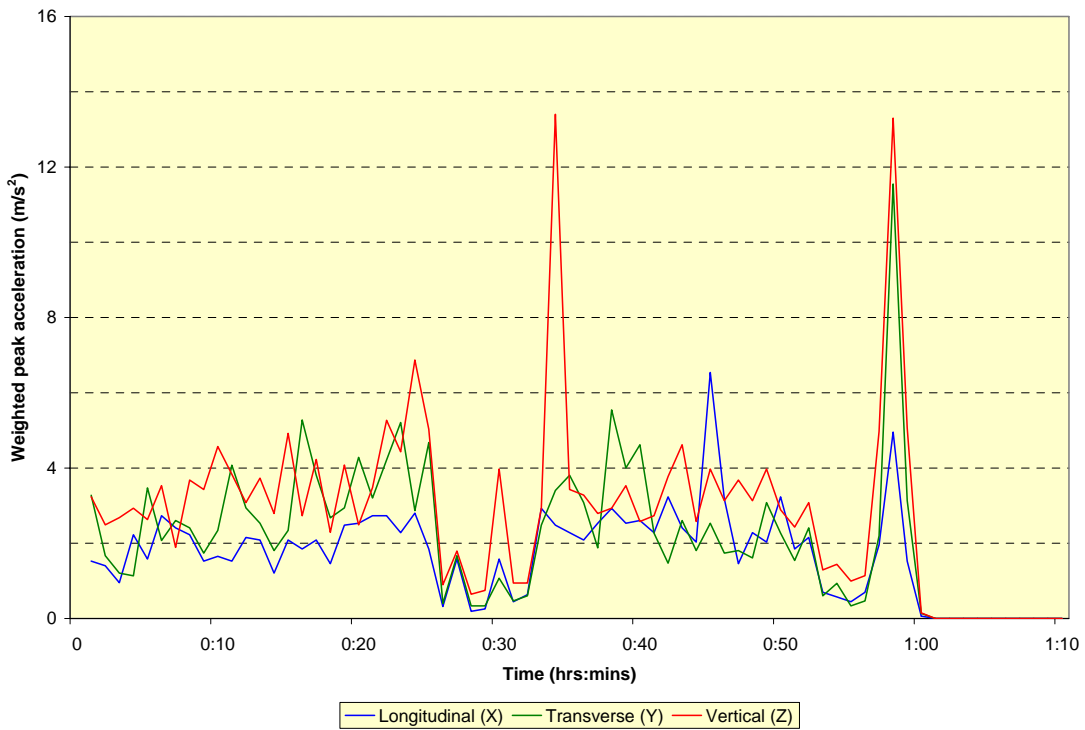
Figure A1.7.4 Bomag BW138 4-tonne twin drum vibrating roller:- time histories of weighted 1-minute peak seat accelerations (X, Y and Z-axes)

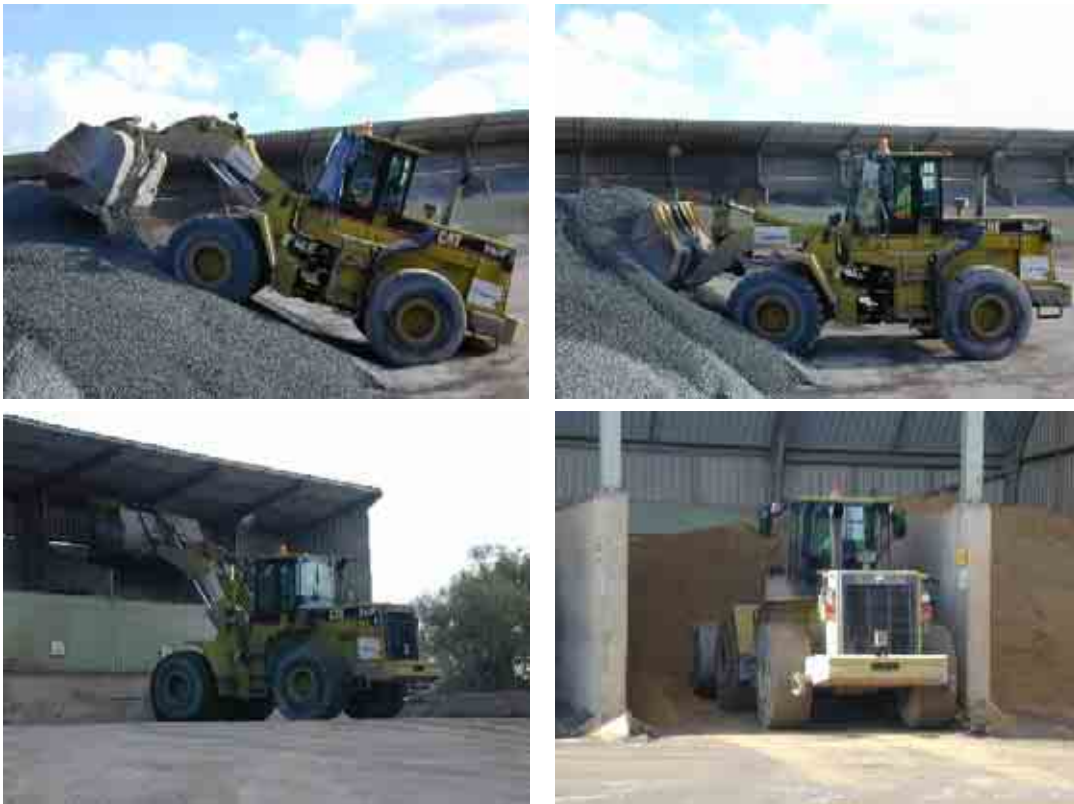
Figure A1.8.1 CAT 950F II articulated loading shovel feeding asphalt plant with aggregate

Full details of these machines, operating applications and resulting WBV levels are presented in Appendices 1.8 and 1.9 for the 18-tonne and 24-tonne loading shovels, respectively. The vibration magnitudes on these machines were strongly affected by the way in which they were used. In all cases, the longitudinal (X-axis) component was the highest, but this could vary between about 0.6 m/s^2 and nearly 1 m/s^2 according to how hard /enthusiastically the bucket was driven into the stockpile, and general operating style (see Tables 4.1 & 4.3). Additionally, it was observed that the machine with the lowest magnitudes of vibration was being used on a less rough ground surface, although both operating surfaces were relatively smooth and perfectly acceptable. The suspension seats on both machines amplified the vertical (Z-axis) vibration (SEAT values = 1.10 – 1.26 depending upon machine & operation). As the energy of this component was centred on a frequency of 2 Hz, it could possibly be better controlled by seat selection: neither seat embodied any suspension capability in the longitudinal (X) axis. However, it is also important that the cab mountings are so designed that the fore-and-aft shocks generated when the machine is driven into a stockpile, is not amplified into a rocking motion of the cab. Potential employer action to minimise operator risk from WBV exposure would include operator training in 'Best Practice' and maintenance of operating surfaces.

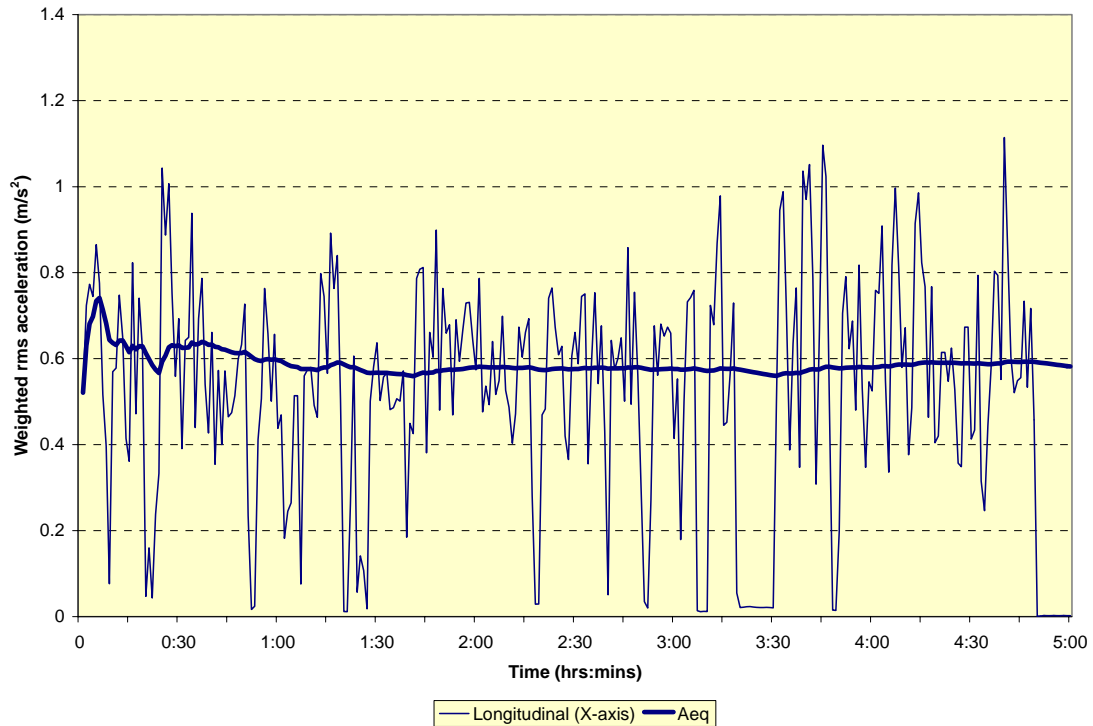
Figure A1.8.2 CAT 950F II articulated loading shovel:- time history of weighted 1-minute rms seat accelerations (X-axis) and equivalent continuous rms acceleration (Aeq)

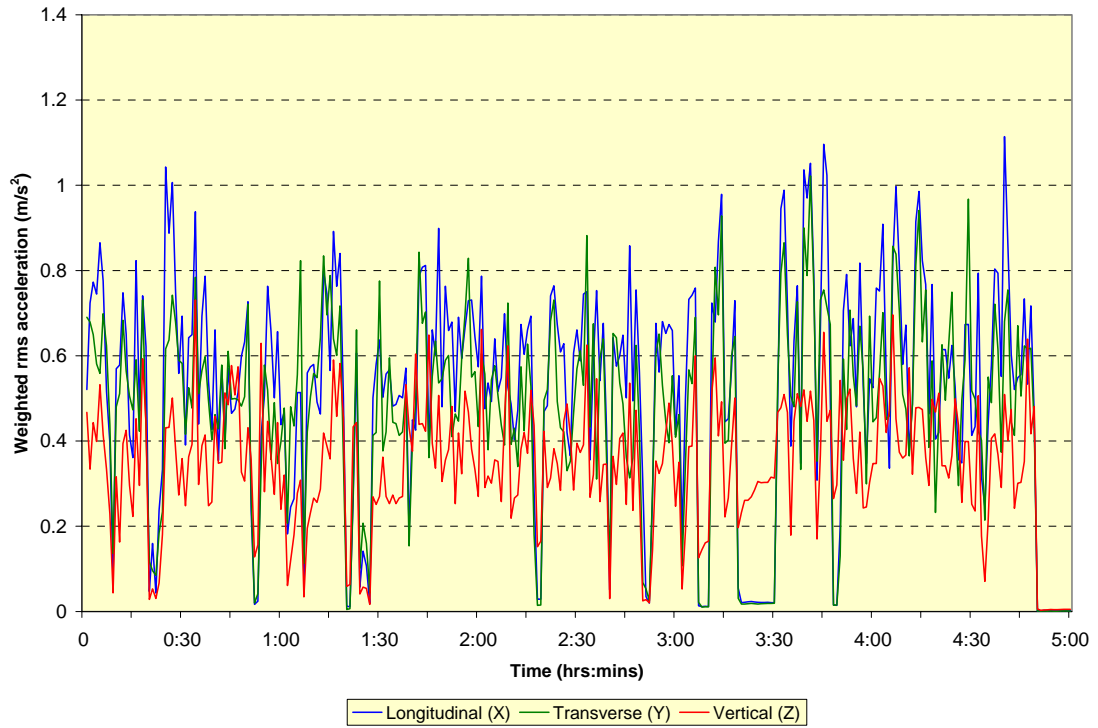
Figure A1.8.3 CAT 950F II articulated loading shovel:- time histories of weighted 1-minute rms seat accelerations (X, Y and Z-axes)

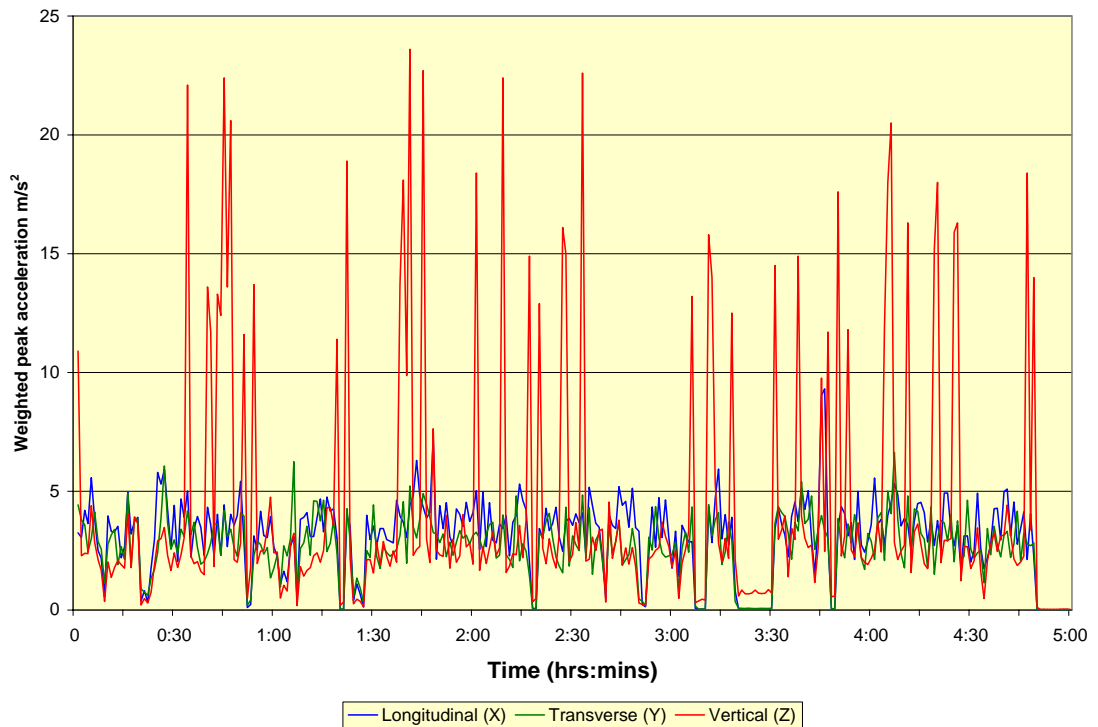
Figure A1.8.4 CAT 950F II articulated loading shovel:- time histories of weighted 1-minute peak seat accelerations (X, Y and Z-axes)

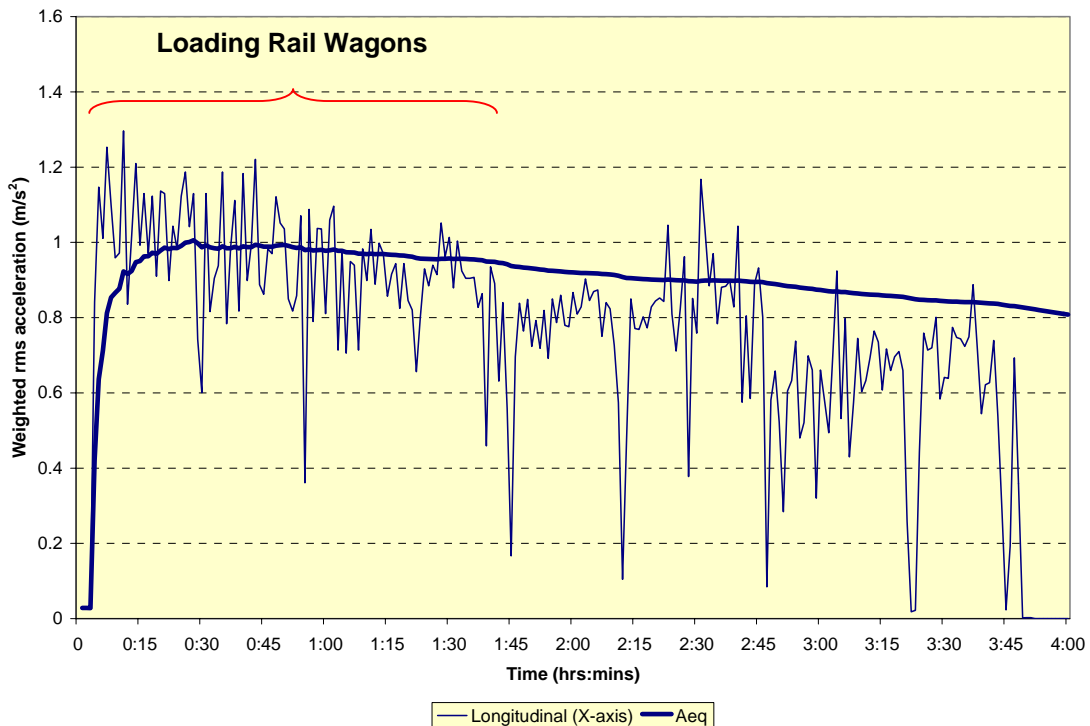
Figure A1.9.2 CAT 970F articulated loading shovel:- time history of weighted 1-minute rms seat accelerations (X-axis) and equivalent continuous rms acceleration (Aeq) – entire recording period

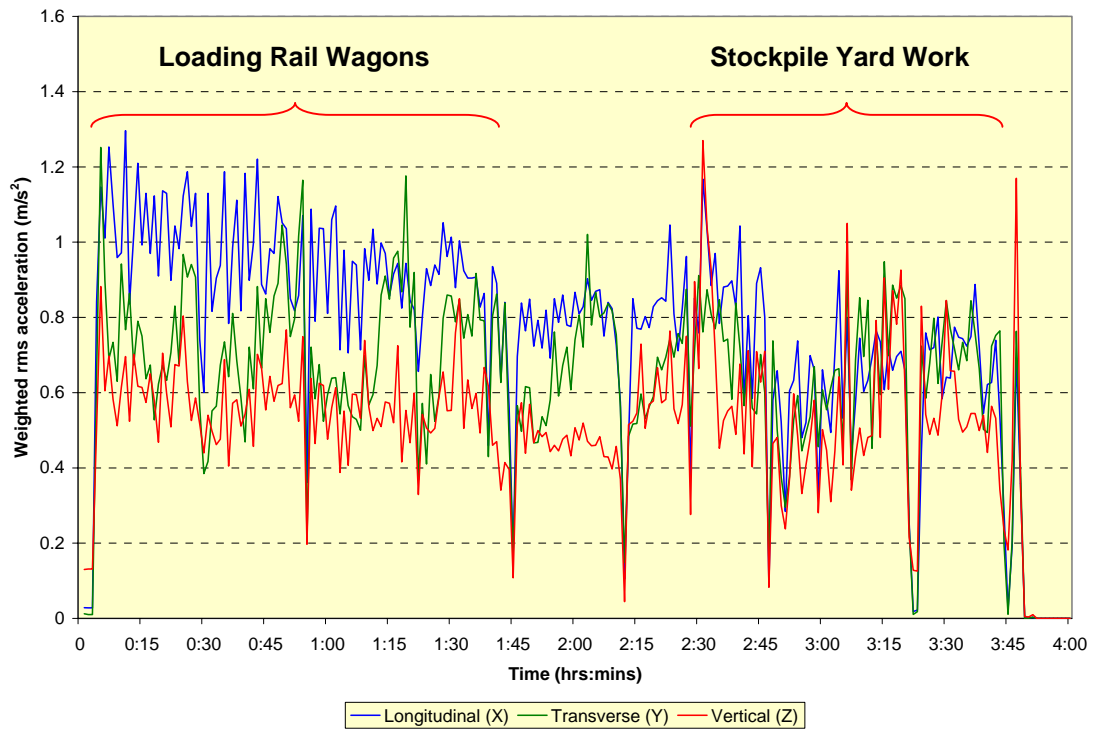
Figure A1.9.3 CAT 970F articulated loading shovel:- time histories of weighted 1-minute rms seat accelerations (X, Y and Z-axes) – entire recording period

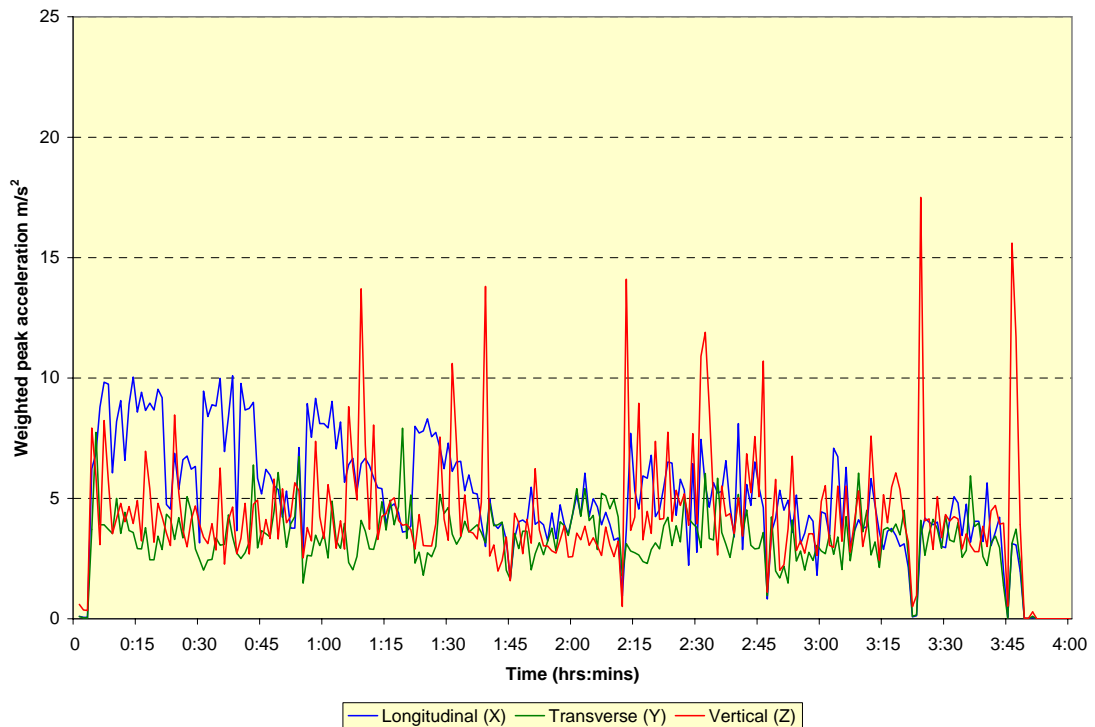
Figure A1.9.4 CAT 970F articulated loading shovel:- time histories of weighted 1-minute peak seat accelerations (X, Y and Z-axes) – entire recording period

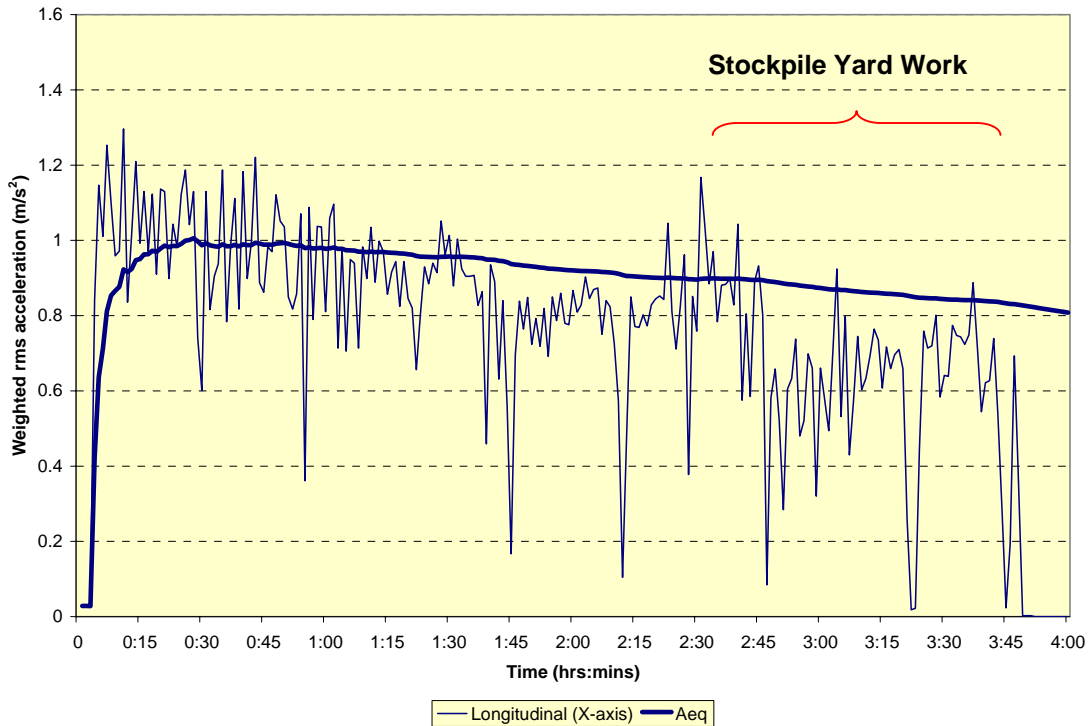
Figure A1.9.9 CAT 970F articulated loading shovel:- time history of weighted 1-minute rms seat accelerations (X-axis) and equivalent continuous rms acceleration (Aeq) – entire recording period
