Whole-body vibration on construction, mining and quarrying machines

Evaluation of emission and estimated
exposure levels

Prepared by **Silsoe Research Institute**
for the Health and Safety Executive 2005

RESEARCH REPORT 400

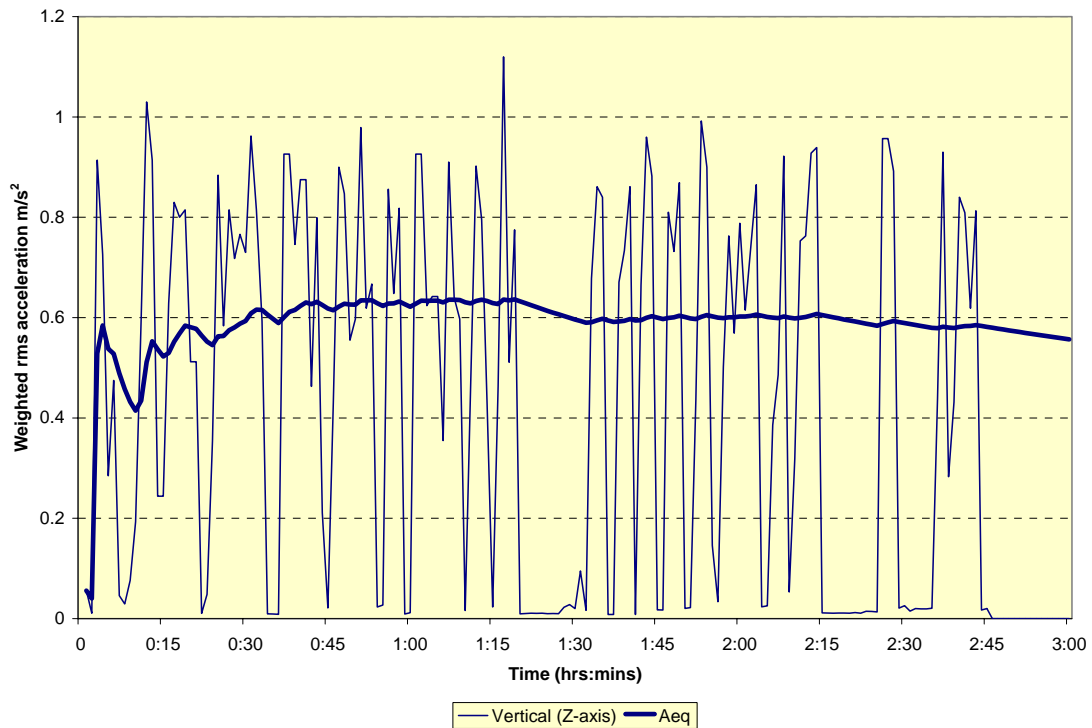
Figure A1.11.3 Linde 2.5 tonne fork lift truck:- time history of weighted 1-minute rms seat accelerations (Z-axis) and equivalent continuous rms acceleration (Aeq)

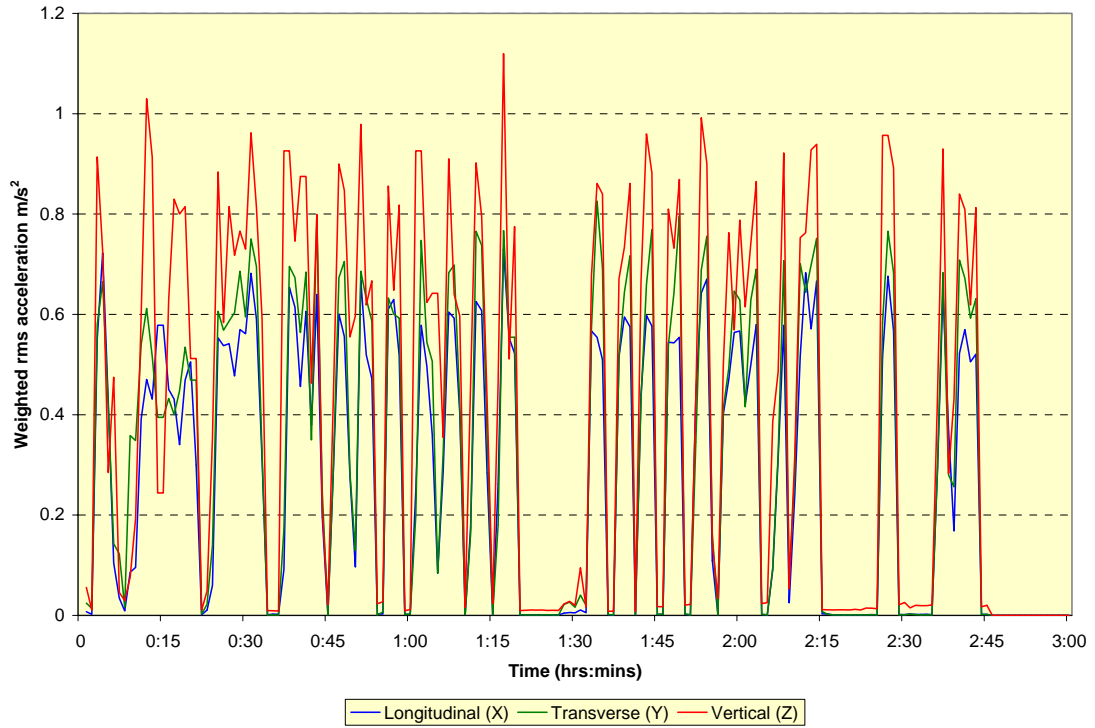
Figure A1.11.4 Linde 2.5 tonne fork lift truck:- time histories of weighted 1-minute rms seat accelerations (X, Y and Z-axes)

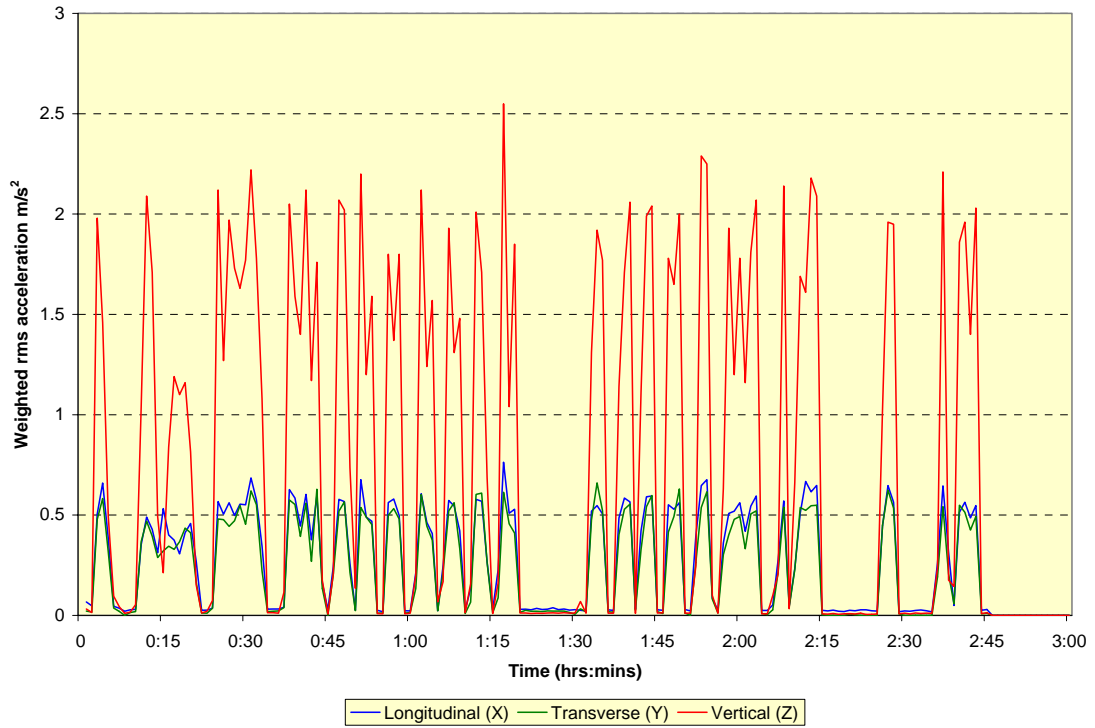
Figure A1.11.6 Linde 2.5 tonne fork lift truck:- time histories of weighted 1-minute rms floor accelerations (X, Y and Z-axes)

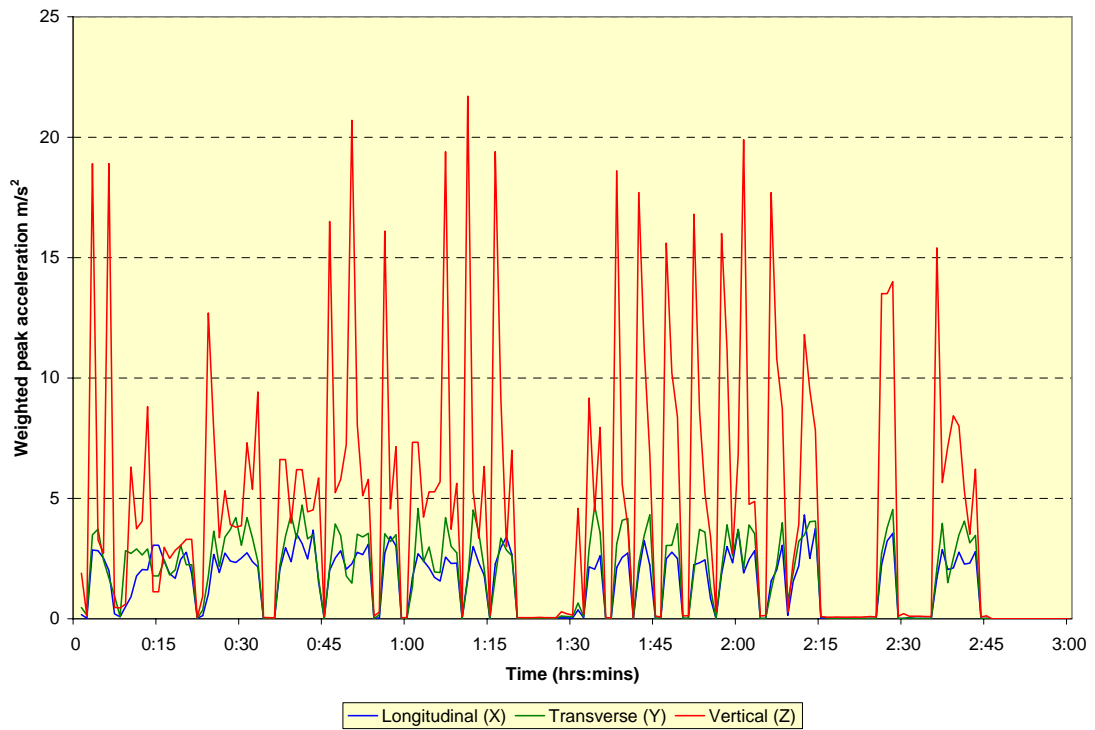
Figure A1.11.7 Linde 2.5 tonne fork lift truck:- time histories of weighted 1-minute peak seat accelerations (X, Y and Z-axes)

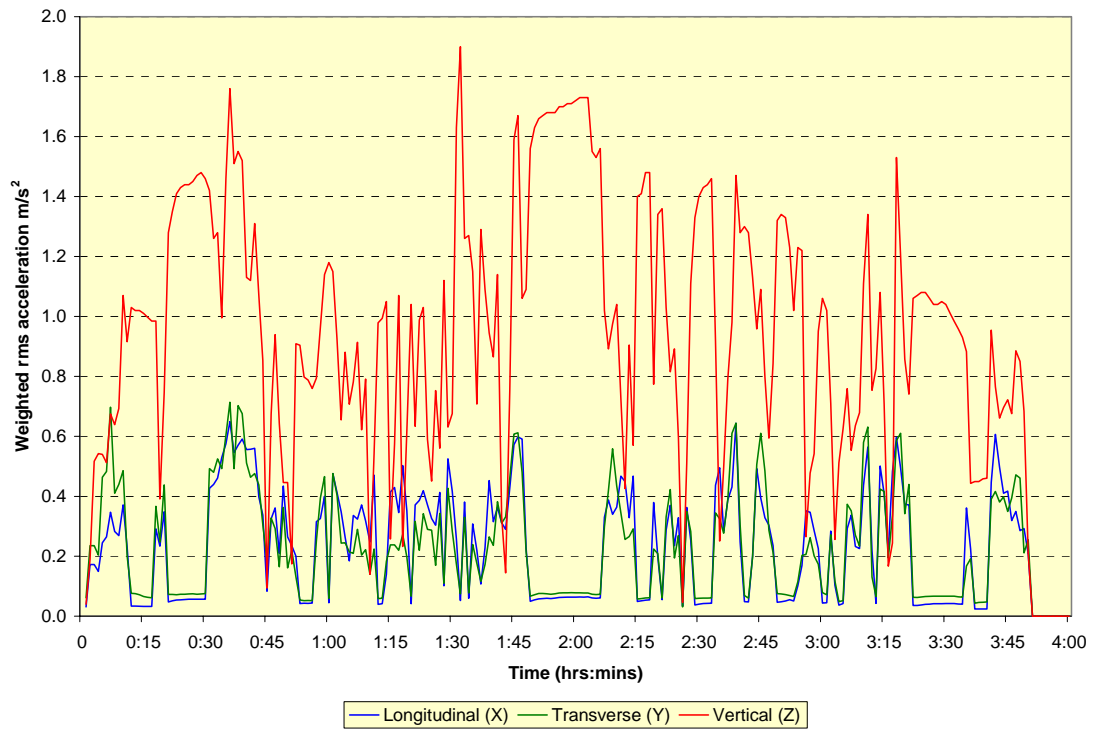
Figure A1.12.4 CAT D70 6.5 tonne fork lift truck:- time histories of weighted 1-minute rms seat accelerations (X, Y and Z-axes)

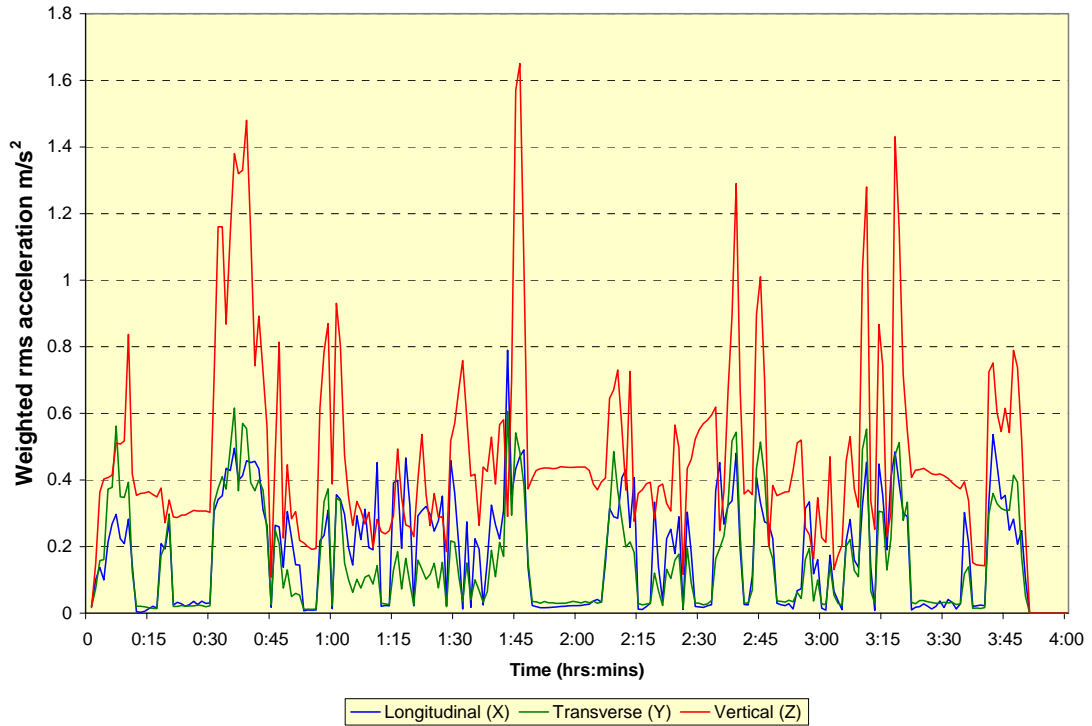
Figure A1.12.6 CAT D70 6.5 tonne fork lift truck:- time histories of weighted 1-minute rms floor accelerations (X, Y and Z-axes)

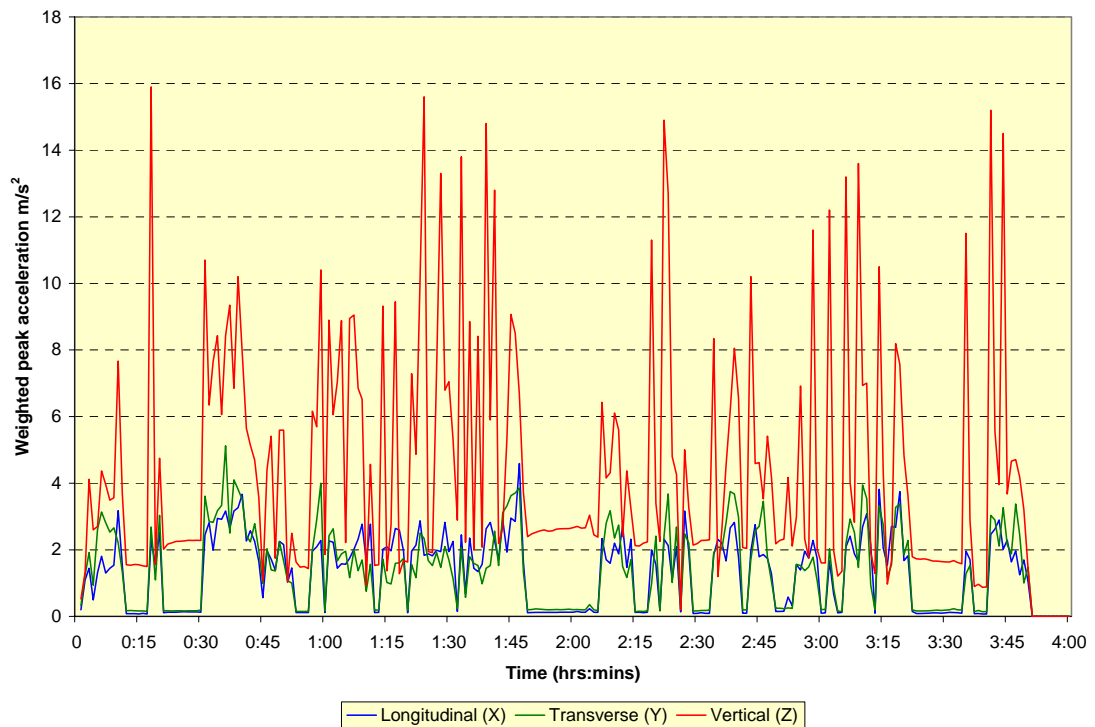
Figure A1.12.7 CAT D70 6.5 tonne fork lift truck:- time histories of weighted 1-minute peak seat accelerations (X, Y and Z-axes)

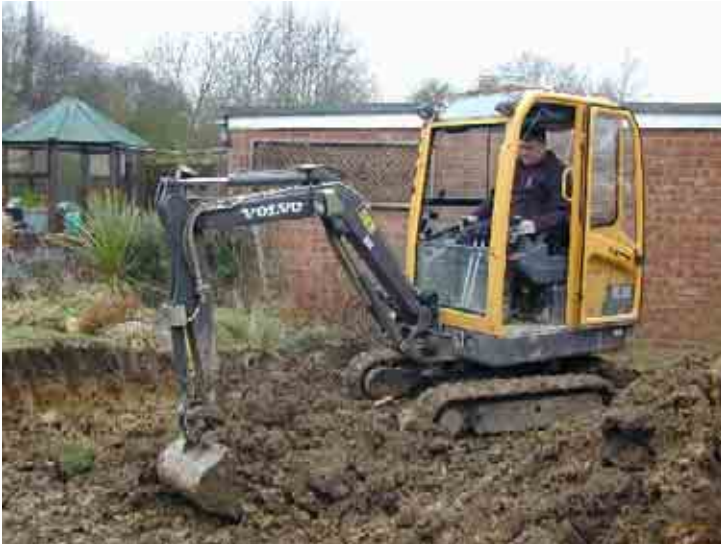
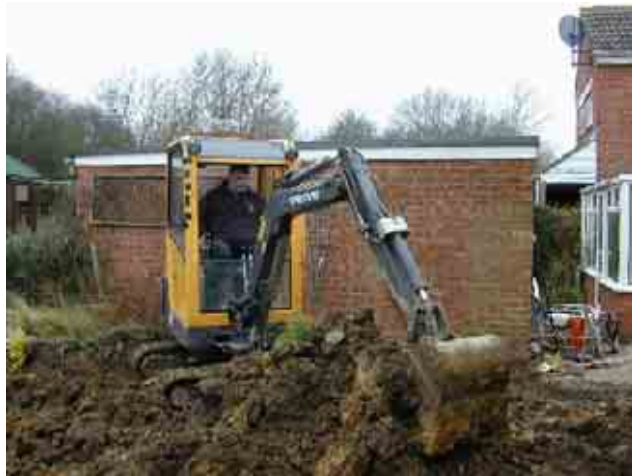
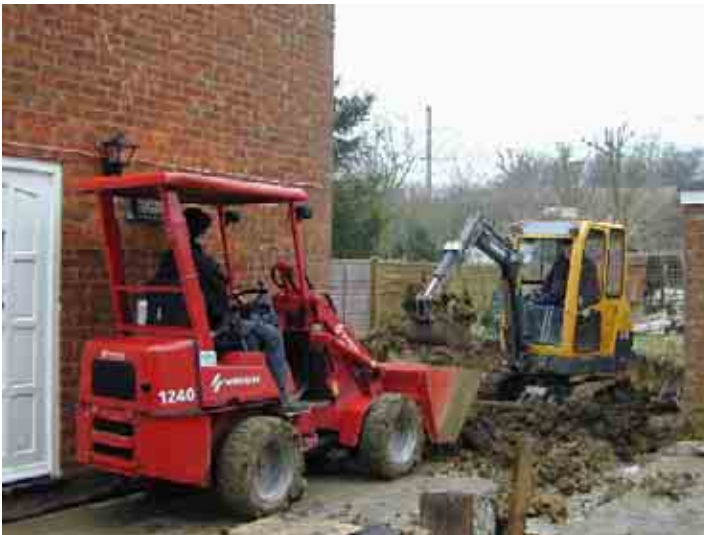
Figure A1.13.1 Volvo EC15B 1.5 tonne compact 360° excavator excavating footings for house extension and patio

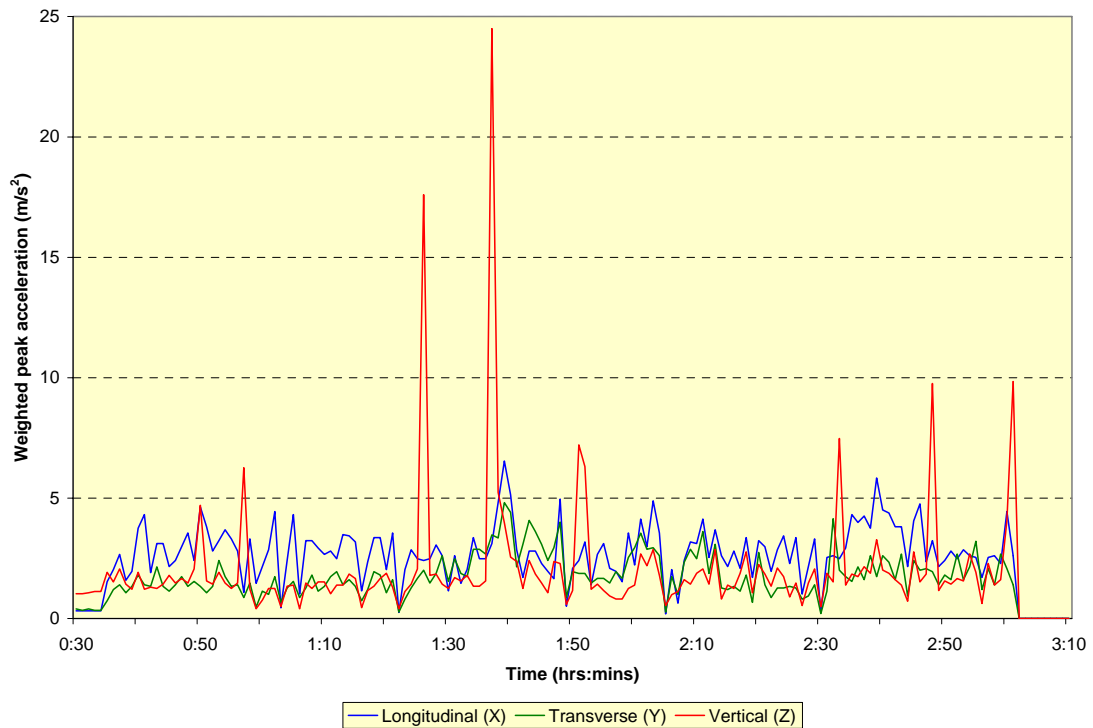
Figure A1.13.4 Volvo EC15B compact 360° excavator:- time histories of weighted 1-minute peak seat accelerations (X, Y and Z-axes)

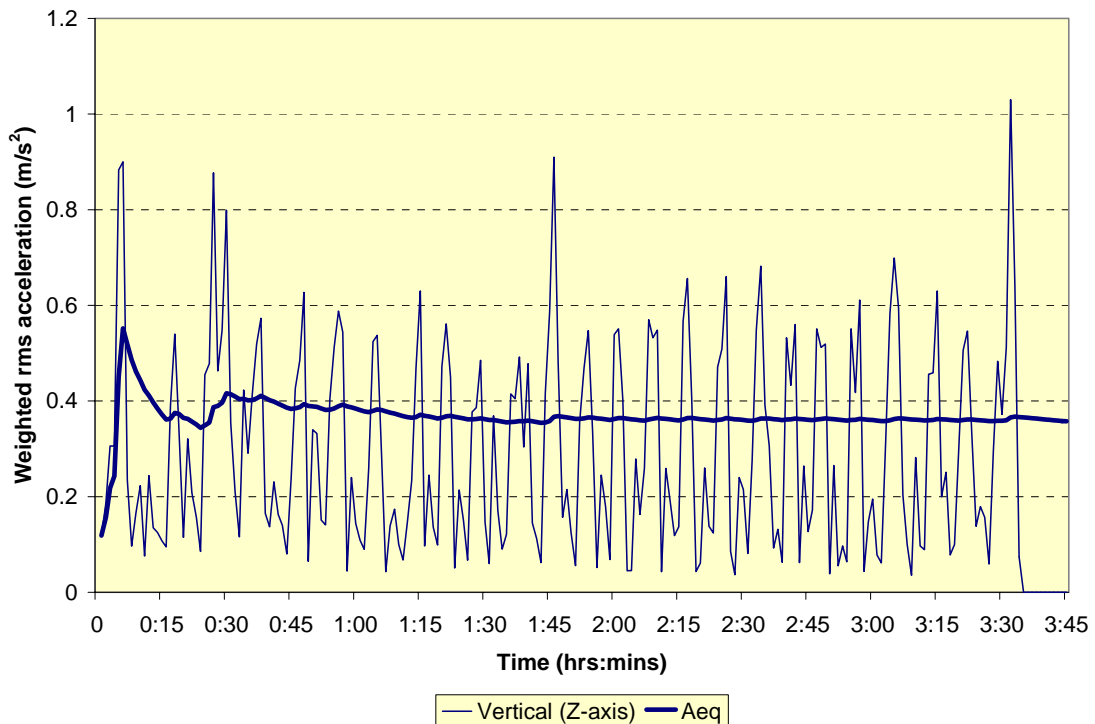
Figure A1.14.2 CAT Rigid Dump Truck:- time history of weighted 1-minute rms seat accelerations (Z-axis) and equivalent continuous rms acceleration (Aeq)

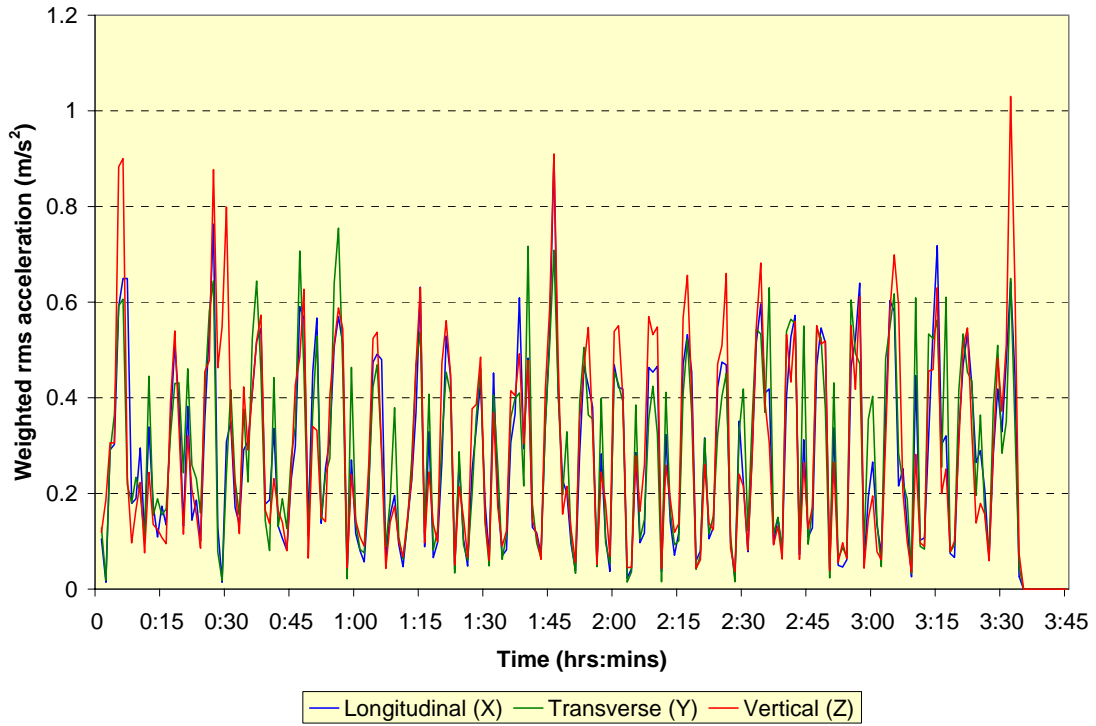
Figure A1.14.3 CAT Rigid Dump Truck:- time histories of weighted 1-minute rms seat accelerations (X, Y and Z-axes)

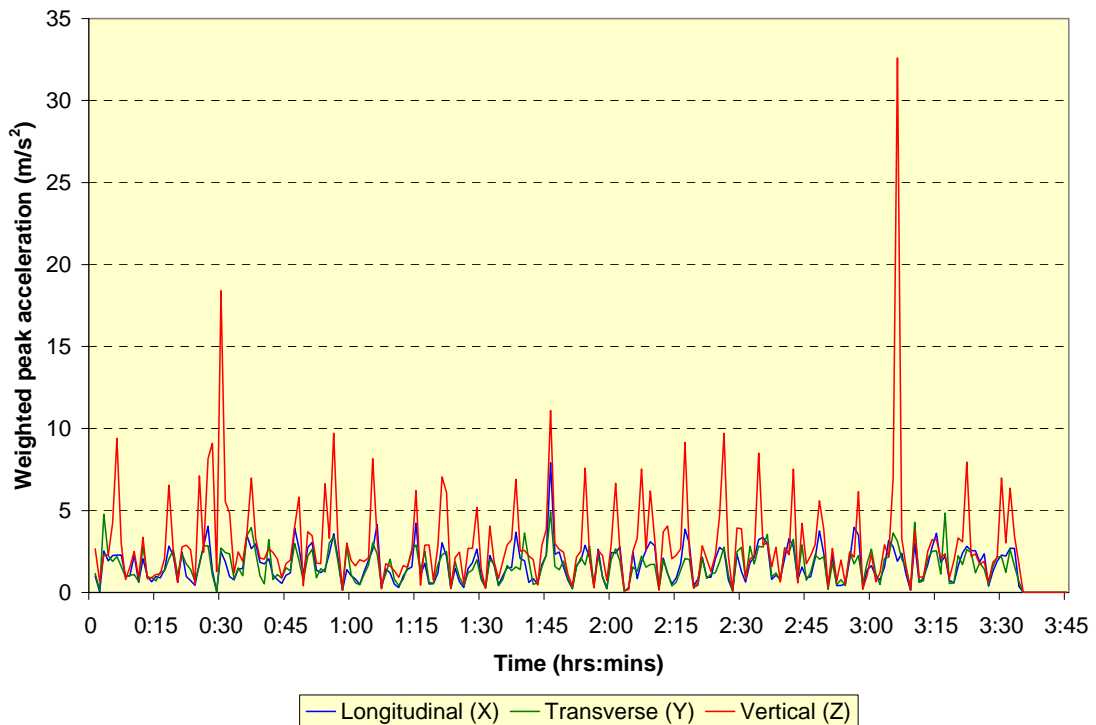
Figure A1.14.4 CAT Rigid Dump Truck:- time histories of weighted 1-minute peak seat accelerations (X, Y and Z-axes)

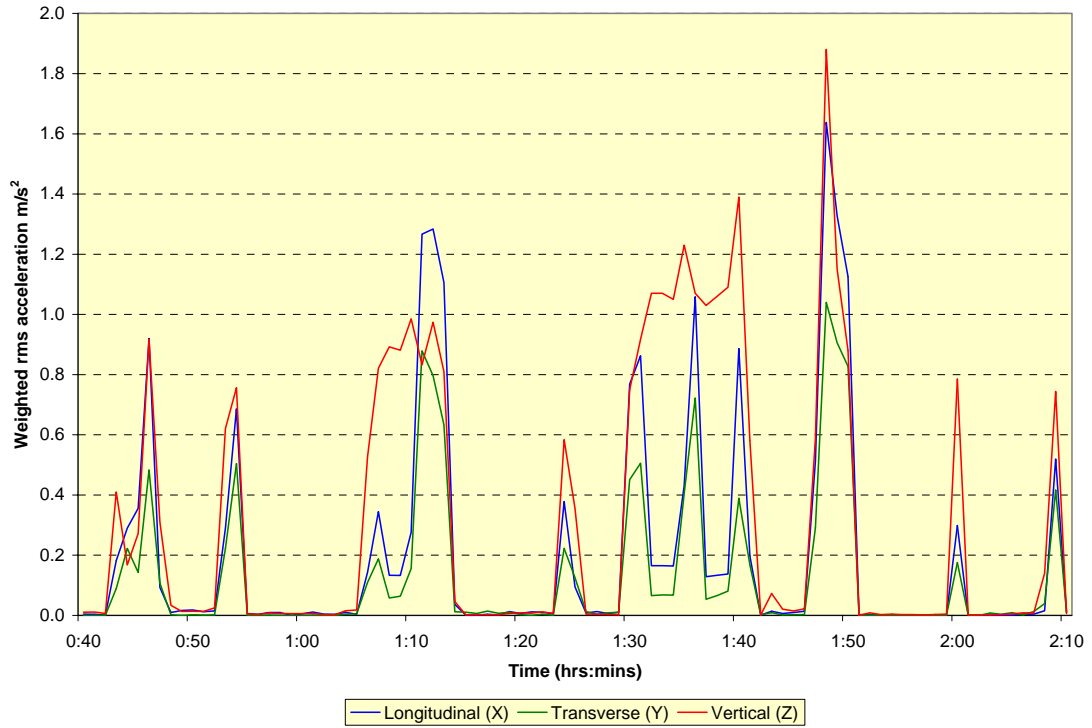
Figure A1.15.3 CAT Skidsteer Loader:- time histories of weighted 1-minute rms seat accelerations (X, Y and Z-axes)

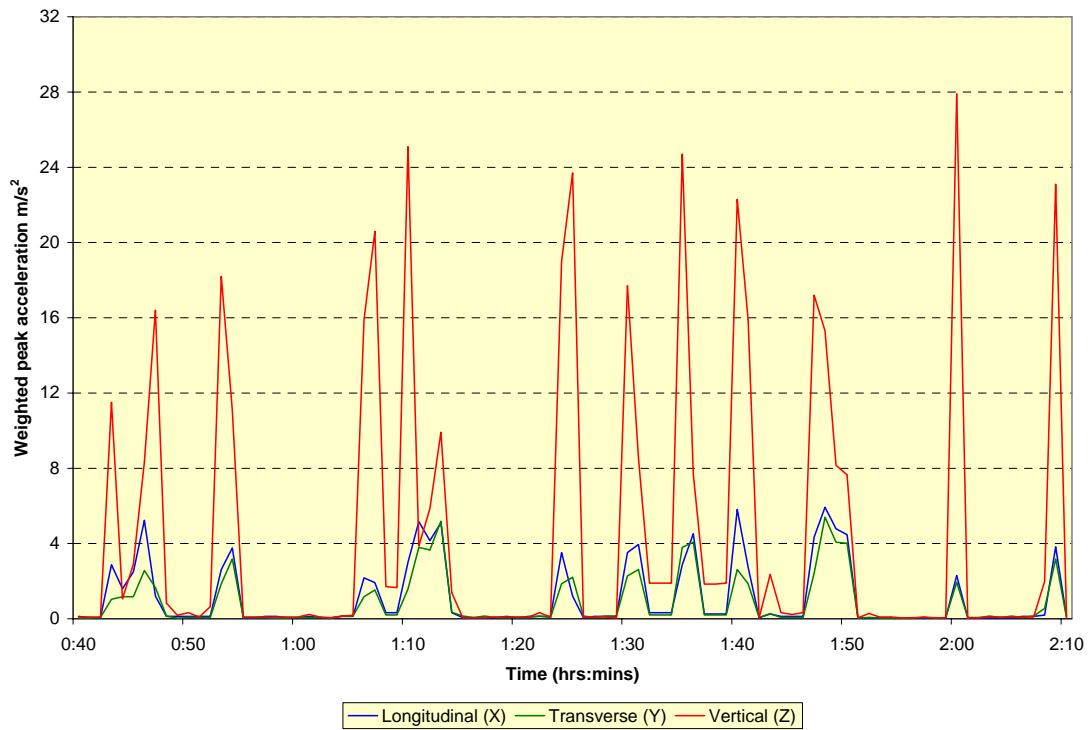
Figure A1.15.4 CAT Skidsteer Loader:- time histories of weighted 1-minute peak seat accelerations (X, Y and Z-axes)

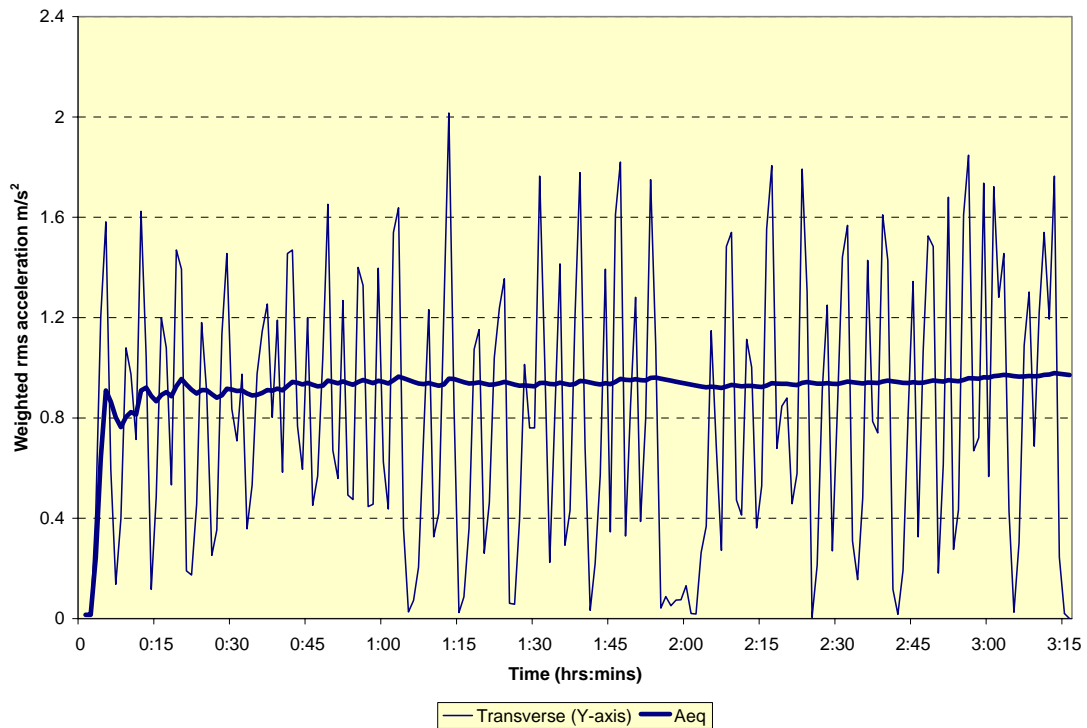
Figure A1.16.3 CAT Wheeled Scraper:- time history of weighted 1-minute rms seat accelerations (Z-axis) and equivalent continuous rms acceleration (Aeq)

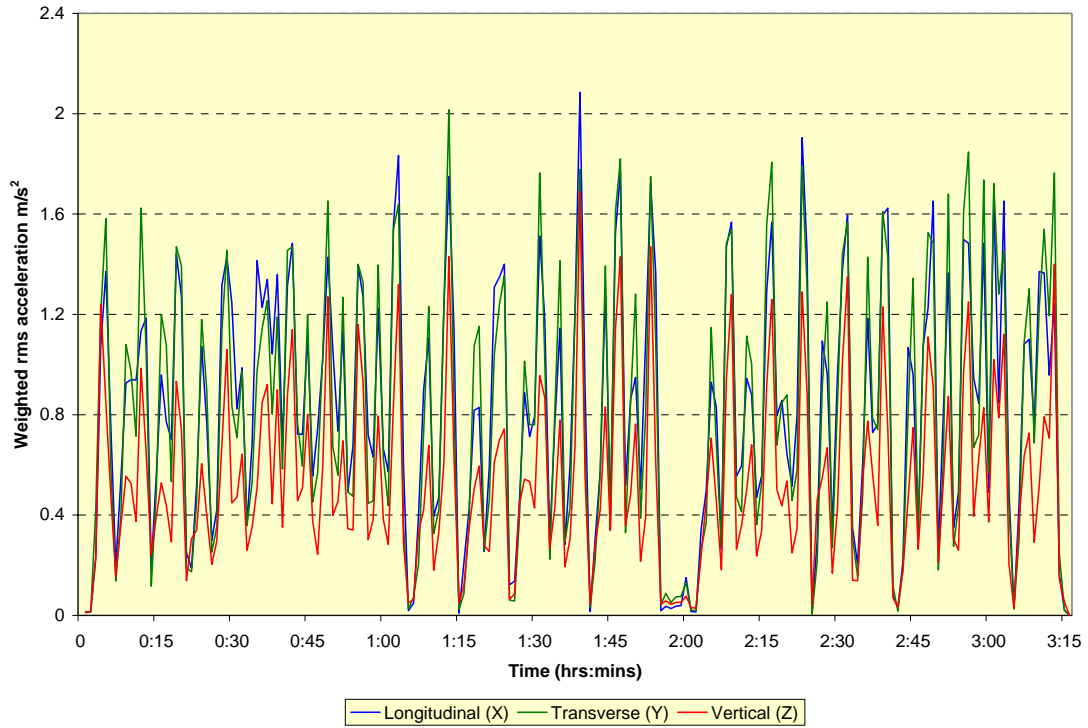
Figure A1.16.4 CAT Wheeled Scraper:- time histories of weighted 1-minute rms seat accelerations (X, Y and Z-axes)

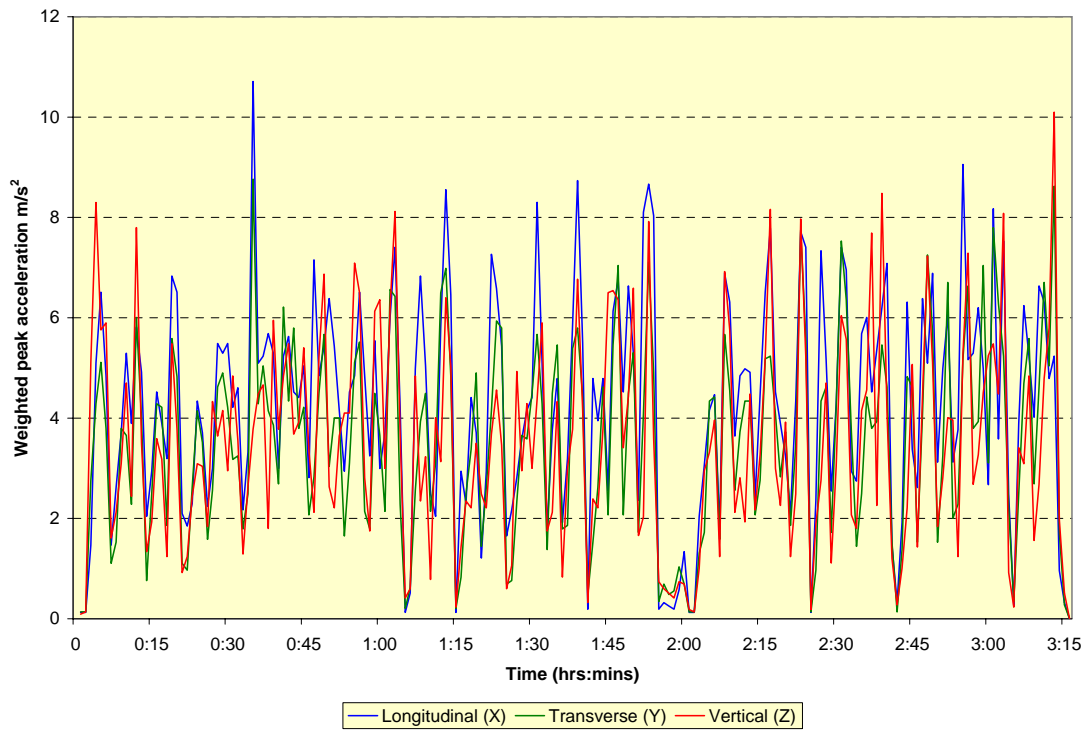
Figure A1.16.5 CAT Wheeled Scraper:- time histories of weighted 1-minute peak seat accelerations (X, Y and Z-axes)
