# **Whole-body vibration on construction, mining and quarrying machines**

Evaluation of emission and estimated  
exposure levels

Prepared by **Silsoe Research Institute**  
for the Health and Safety Executive 2005

**RESEARCH REPORT 400**

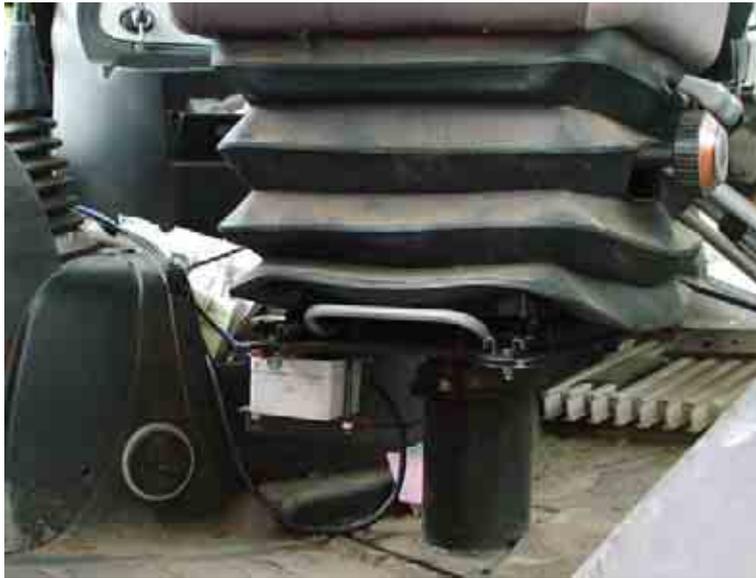
**Figure 2.1** 'Floor' tri-axial accelerometer configuration (Transducer set 1)

Tri-axial vibration present on the cab floor, close to the seat mounting point was measured using an array of three mutually-perpendicular piezo-resistive accelerometers with integral signal conditioning (*IC Sensors type 3140-005*), housed within a rigid plastic enclosure (see Figure 2.1). Vibration on the driver's seat was measured by placing a semi-rigid mounting disc, incorporating a tri-axial 100mV/g ICP accelerometer (*PCB model 356B40*), on the seat cushion, approximately between the driver's ischial tuberosities (vertically below the Seat Index Point). The operator presence switch, which was actually an array of 4 switches connected in parallel, was fitted immediately over the seat accelerometer pad. The seat pad was attached to the cushion using a combination of double-sided tape and "Gaffa" tape, and the operator presence switch by means of "Gaffa" tape alone. The whole was covered with a thin polythene sheet for protection (see Figure 2.2).

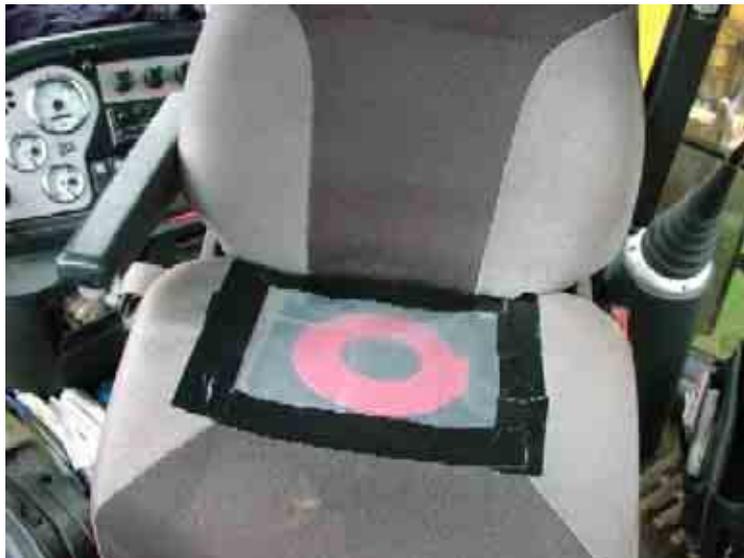
**Figure 2.2** 'Seat' accelerometer configuration incorporating operator presence switch

Independently of the above two transducer configurations, measurements were made upon certain target machines with two tri-axial 100mV/g ICP accelerometers (*PCB model 356B40*). One of these was attached to the machine floor by a magnetic clamp as for transducer set 2 (see Figure 2.3), while the other was fitted into a pad that was attached to the seat cushion (as in Figure 2.2). As in both of the above arrangements, a switch array was used to detect operator presence.

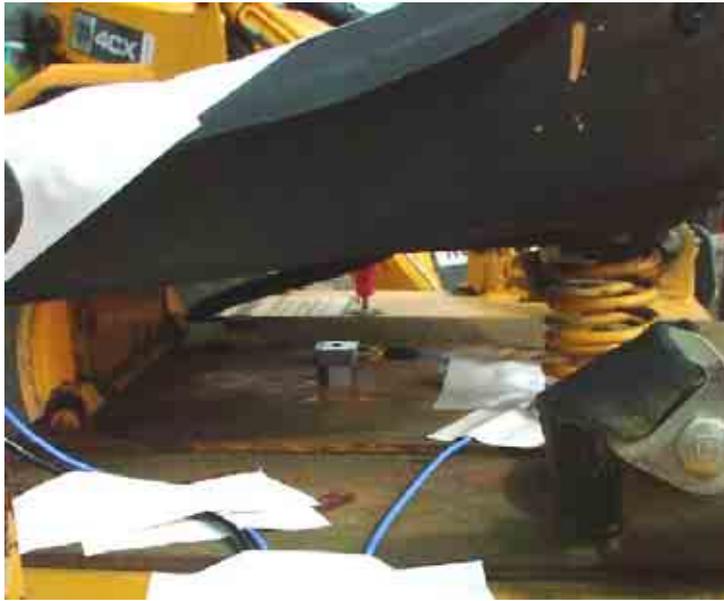
**Figure 2.3** Tri-axial 'Floor' accelerometer installation using magnetic mounting

In some machines there was not enough space for the piezo-resistive floor accelerometer box. In these cases, the tri-axial accelerometer from the PCB seat pad (*PCB model 356B40*) was attached to the machine by means of a magnetic clamp (see Figure 2.3), and a pad containing a tri-axial piezoelectric accelerometer (*B&K model 4322*) substituted on the seat surface.

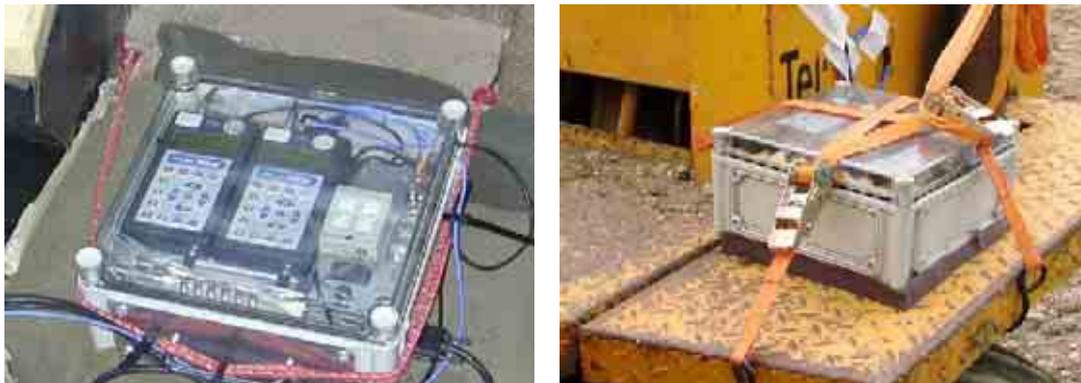
**Figure 2.4** Data acquisition pack installations on machines: within cab (left) and 'alfresco' (right)

The data acquisition pack used with transducer sets 1 and 2 (see Section 2.1) also included signal conditioning for the piezo-resistive floor accelerometers. This arrangement produced a compact and rugged system that was suitable for attachment either inside or outside the cabs of the machines to be investigated (see Figure 2.4). The digitising rates of the PC card recorders were set to 500 Hz.

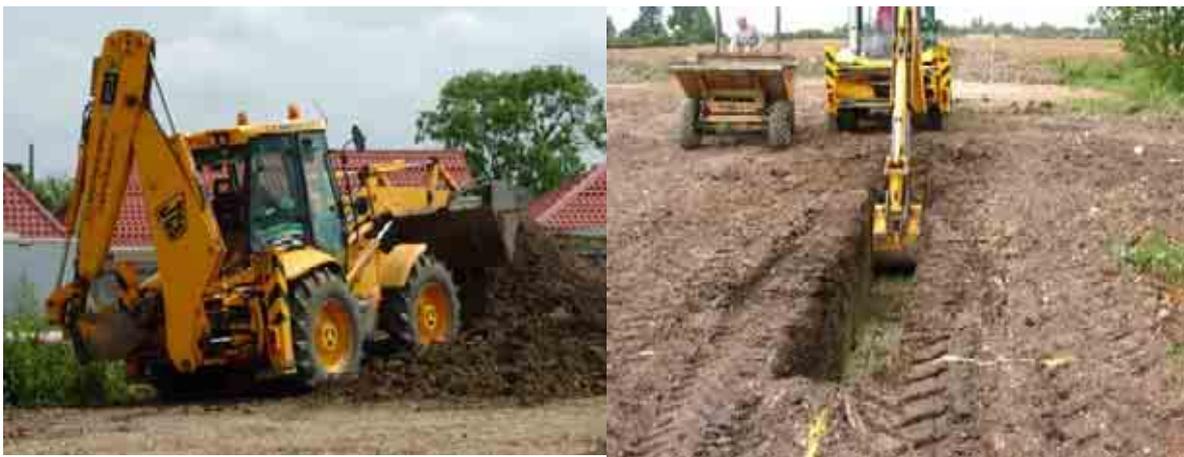
**Figure A1.1.1** JCB 4CX Super backhoe loader at work on-site

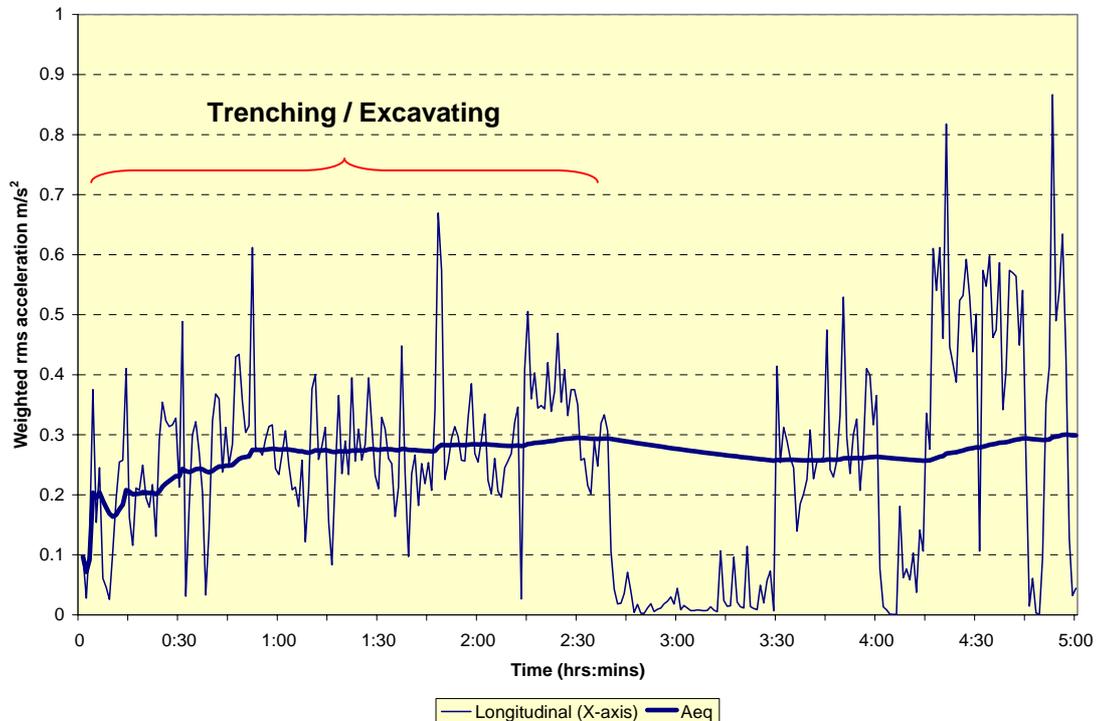
**Figure A1.1.2** JCB 4CX backhoe loader:- time history of weighted 1-minute rms seat accelerations (X-axis) and equivalent continuous rms acceleration (Aeq) – entire measurement period

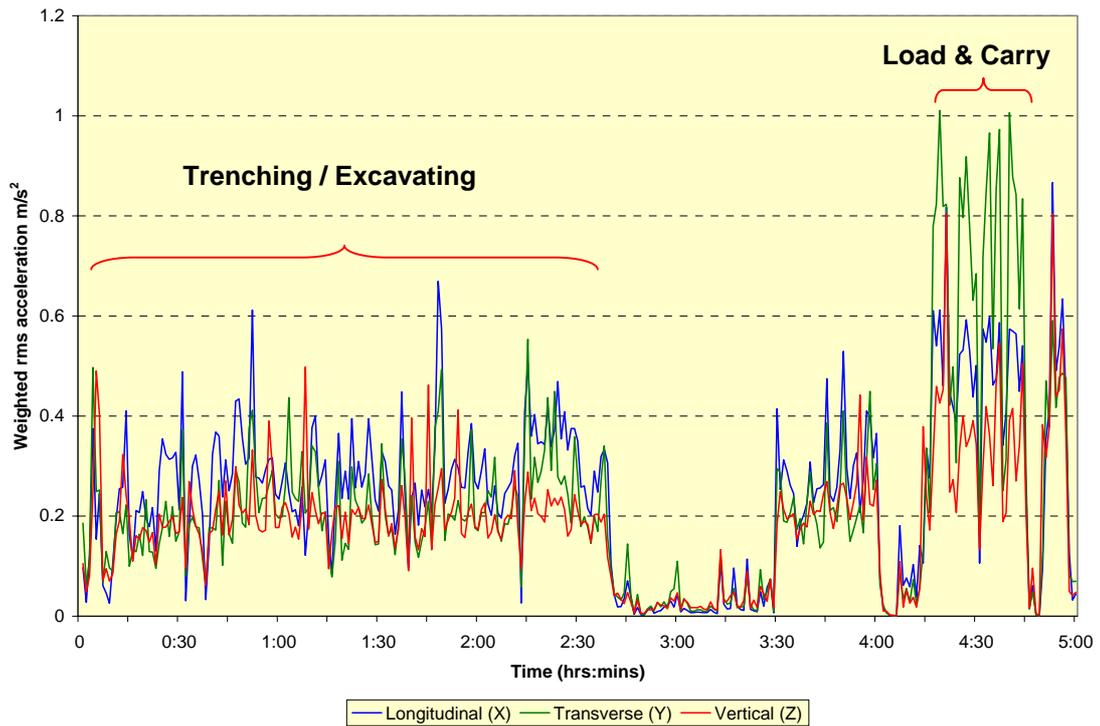
**Figure A1.1.3** JCB 4CX backhoe loader:- time histories of weighted 1-minute rms seat accelerations (X, Y and Z-axes) – entire measurement period

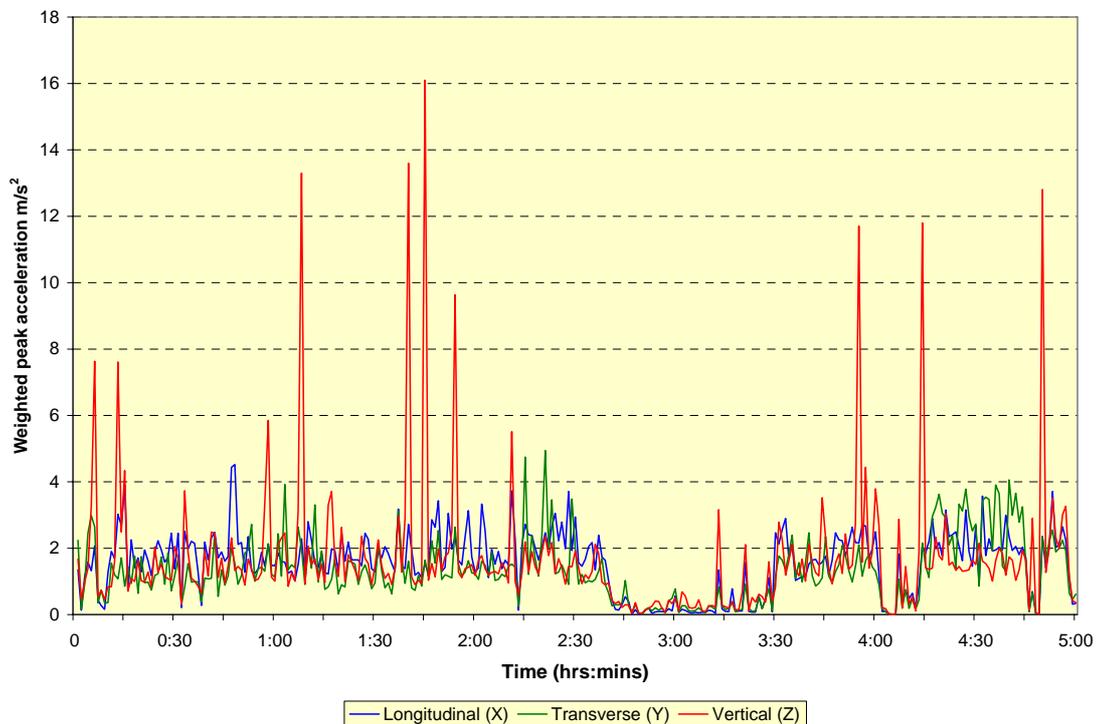
**Figure A1.1.4** JCB 4CX backhoe loader:- time histories of weighted 1-minute peak seat accelerations (X, Y and Z-axes) – entire measurement period

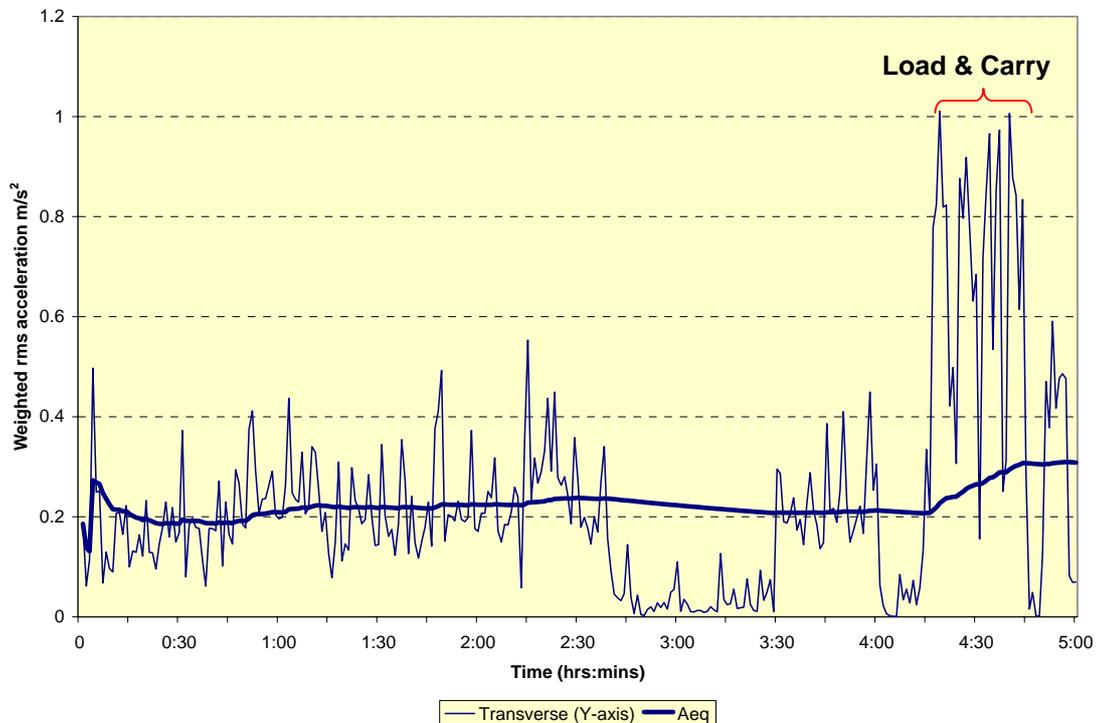
**Figure A1.1.6** JCB 4CX backhoe loader:- time history of weighted 1-minute rms seat accelerations (Y-axis) and equivalent continuous rms acceleration (Aeq) – entire measurement period

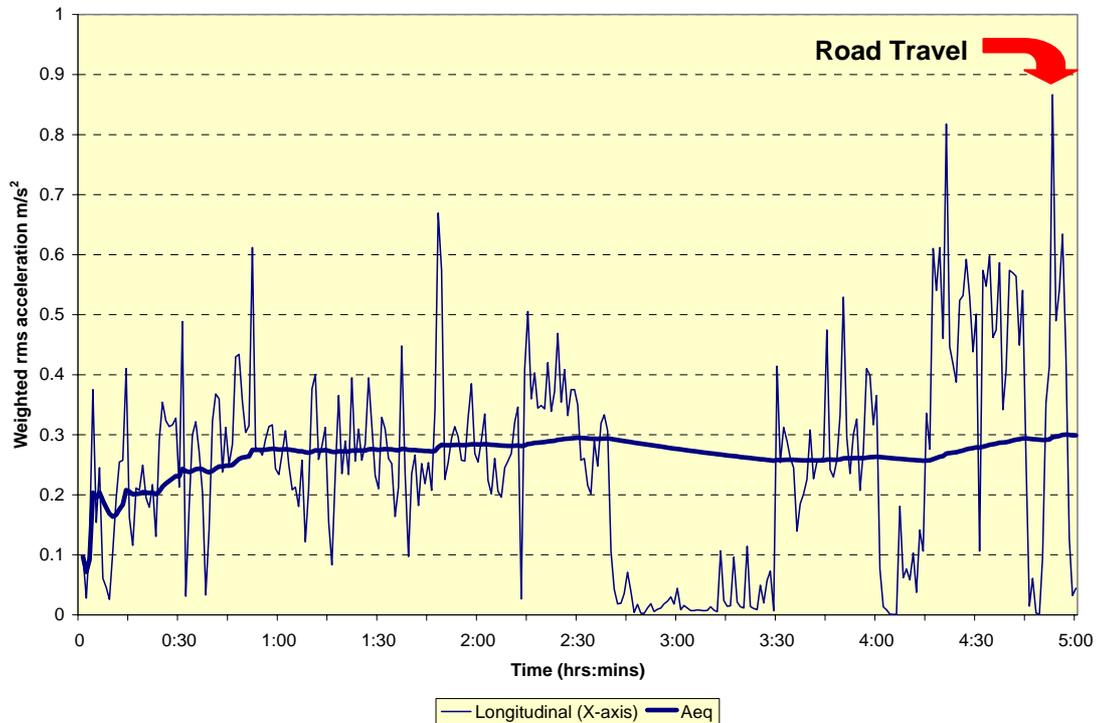
**Figure A1.1.11** JCB 4CX backhoe loader:- time history of weighted 1-minute rms seat accelerations (X-axis) and equivalent continuous rms acceleration (Aeq) – entire measurement period

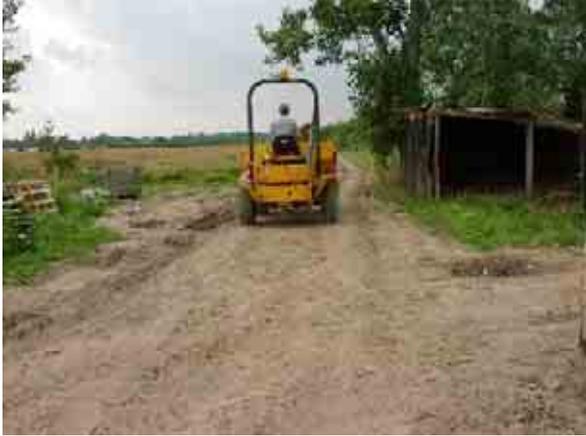
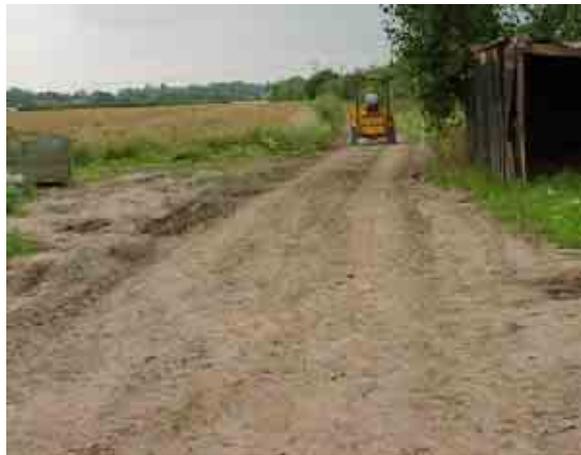
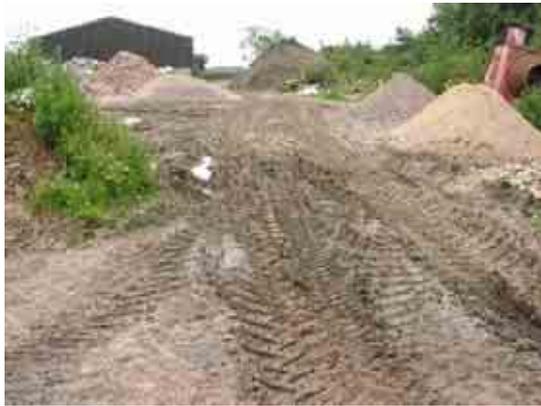
**Figure A1.2.2** Thwaites 3-tonne articulated site dumper undertaking 'soil transport'

- 1) Spoil Removal:-** While a Backhoe Loader was excavating footings for 15m x 7m house using backhoe, the Site Dumper removed the spoil to a nearby spoil heap ('V-shaped motion'). The distance between the Loader and the heap varied from 30m down to less than 10m. The cycle time was almost constant at about 4 minutes. The driver remained in his seat most of the time.
- 2) Soil Transport:-** Moving spoil along farm track to new location on-site. Total distance about 330m; cycle time about 8 minutes. Track relatively smooth - pot holes absent, maintained in good condition.

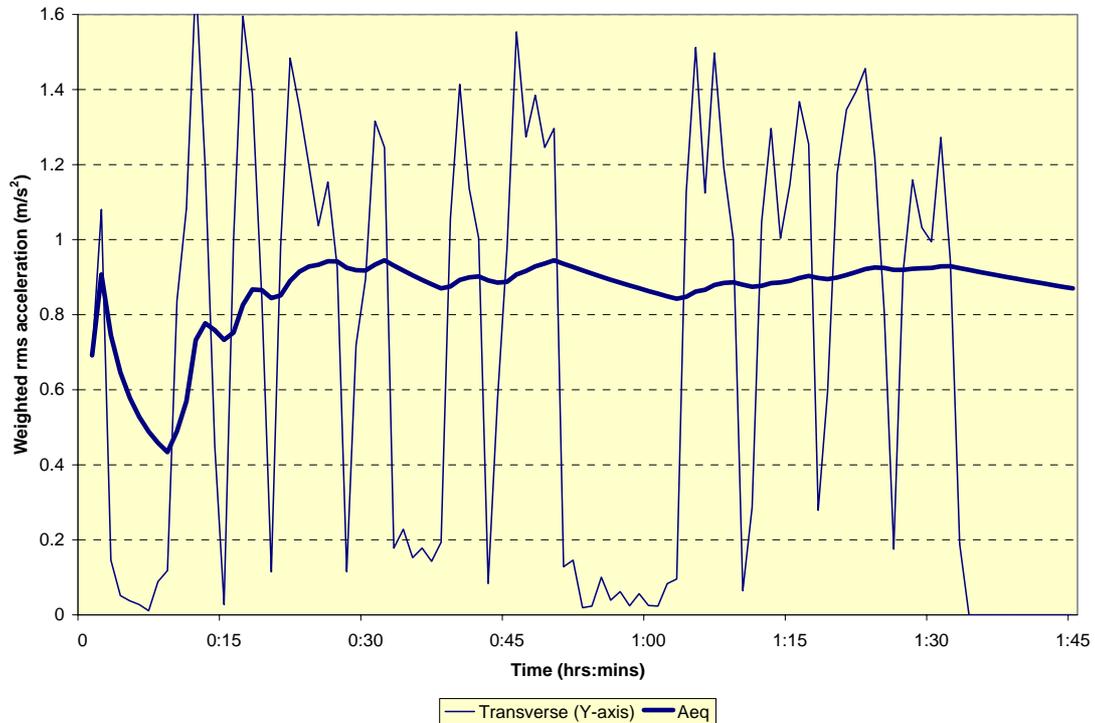
**Figure A1.3.2** Caterpillar 25-tonne Articulated Dump Truck:- time history of weighted 1-minute rms seat accelerations (Y-axis) and equivalent continuous rms acceleration (Aeq)

Full details of this machine, operating application and resulting WBV levels are presented in Appendix 1.3. Despite what were considered to be moderate – favourable operating conditions, this machine exhibited one of the highest sets of WBV magnitudes of those investigated in this study, the highest component appearing in the transverse (Y) axis, followed (in slightly lower magnitude) by the longitudinal (X) axis (see Table 4.1). The haul road was reported to be relatively well maintained, yet the driver restricted his forward speed because of WBV discomfort. As expected, the suspension seat did little to attenuate the vertical (Z-axis) vibration, whose energy was primarily in the region of 1.5 Hz: this being below the practical attenuation limit for seat suspensions (typically ~ 2 Hz). However the Z-axis component was significantly lower than that in the transverse (Y) and longitudinal (X) axes. The operator would approach the Exposure Limit Value (ELV) during a normal working shift, and probably exceed it if operating conditions were poorer. Risk would best be minimised by operator training in 'Best Practice' and maintenance of haul roads (as was the case in this application).

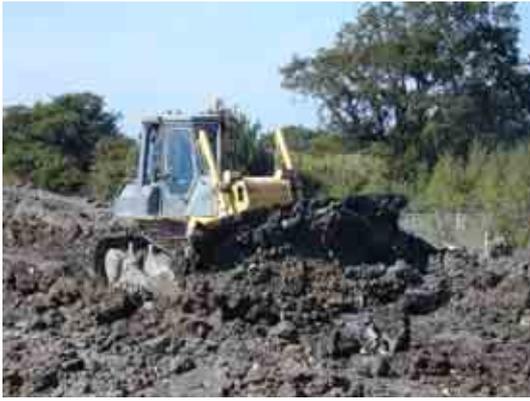
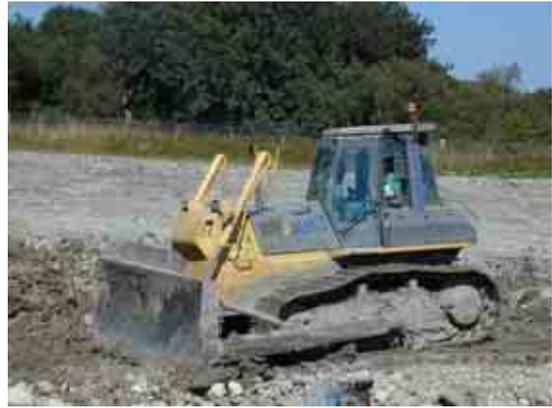
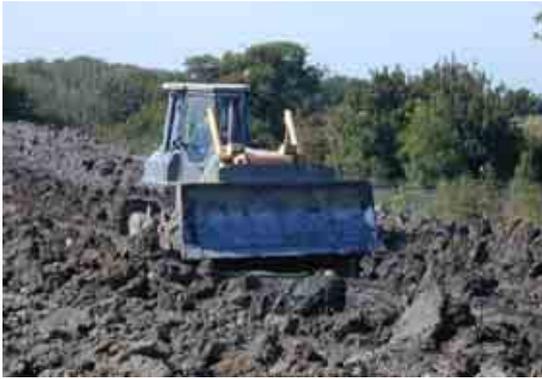
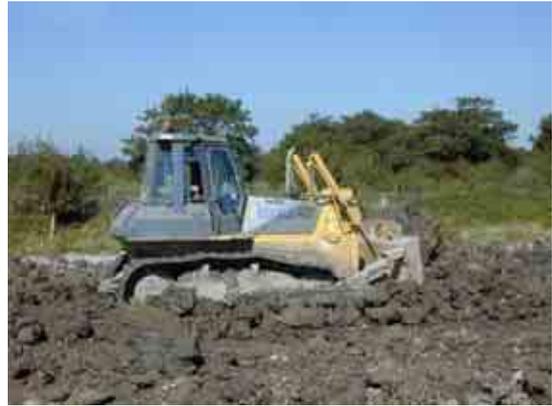
**Figure A1.4.1** Komatsu D65EX-12 bulldozer at work on-site

**Driver's Suspension Seat:-** KAB Model No. 411 scissor-type, mechanical spring and damper z-axis suspension. Seat upholstery in acceptable condition, but the suspension system is very worn & also set very firmly, giving little vibration isolation in the vertical axis. Additionally, the seat upper, which has tilt adjustments, is poorly attached to the seat suspension system and is capable of a degree of fore and aft pitch. A seat belt is fitted to the seat but is not used by the operator.

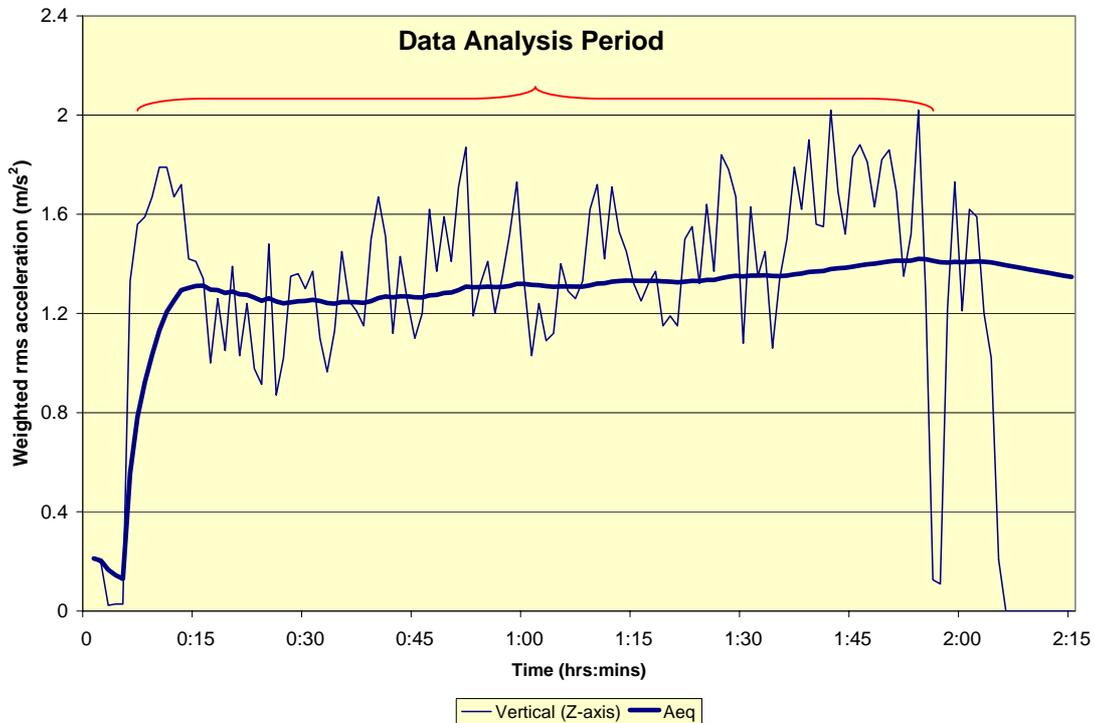
**Figure A1.4.2** Komatsu Dozer:- time history of weighted 1-minute rms seat accelerations (Z-axis) and equivalent continuous rms acceleration (Aeq)

Full details of this machine, operating application and resulting WBV levels are presented in Appendix 1.4. In ‘as found’ condition, this machine exhibited the highest WBV levels encountered in the study, passing the ELV in little more than half a day. This was dominated by the vertical (Z-axis) vibration component, as a result of a very badly maintained (and largely dysfunctional) suspension seat.

The vibration encountered had most of its energy at frequencies above 5 Hz; primarily a result of the characteristic vibration frequency spectrum generated by the dozer’s track undercarriage (soil conditions being soft / moderate). However, the SEAT value in this instance was 1.16. This application or rather the frequency distribution of vertical (Z) axis vibration energy, places a significant demand upon a suspension seat, albeit one well within its capabilities if properly maintained and replaced at the end of its service life (~ 4000 hrs). This had not occurred in this application, the dozer having reached 8600 operating hours with the original seat. An appropriate seat for such a machine, properly maintained, should have a SEAT value of about 0.6, which would reduce the operator’s WBV exposure to a much more moderate level.

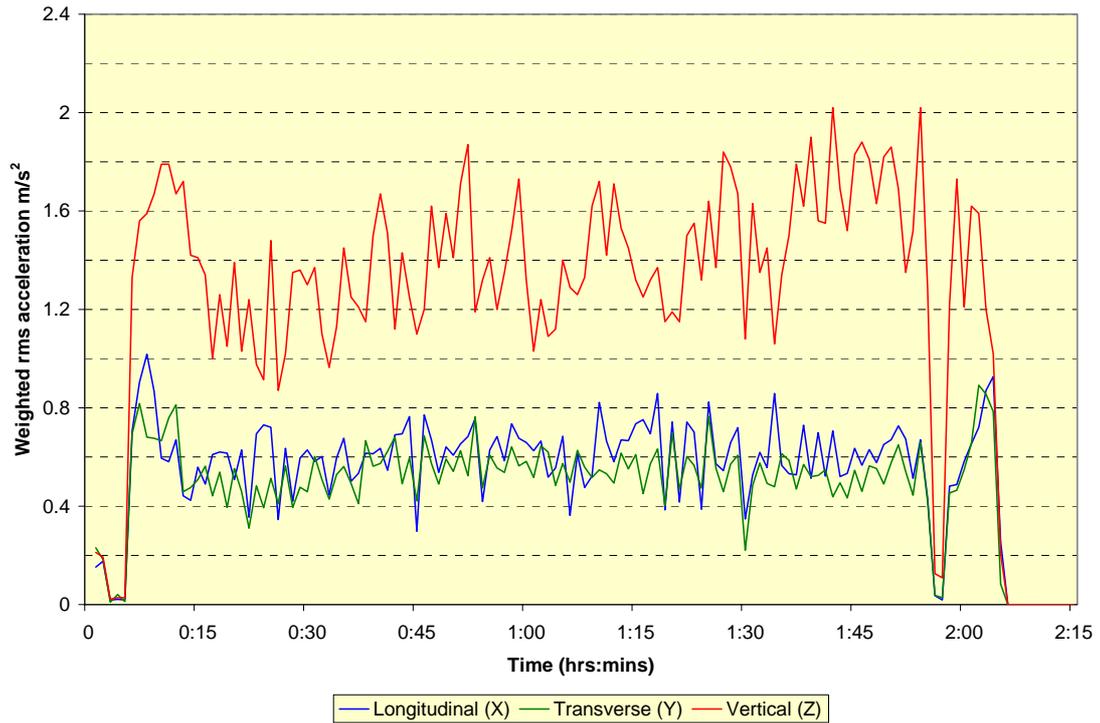
**Figure A1.4.3** Komatsu Dozer:- time histories of weighted 1-minute rms seat accelerations (X, Y and Z-axes)

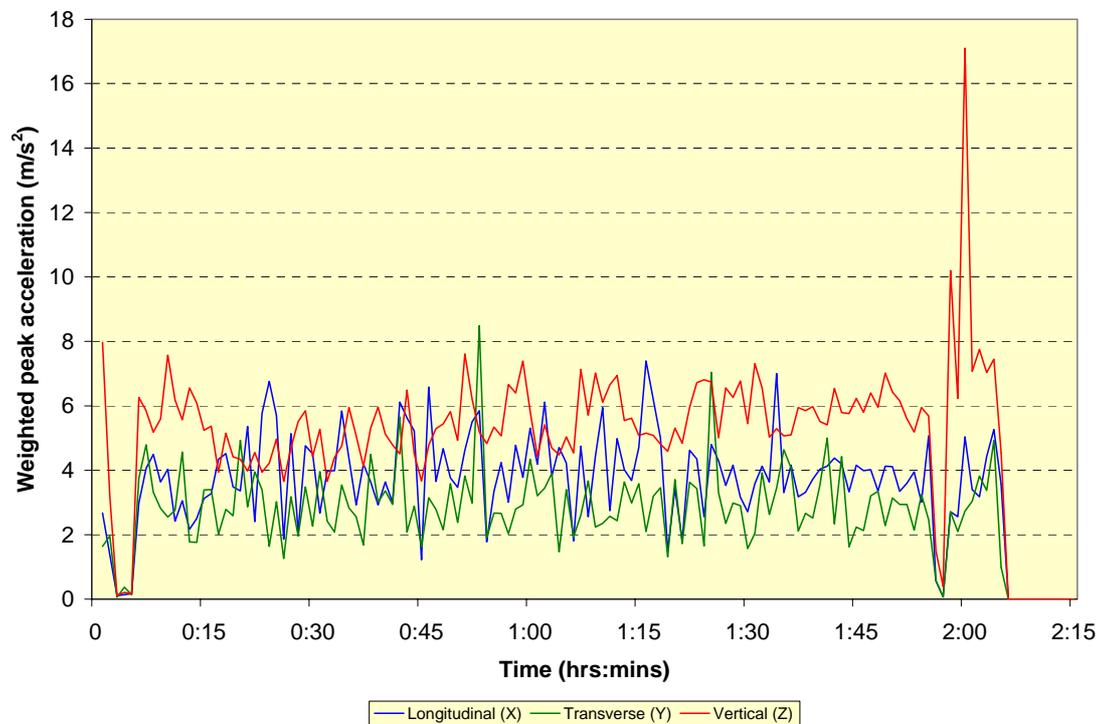
**Figure A1.4.4** Komatsu Dozer:- time histories of weighted 1-minute peak seat accelerations (X, Y and Z-axes)

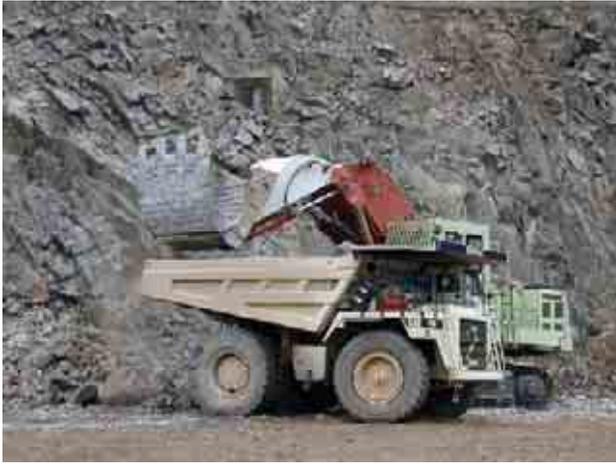
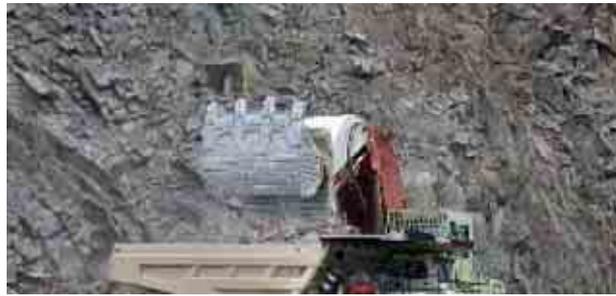
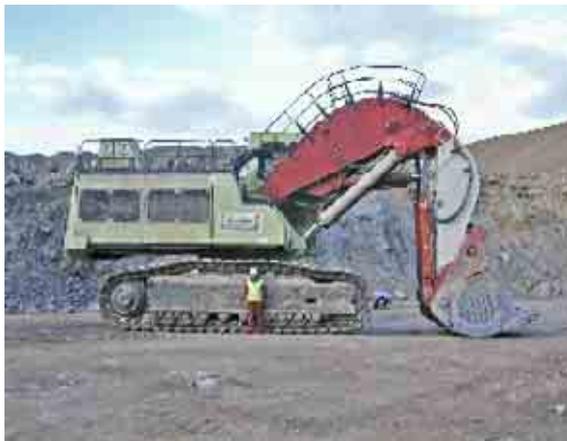
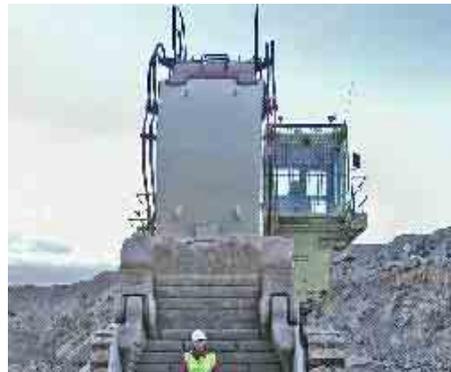
**Figure A1.5.1** Liebherr R994 face shovel – at rest and play

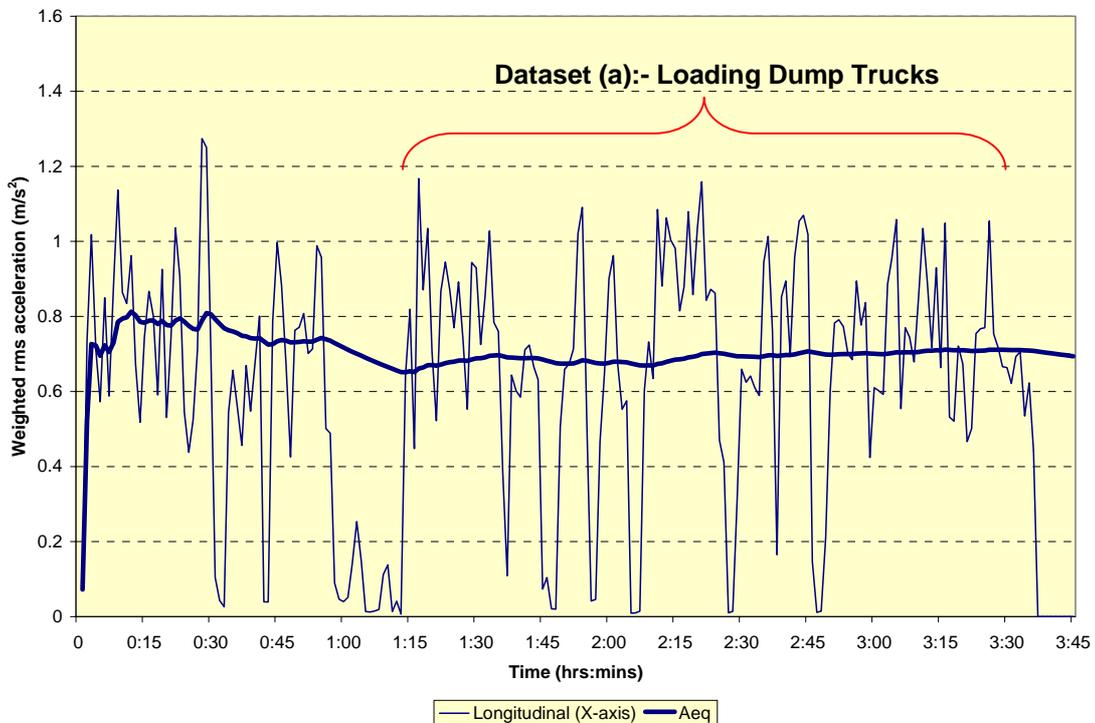
**Figure A1.5.2** Liebherr Face Shovel:- time history of weighted 1-minute rms seat accelerations (X-axis) and equivalent continuous rms acceleration (Aeq) – entire recording period

Full details of this machine, operating applications and resulting WBV levels are presented in Appendix 1.5. For most of its operating time, i.e. when loading rock into dump trucks after blasting (see Appendix 1.5.2), the vibration levels were found to be only moderate, with the largest component in the longitudinal (X) axis. The seat did reduce the vertical (Z-axis) vibration component, which has most of its energy at frequencies above 6 Hz. The vibration magnitude in the vertical (Z-axis) direction was very much higher when the machine ‘tracked’ (travelled under its own power) from the quarry face to a safety zone, prior to daily blasting (see Appendix 1.5.3). However this activity only takes about 16 – 18 minutes per day and so is of little consequence in a 12 hour shift. During excavating / loading dump trucks, the more important longitudinal (X-axis) vibration component has energy in a band of frequencies between 1 Hz and 5 Hz. There is limited scope for controlling this with fore-and-aft seat suspension and, as in the case of articulated loading shovels, it is important that the cab mounting system (which in this instance incorporated vibration isolation) is so designed that the fore-and-aft shocks generated when the bucket enters the rock pile is not amplified into the rocking motion of the cab. Maintenance of machine cab vibration isolation systems is therefore important.

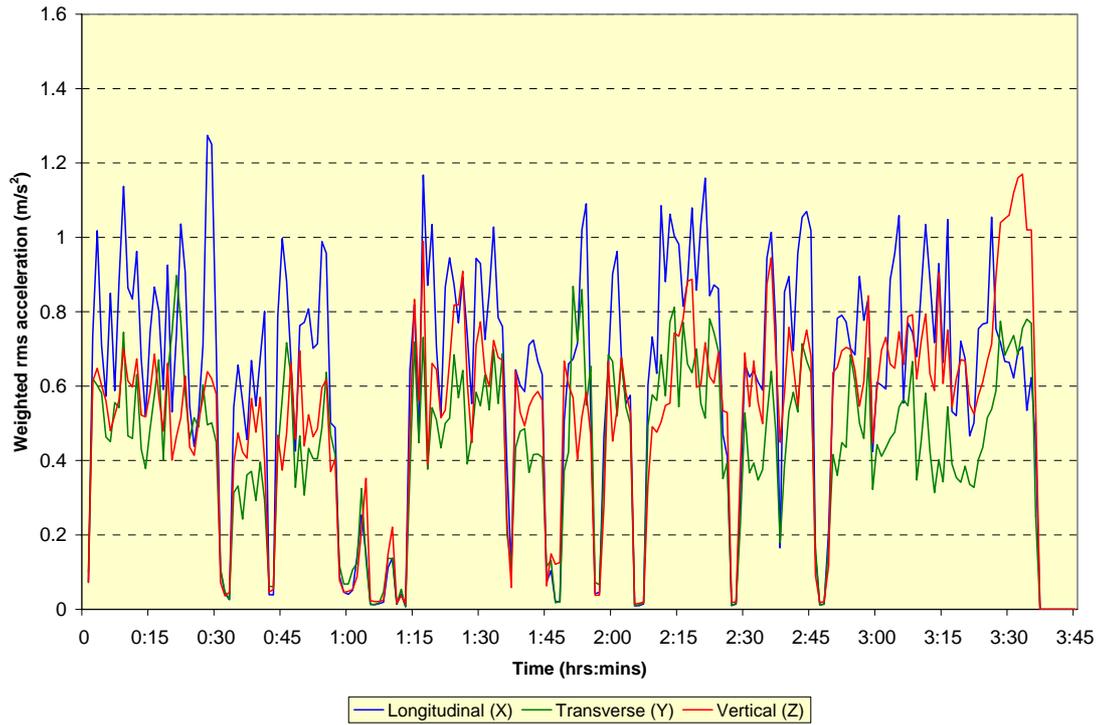
**Figure A1.5.3** Liebherr Face Shovel:- time histories of weighted 1-minute rms seat accelerations (X, Y and Z-axes) – entire recording period

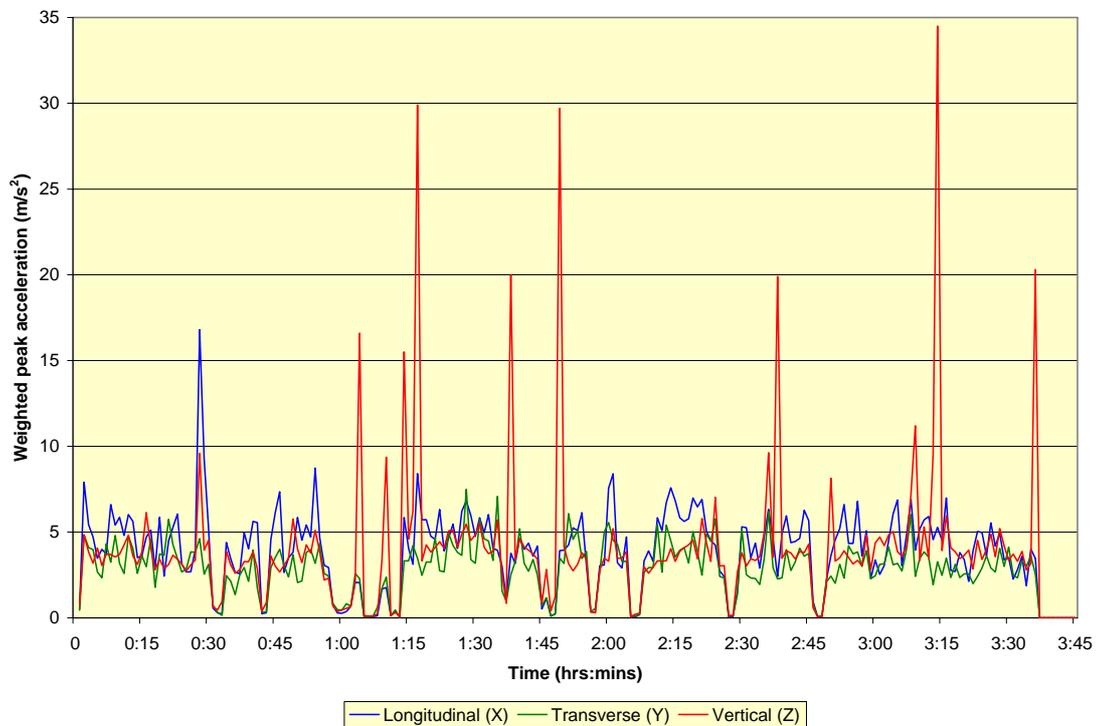
**Figure A1.5.4** Liebherr Face Shovel:- time histories of weighted 1-minute peak seat accelerations (X, Y and Z-axes) – entire recording period

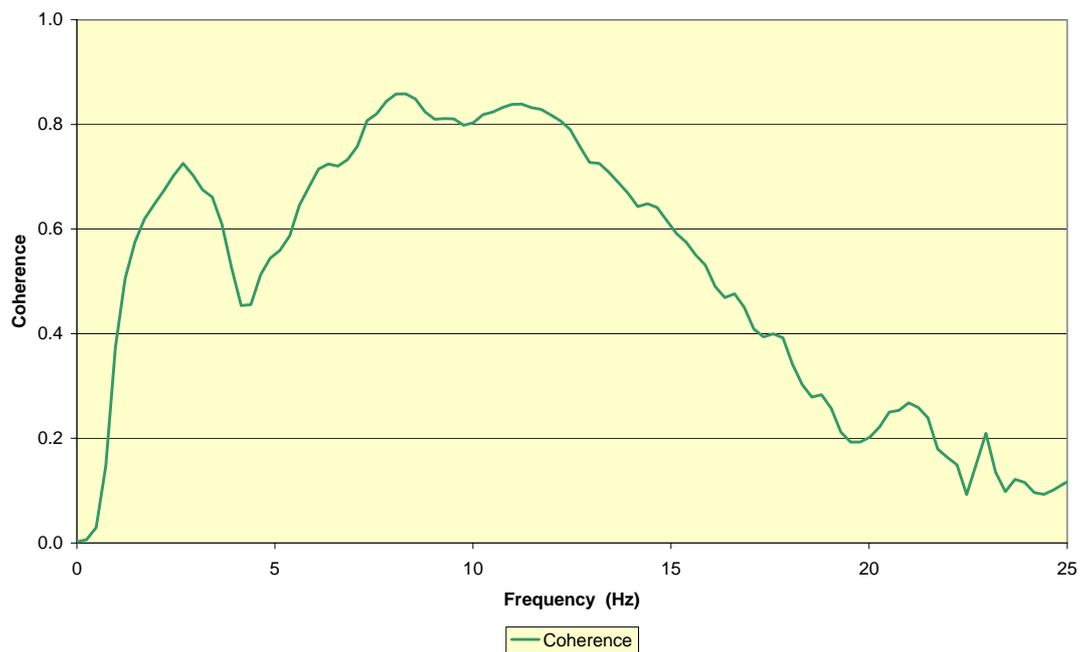
**Figure A1.5.8** Liebherr Face Shovel:- seat transfer function – Coherence – whilst loading dump trucks

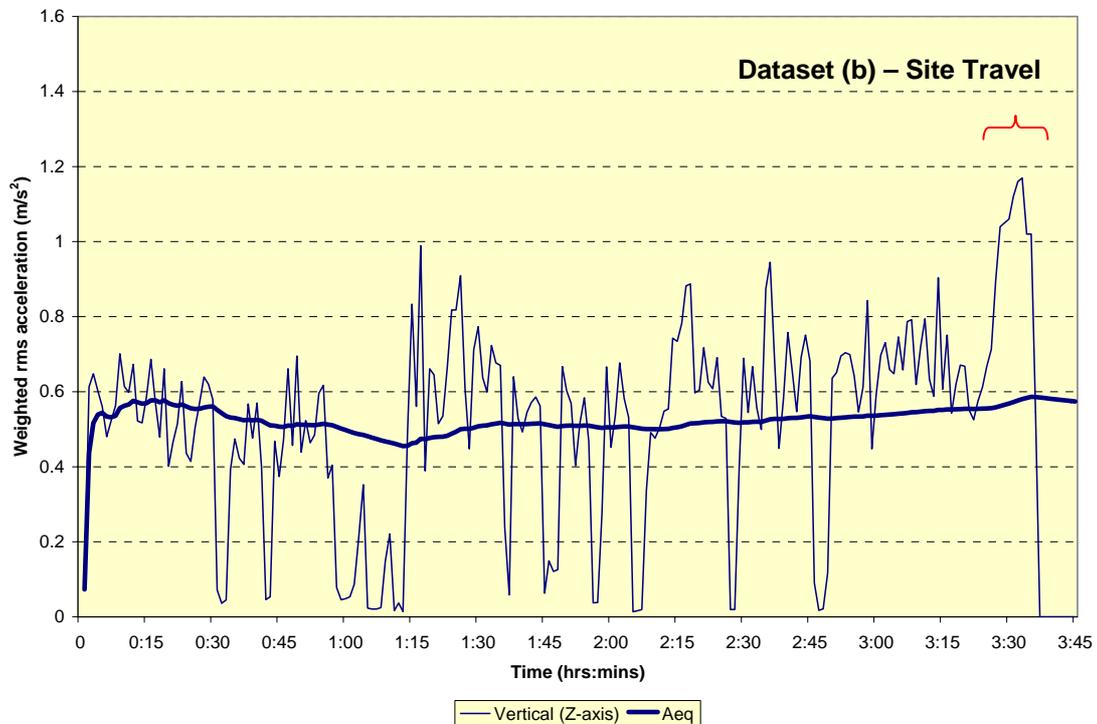
**Figure A1.5.9** Liebherr Face Shovel:- time history of weighted 1-minute rms seat accelerations (Z-axis) and equivalent continuous rms acceleration (Aeq):- entire recording period

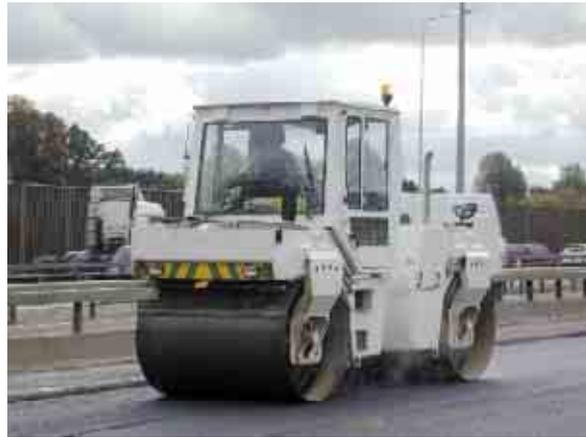
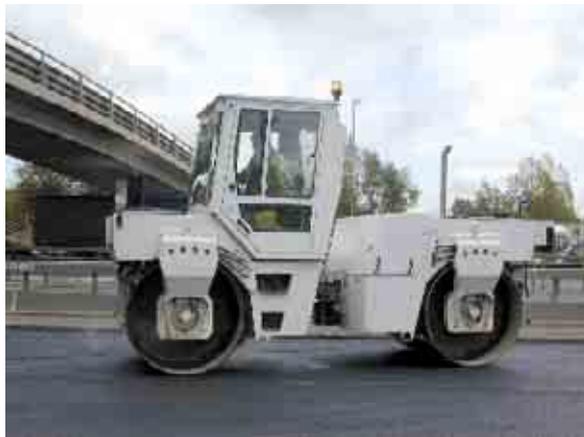
**Figure A1.6.1** Bomag BW161 AD2 10-tonne articulated twin-drum vibrating roller compacting freshly-laid hot asphalt on M25

- Each time the roller approaches a change in direction, the roller's internal vibration system is turned off, resulting in a reduction in vibration frequency down to zero. Upon having changed direction of travel, the vibration system is turned on once more and has to accelerate back up to operating frequency from zero. This causes a significant change in vibration frequency through the chassis of the roller, which can be felt through the feet of bystanders, particularly strong at approximately half way through acceleration to normal operating frequency.

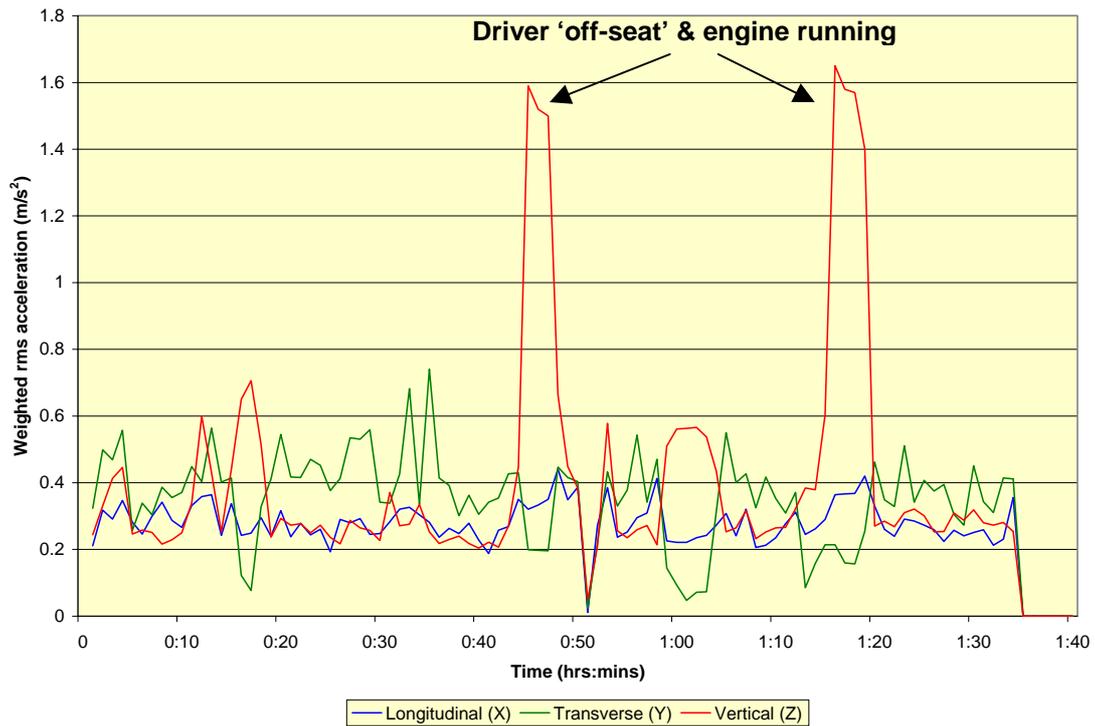
**Figure A1.6.3** Bomag BW161 10-tonne twin drum vibrating roller:- time histories of weighted 1-minute rms seat accelerations (X, Y and Z-axes)

- Periods of machine idleness (at engine tickover) and/or operator absence from the driver's seat appear to cause higher Z-axis WBV values;
- Datasets derived from periods when the driver is "on-seat" generate significantly lower Z-axis WBV levels than those relating to the entire measurement period (particularly for "seat" WBV values);
- High Z-axis rms seat acceleration values (see Figure A1.6.3) appear to coincide with the periods when the driver is "off-seat" (see Figure A1.6.4).

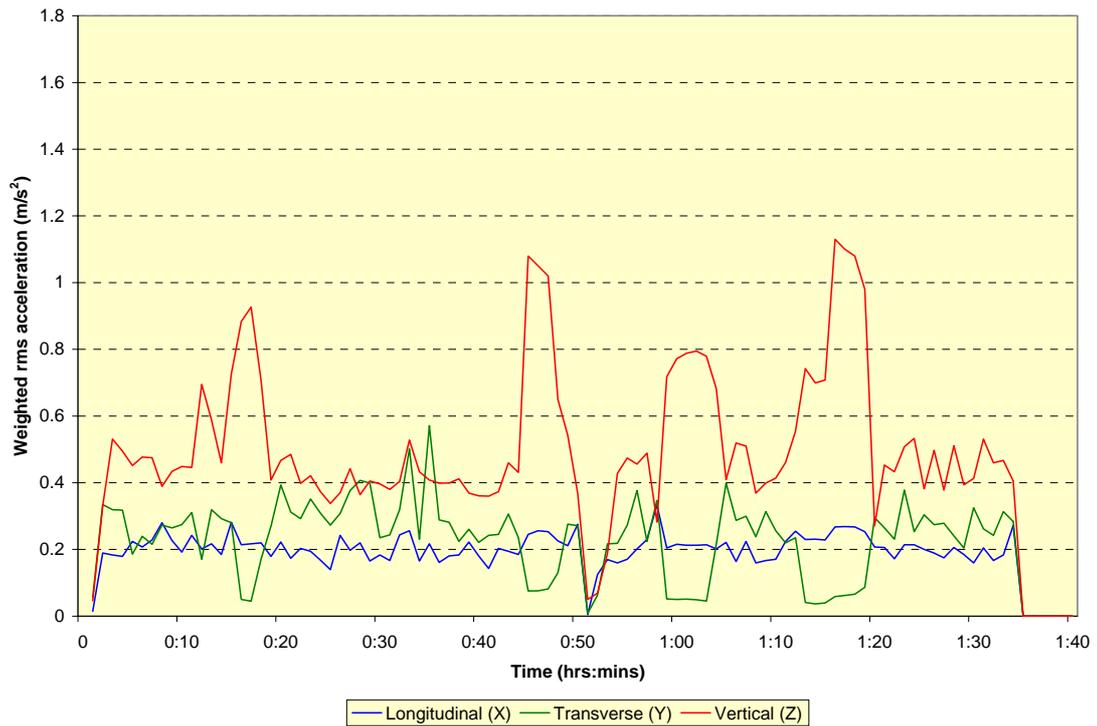
**Figure A1.6.5** Bomag BW161 10-tonne twin drum vibrating roller:- time histories of weighted 1-minute rms floor accelerations (X, Y and Z-axes)

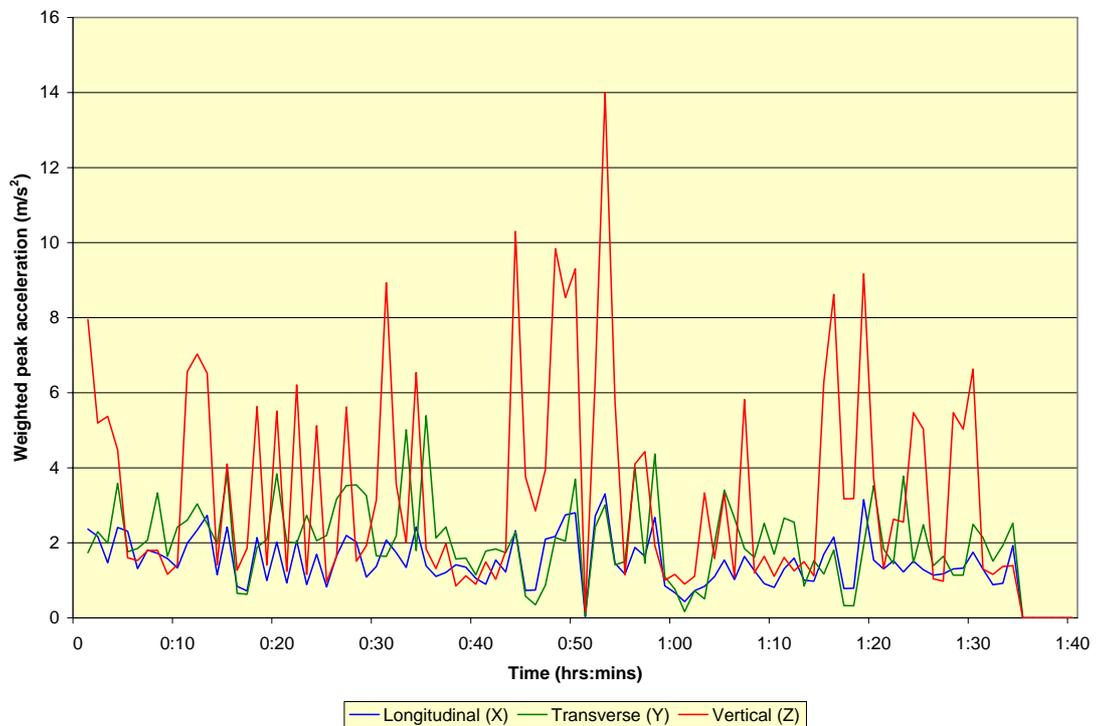
**Figure A1.6.6** Bomag BW161 10-tonne twin drum vibrating roller:- time histories of weighted 1-minute peak seat accelerations (X, Y and Z-axes)

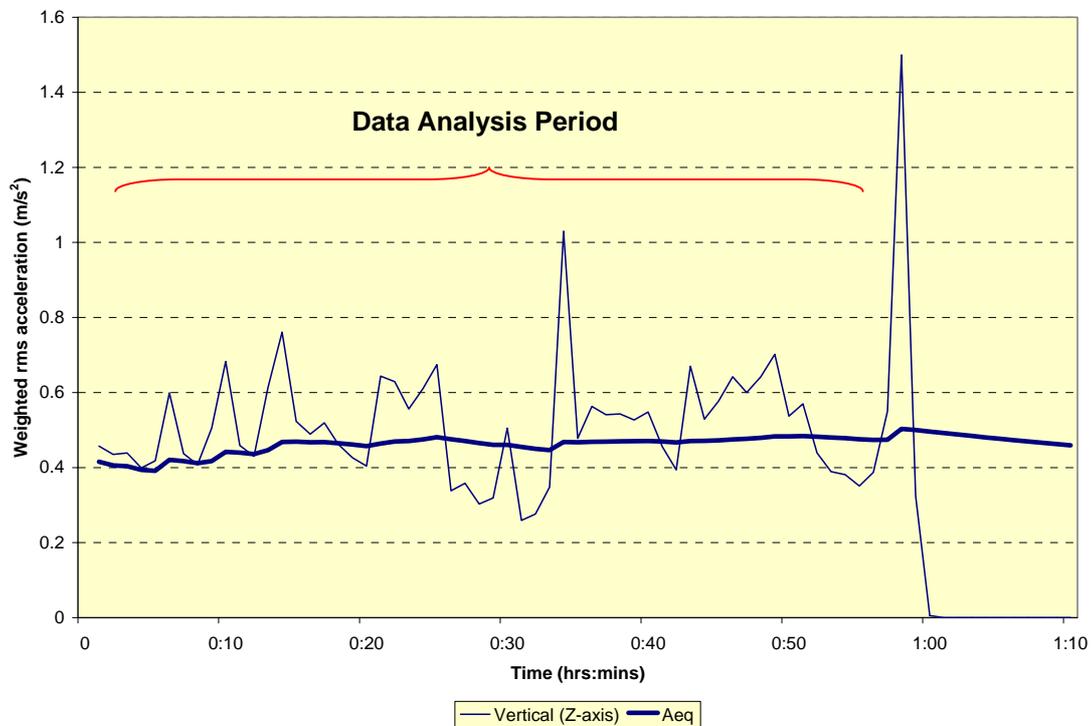
**Figure A1.7.2** Bomag BW138 4-tonne twin drum vibrating roller:- time history of weighted 1-minute rms seat accelerations (Z-axis) and equivalent continuous rms acceleration (Aeq)
