# **Whole-body vibration on construction, mining and quarrying machines**

Evaluation of emission and estimated  
exposure levels

Prepared by **Silsoe Research Institute**  
for the Health and Safety Executive 2005

**RESEARCH REPORT 400**

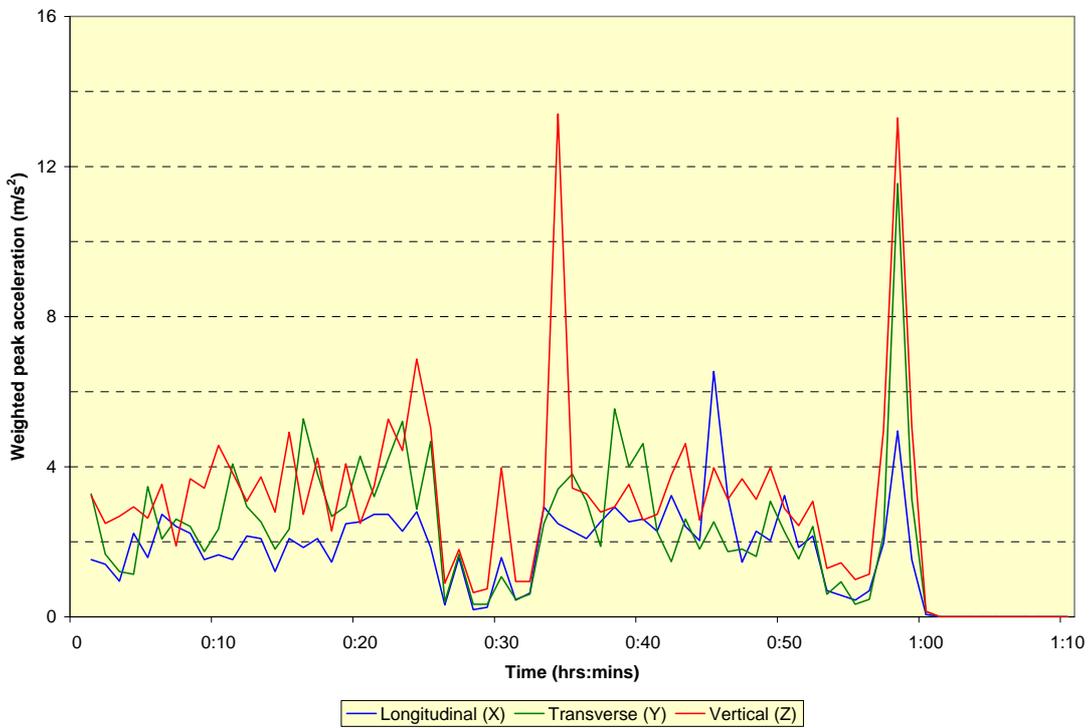
**Figure A1.7.4** Bomag BW138 4-tonne twin drum vibrating roller:- time histories of weighted 1-minute peak seat accelerations (X, Y and Z-axes)

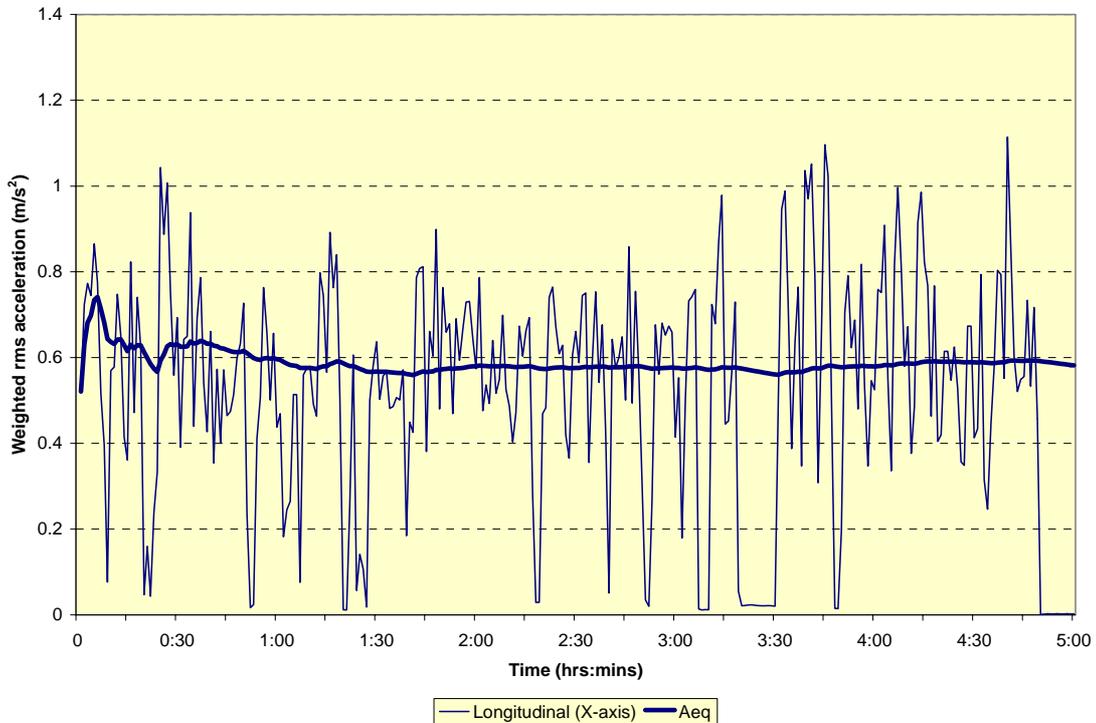
**Figure A1.8.2** CAT 950F II articulated loading shovel:- time history of weighted 1-minute rms seat accelerations (X-axis) and equivalent continuous rms acceleration (Aeq)

Full details of these machines, operating applications and resulting WBV levels are presented in Appendices 1.8 and 1.9 for the 18-tonne and 24-tonne loading shovels, respectively. The vibration magnitudes on these machines were strongly affected by the way in which they were used. In all cases, the longitudinal (X-axis) component was the highest, but this could vary between about  $0.6 \text{ m/s}^2$  and nearly  $1 \text{ m/s}^2$  according to how hard /enthusiastically the bucket was driven into the stockpile, and general operating style (see Tables 4.1 & 4.3). Additionally, it was observed that the machine with the lowest magnitudes of vibration was being used on a less rough ground surface, although both operating surfaces were relatively smooth and perfectly acceptable. The suspension seats on both machines amplified the vertical (Z-axis) vibration (SEAT values = 1.10 – 1.26 depending upon machine & operation). As the energy of this component was centred on a frequency of 2 Hz, it could possibly be better controlled by seat selection: neither seat embodied any suspension capability in the longitudinal (X) axis. However, it is also important that the cab mountings are so designed that the fore-and-aft shocks generated when the machine is driven into a stockpile, is not amplified into a rocking motion of the cab. Potential employer action to minimise operator risk from WBV exposure would include operator training in 'Best Practice' and maintenance of operating surfaces.

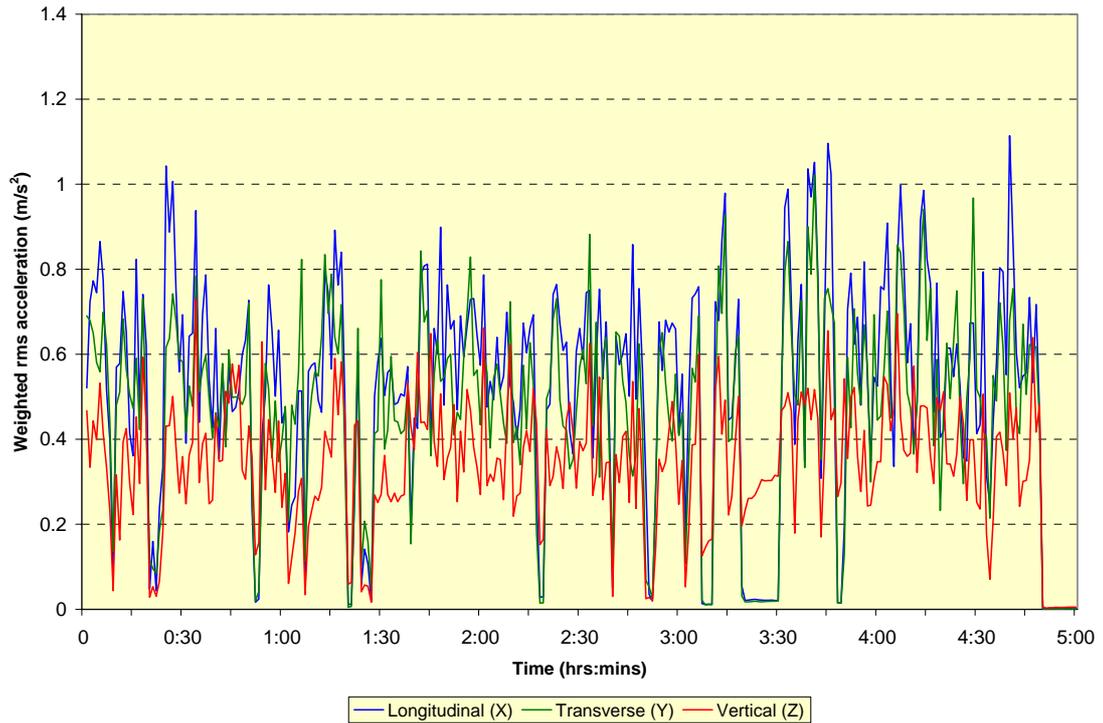
**Figure A1.8.3** CAT 950F II articulated loading shovel:- time histories of weighted 1-minute rms seat accelerations (X, Y and Z-axes)

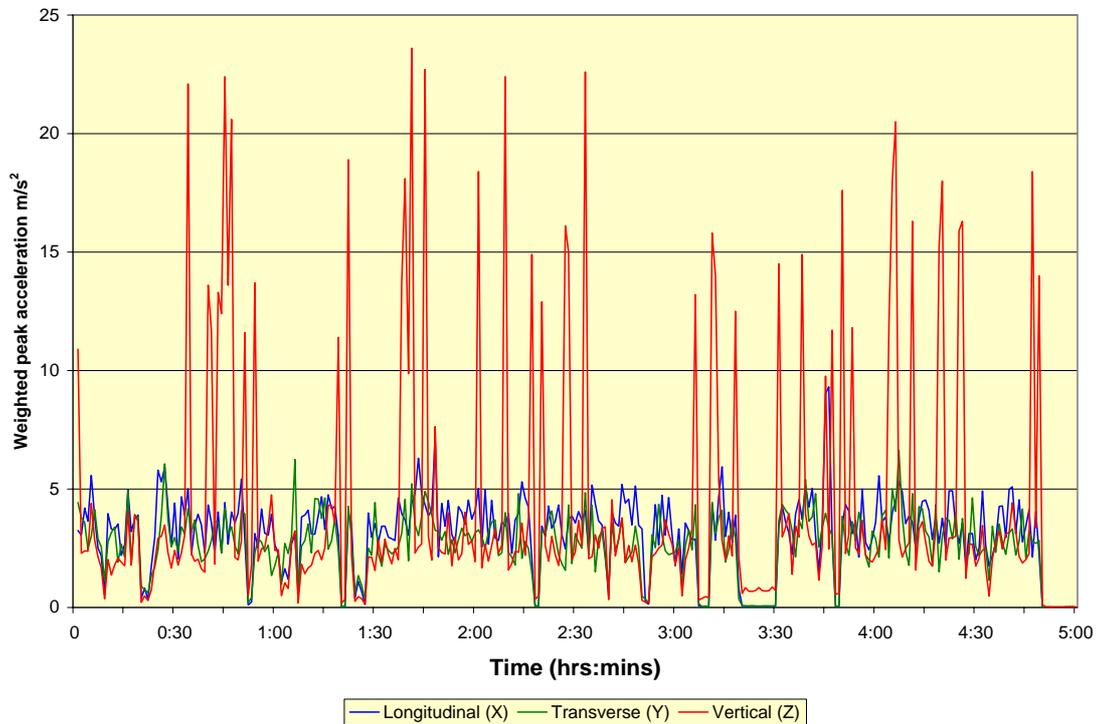
**Figure A1.8.4** CAT 950F II articulated loading shovel:- time histories of weighted 1-minute peak seat accelerations (X, Y and Z-axes)

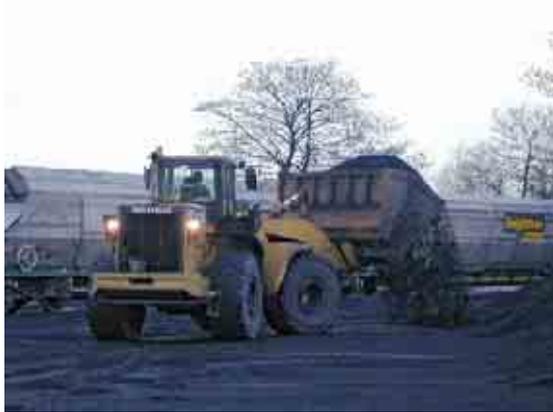
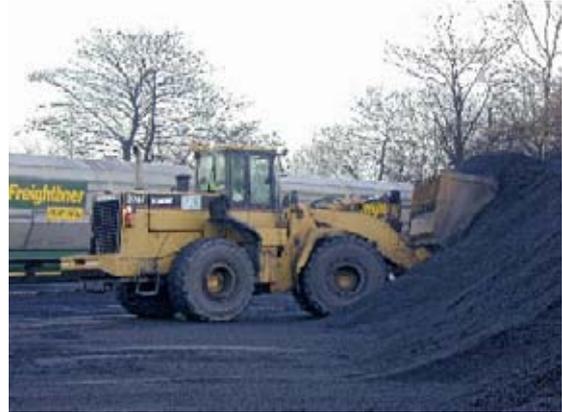
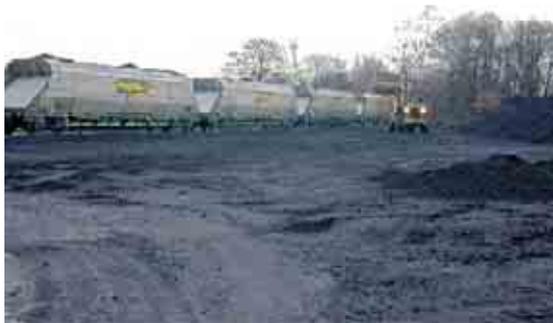
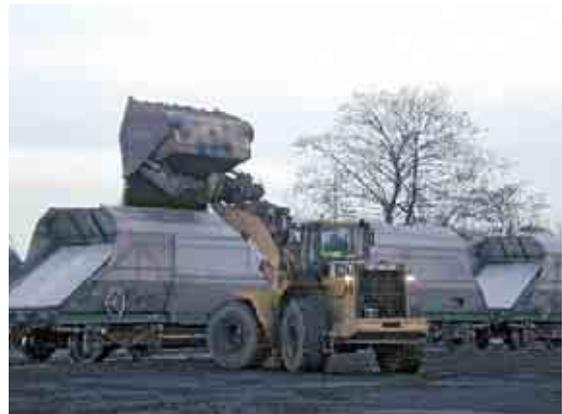
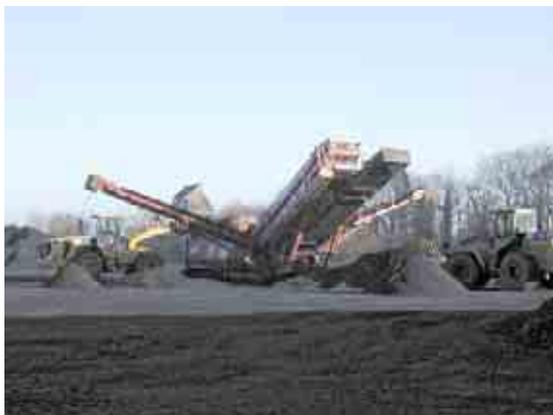
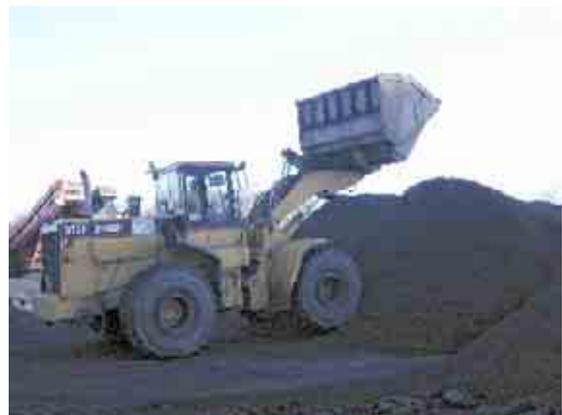
**Figure A1.9.1** CAT 970F articulated loading shovel loading rail wagons with coal (1200 tonnes) and performing stockpile yard duties

- **Stockpile Transfer:-** V-shaped operation from one stockpile to another. When discharging operator drives into stockpile with bucket fully raised and uses toe-tip bucket to achieve necessary heap of stock. Approx. 50 m between stockpiles. Stockpile yard area completely flat concrete surface;
- **Loading Lorries:-** Loading 38-tonne articulated lorries with screened coal;
- **Feeding Screening Machine:-** Filling feed hopper of screening machine and moving material from machine discharge heaps to storage stockpiles.

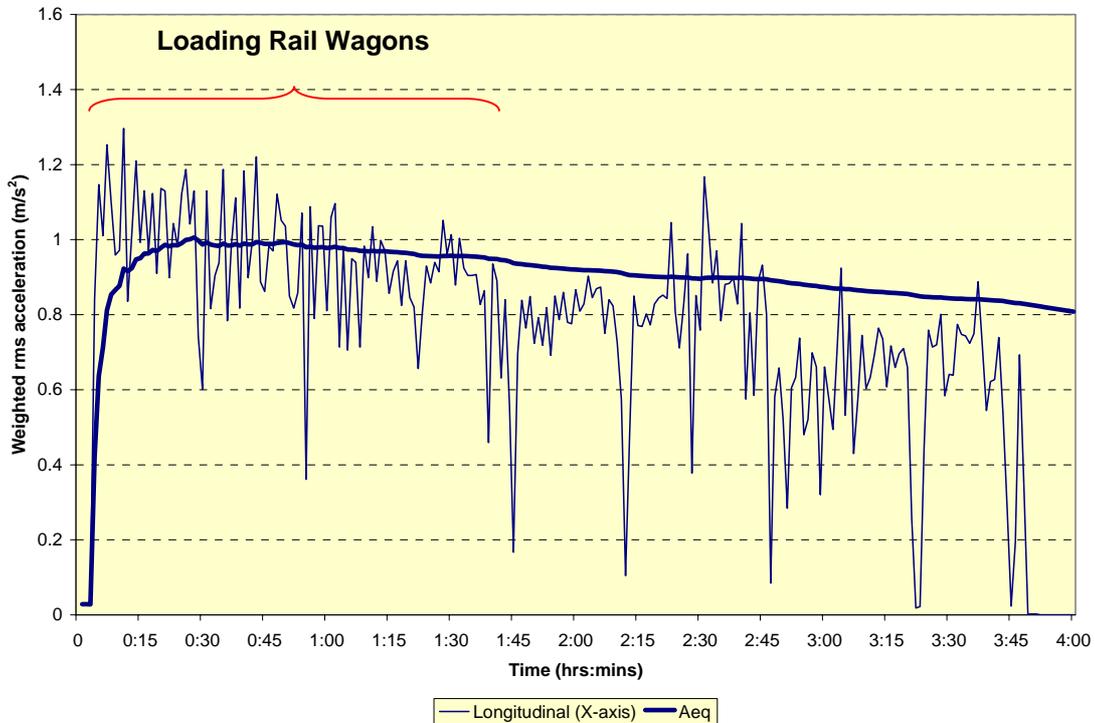
**Figure A1.9.2** CAT 970F articulated loading shovel:- time history of weighted 1-minute rms seat accelerations (X-axis) and equivalent continuous rms acceleration (Aeq) – entire recording period

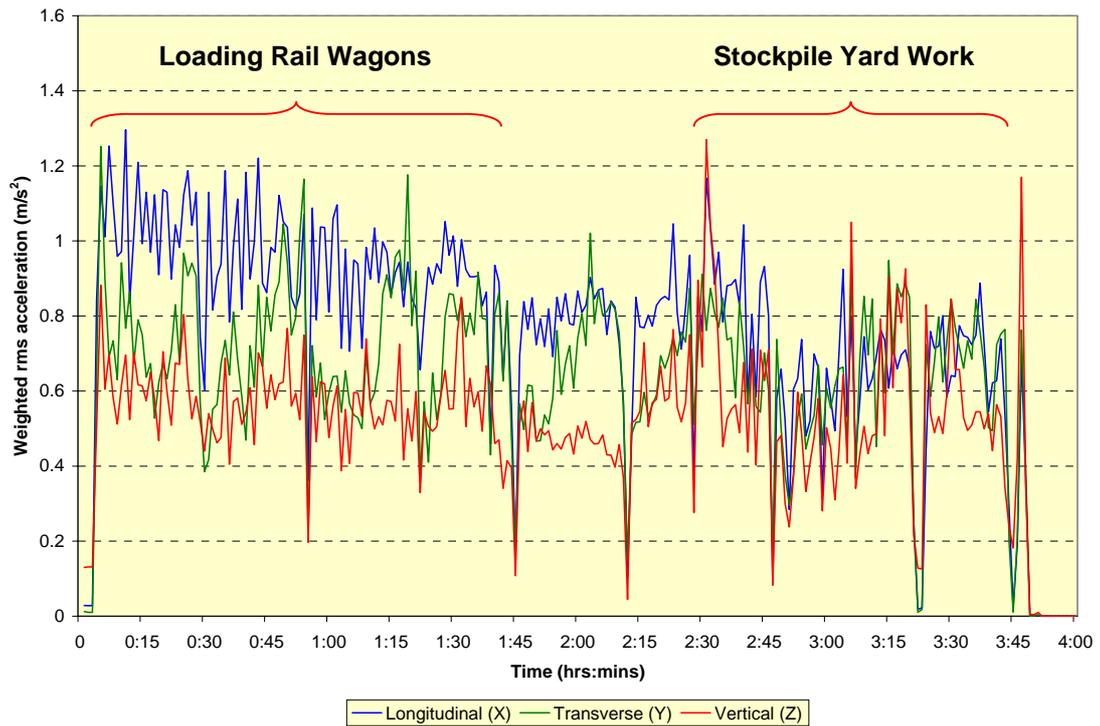
**Figure A1.9.3** CAT 970F articulated loading shovel:- time histories of weighted 1-minute rms seat accelerations (X, Y and Z-axes) – entire recording period

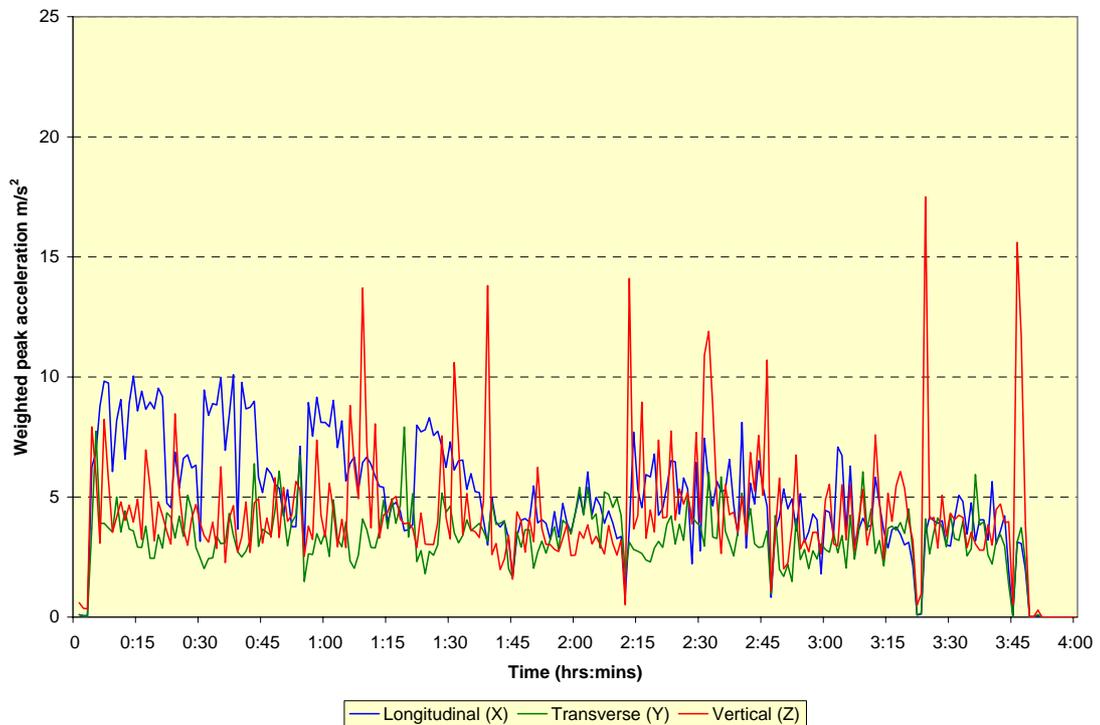
**Figure A1.9.4** CAT 970F articulated loading shovel:- time histories of weighted 1-minute peak seat accelerations (X, Y and Z-axes) – entire recording period

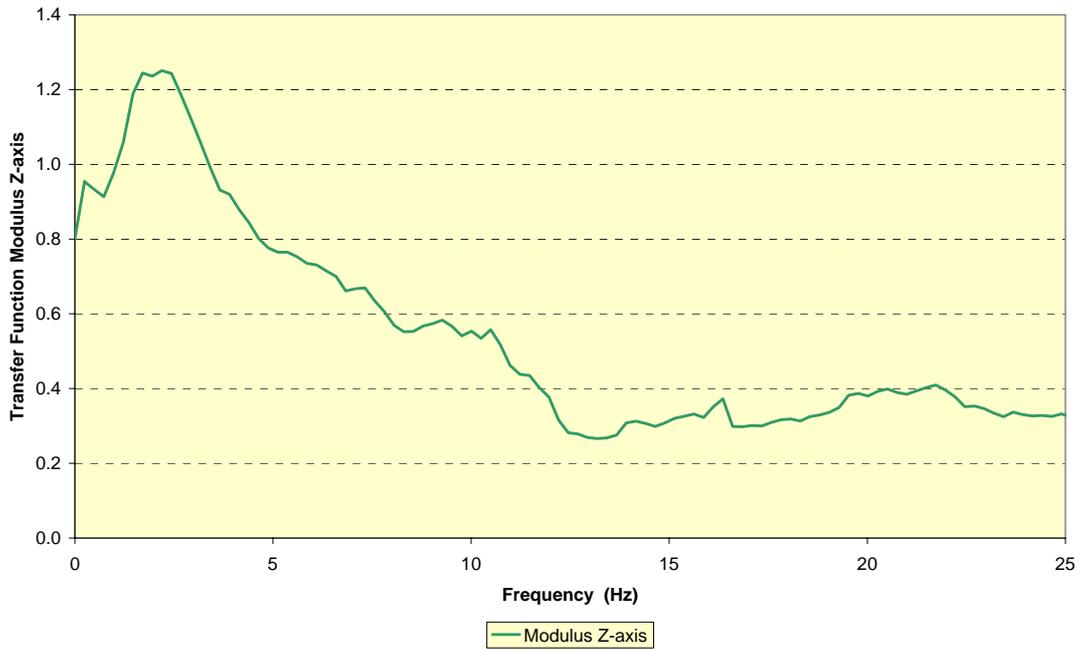
**Figure A1.9.7** CAT 970F articulated loading shovel:- seat transfer function – Magnitude – whilst loading rail wagons

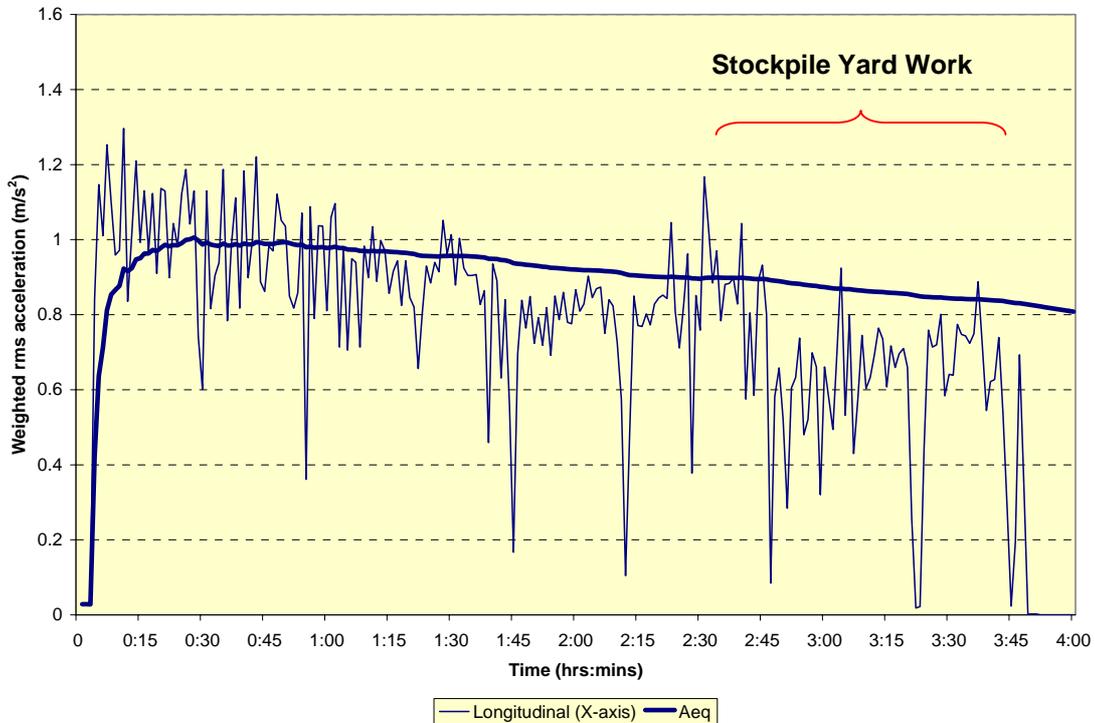
**Figure A1.9.9** CAT 970F articulated loading shovel:- time history of weighted 1-minute rms seat accelerations (X-axis) and equivalent continuous rms acceleration (Aeq) – entire recording period

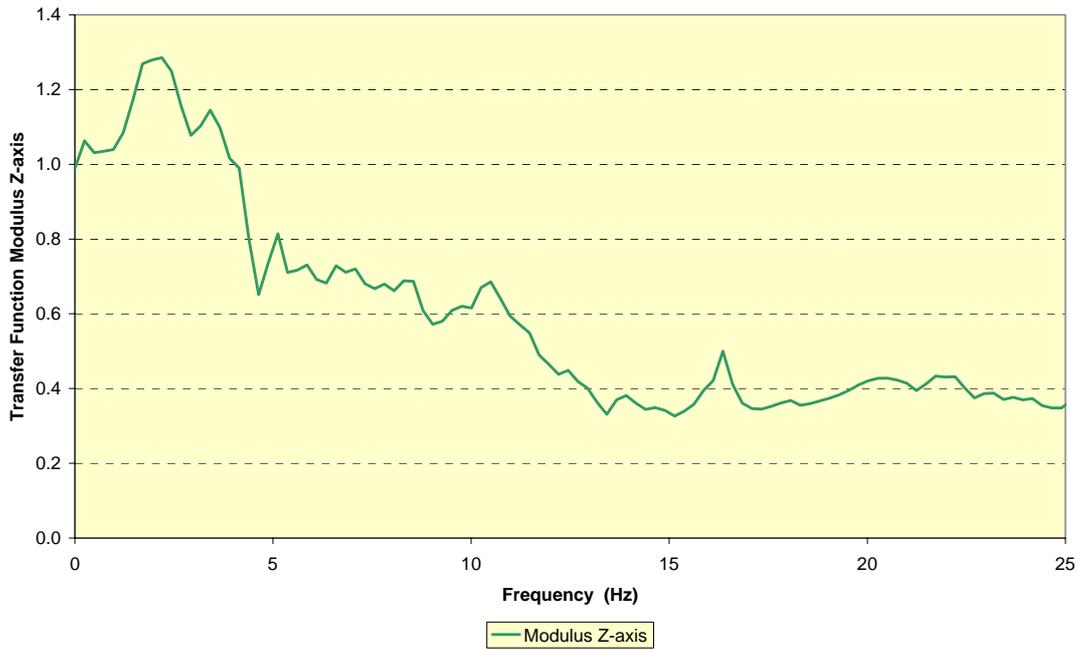
**Figure A1.9.12** CAT 970F articulated loading shovel:- seat transfer function – Magnitude – whilst performing general yard work

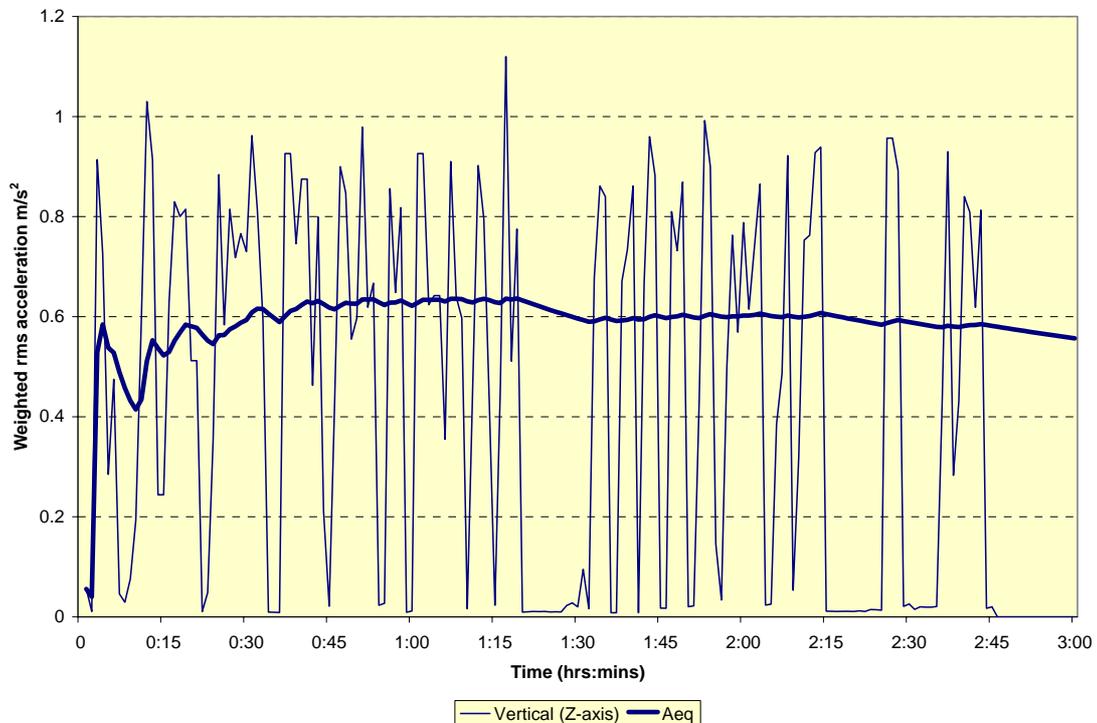
**Figure A1.11.3** Linde 2.5 tonne fork lift truck:- time history of weighted 1-minute rms seat accelerations (Z-axis) and equivalent continuous rms acceleration (Aeq)

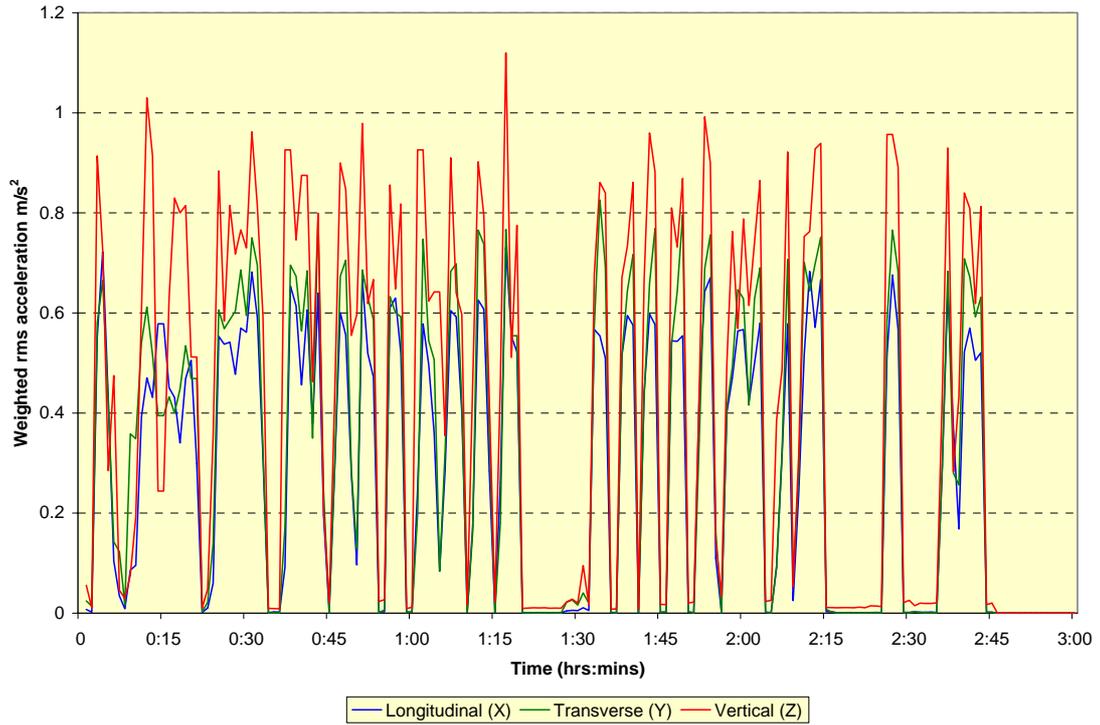
**Figure A1.11.4** Linde 2.5 tonne fork lift truck:- time histories of weighted 1-minute rms seat accelerations (X, Y and Z-axes)

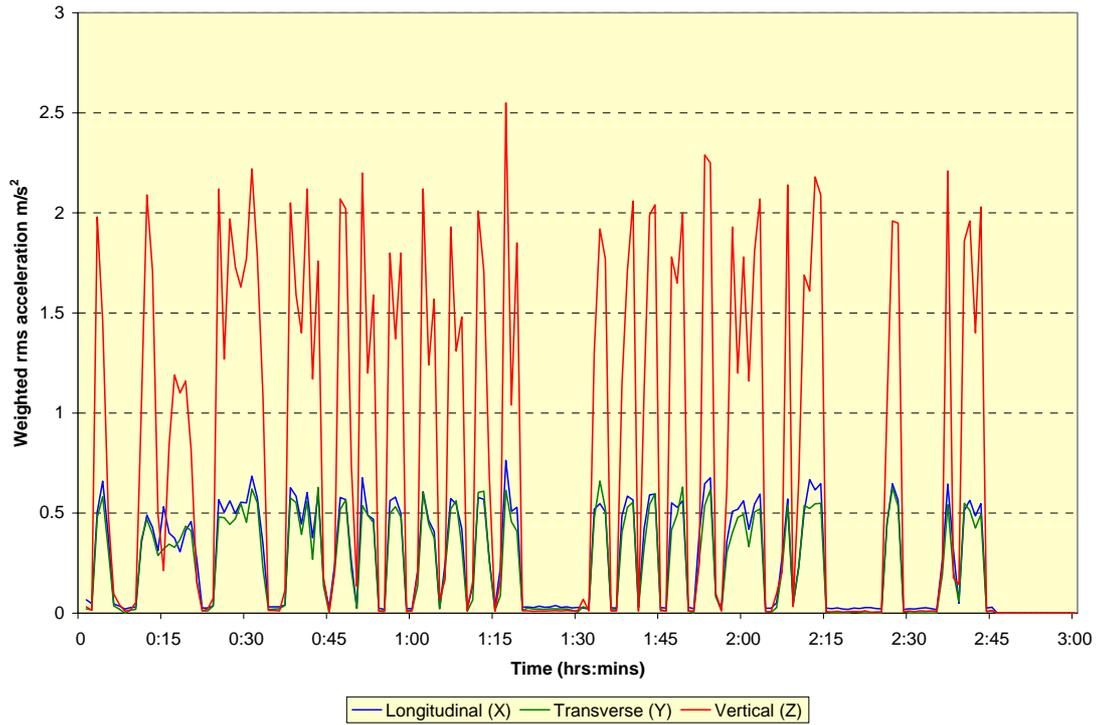
**Figure A1.11.6** Linde 2.5 tonne fork lift truck:- time histories of weighted 1-minute rms floor accelerations (X, Y and Z-axes)

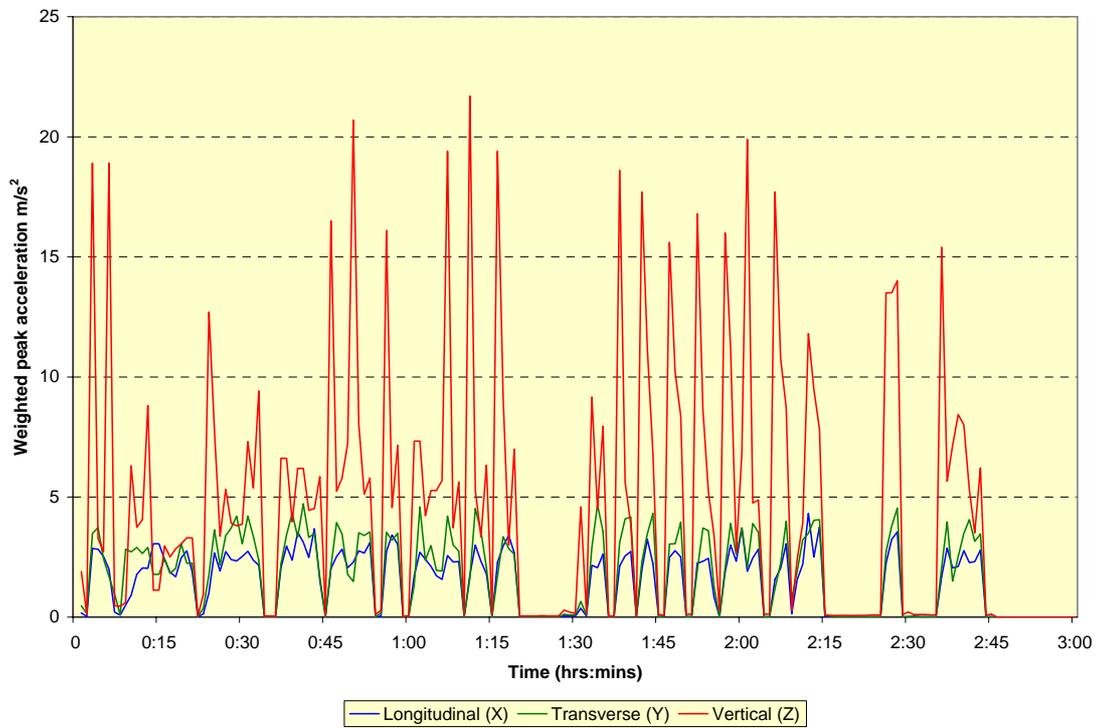
**Figure A1.11.7** Linde 2.5 tonne fork lift truck:- time histories of weighted 1-minute peak seat accelerations (X, Y and Z-axes)

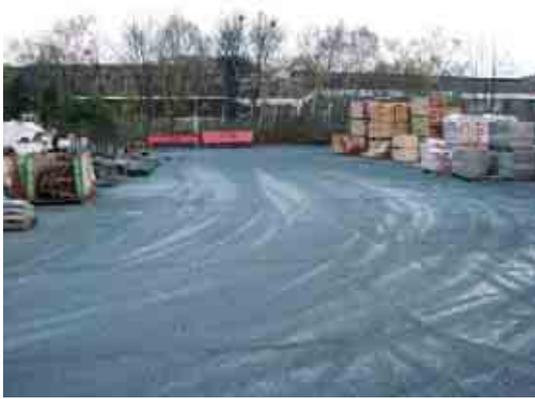
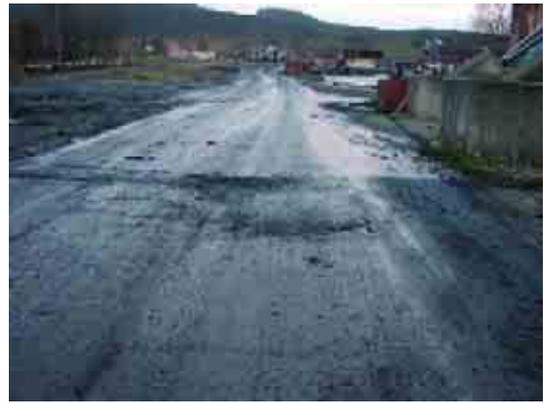
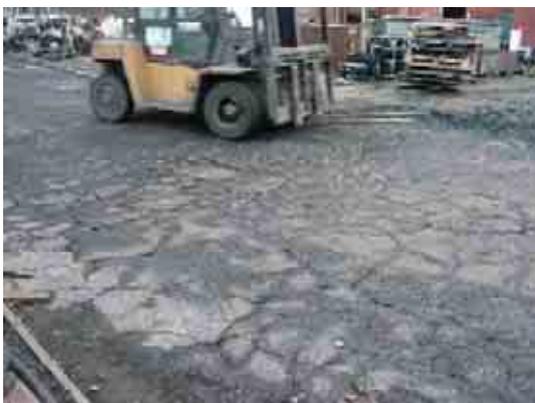
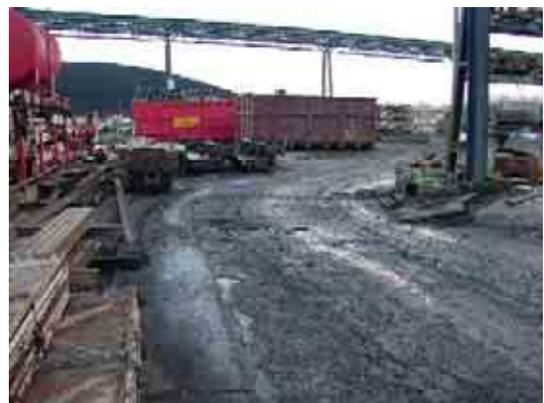
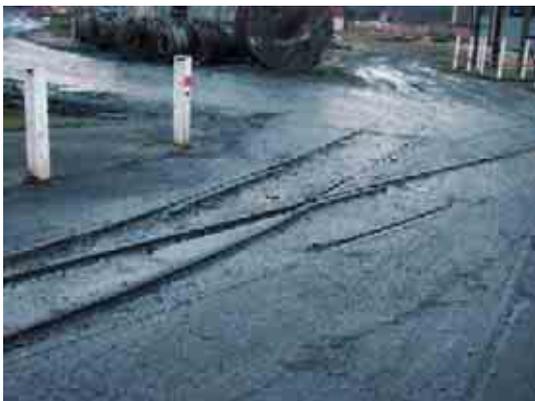
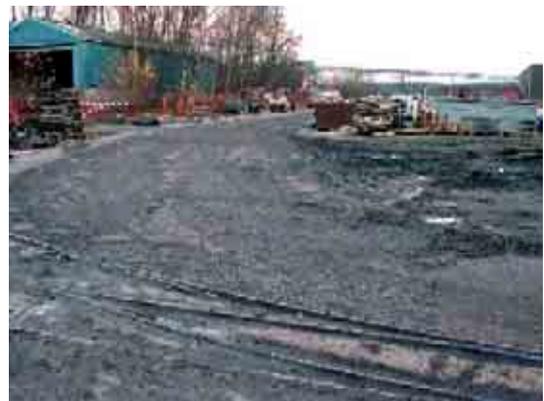
**Figure A1.12.2**      Operating conditions on Maltby Colliery site

**Stockyard**

**Track to Reclaims Yard**

**Reclaims Yard**

**Rails (1)**

**Rails (2)**

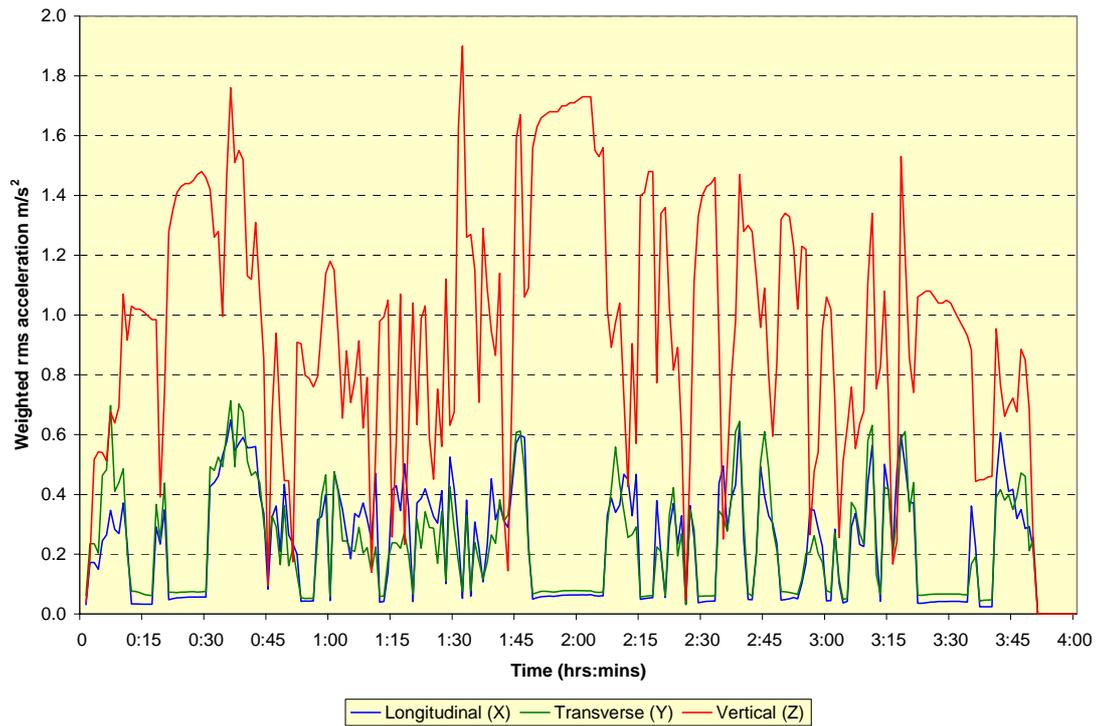
**Figure A1.12.4** CAT D70 6.5 tonne fork lift truck:- time histories of weighted 1-minute rms seat accelerations (X, Y and Z-axes)

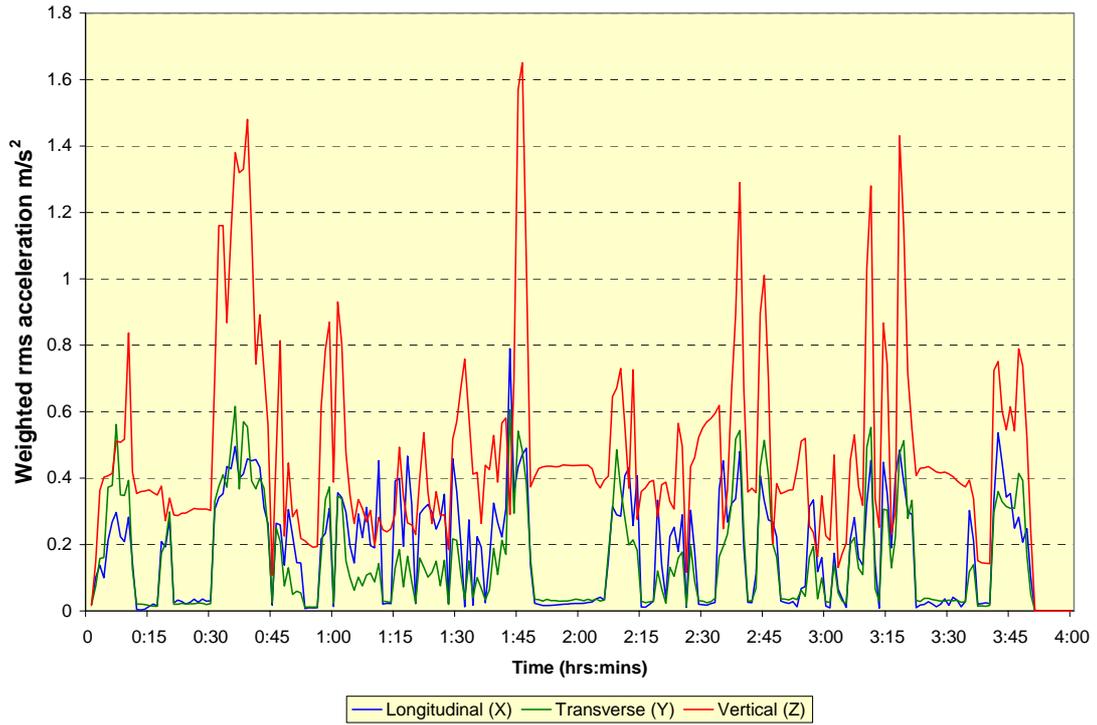
**Figure A1.12.6** CAT D70 6.5 tonne fork lift truck:- time histories of weighted 1-minute rms floor accelerations (X, Y and Z-axes)

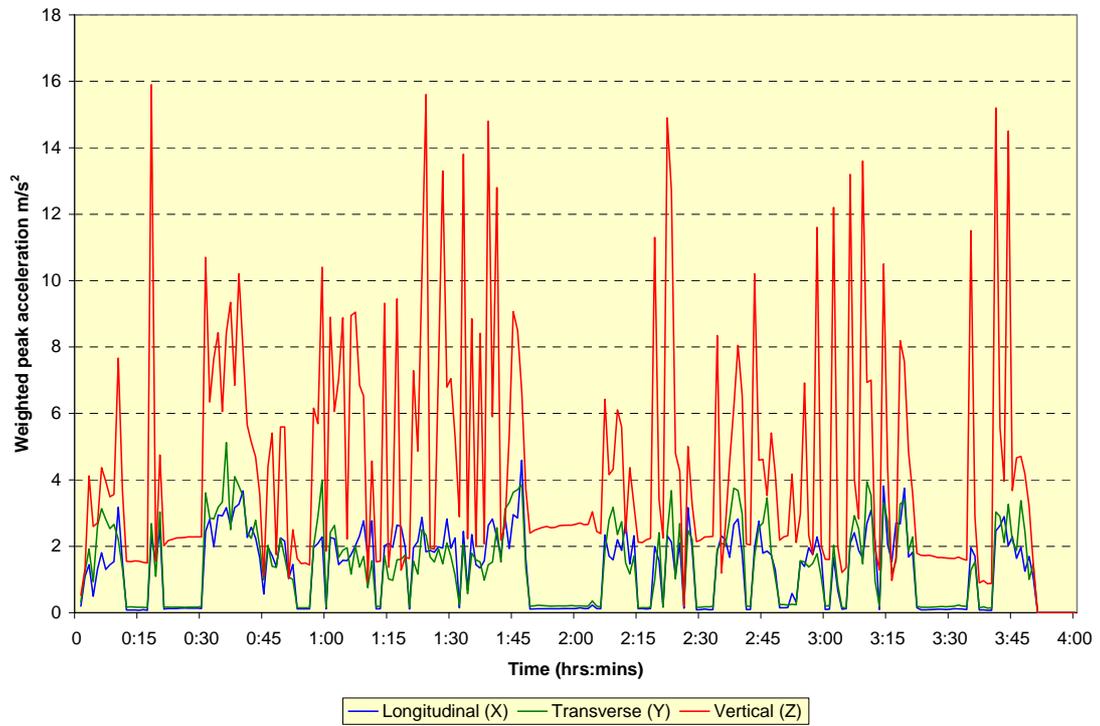
**Figure A1.12.7** CAT D70 6.5 tonne fork lift truck:- time histories of weighted 1-minute peak seat accelerations (X, Y and Z-axes)

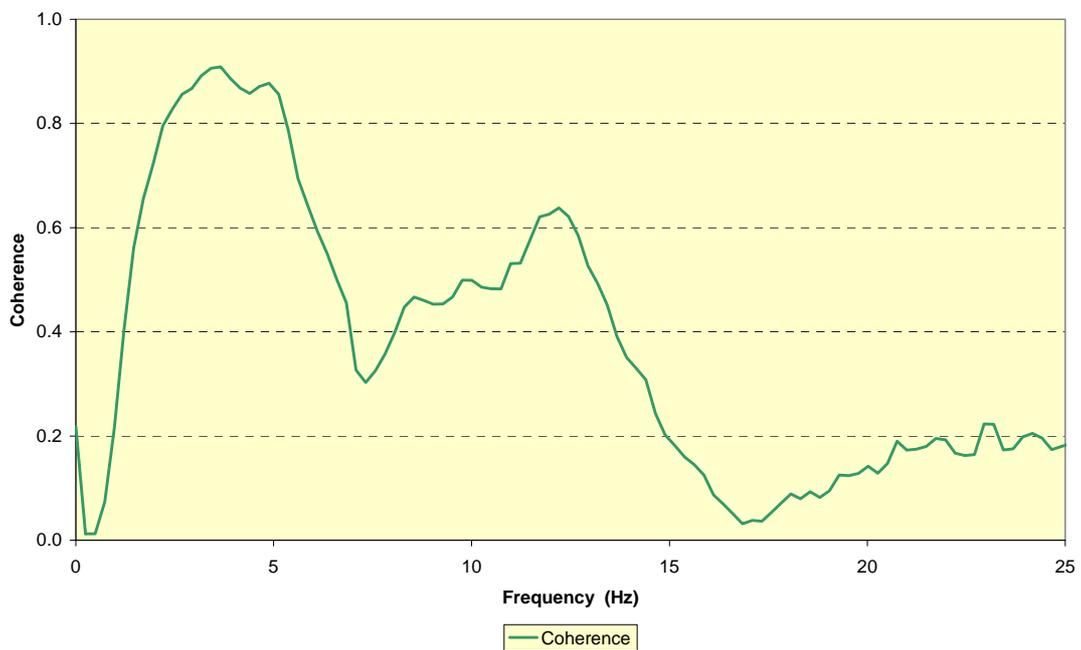
**Figure A1.12.11** CAT D70 6.5 tonne fork lift truck:- seat transfer function – Coherence – for sections of recording period when driver is ‘on-seat’

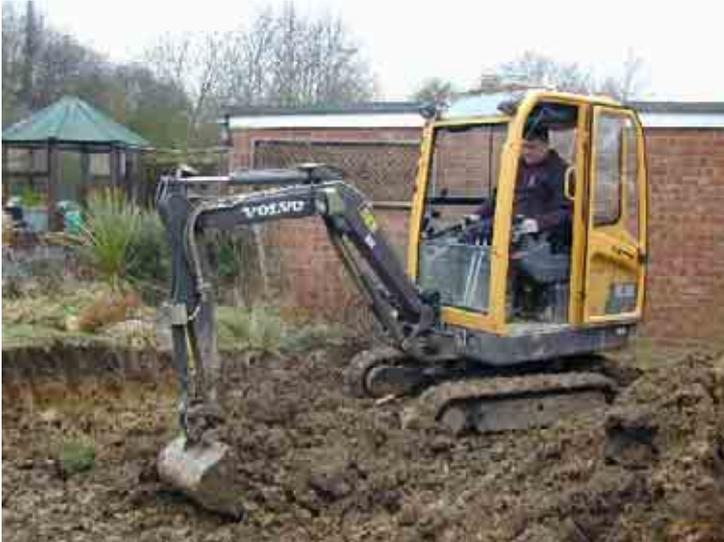
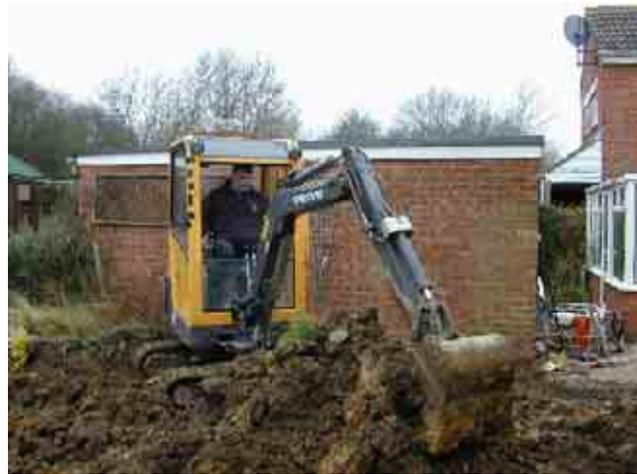
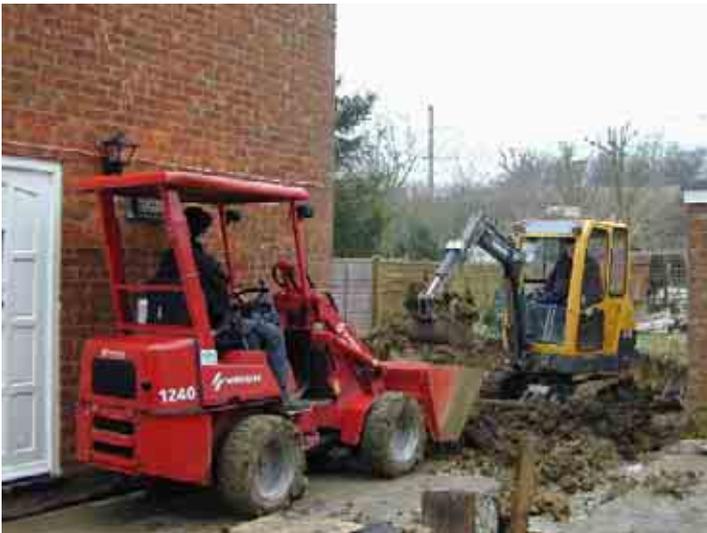
**Figure A1.13.1** Volvo EC15B 1.5 tonne compact 360° excavator excavating footings for house extension and patio

**Site Operation:-** Machine being used to excavate house extension footings / patio area to rear of semi-detached residential property. Loading excavated material into a compact site dumper for removal. No significant ground-induced vibrations – Moderate / smooth (but typical) operating conditions.

**Ground conditions:-** Moist, sticky clay.

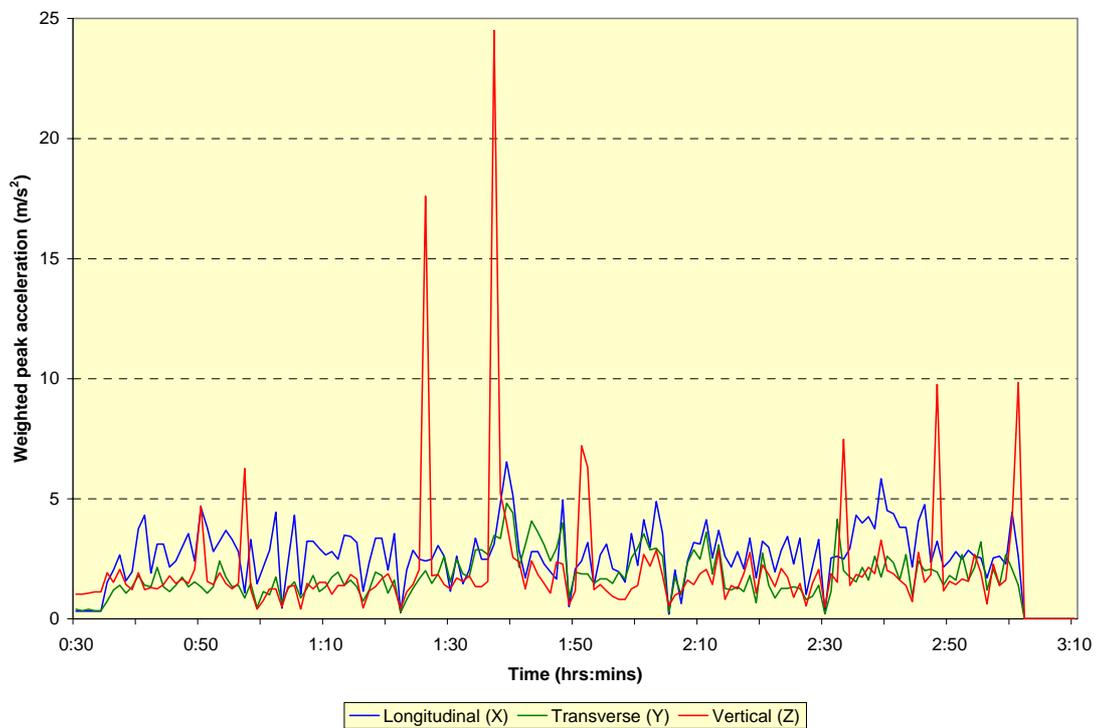
**Figure A1.13.4** Volvo EC15B compact 360° excavator:- time histories of weighted 1-minute peak seat accelerations (X, Y and Z-axes)

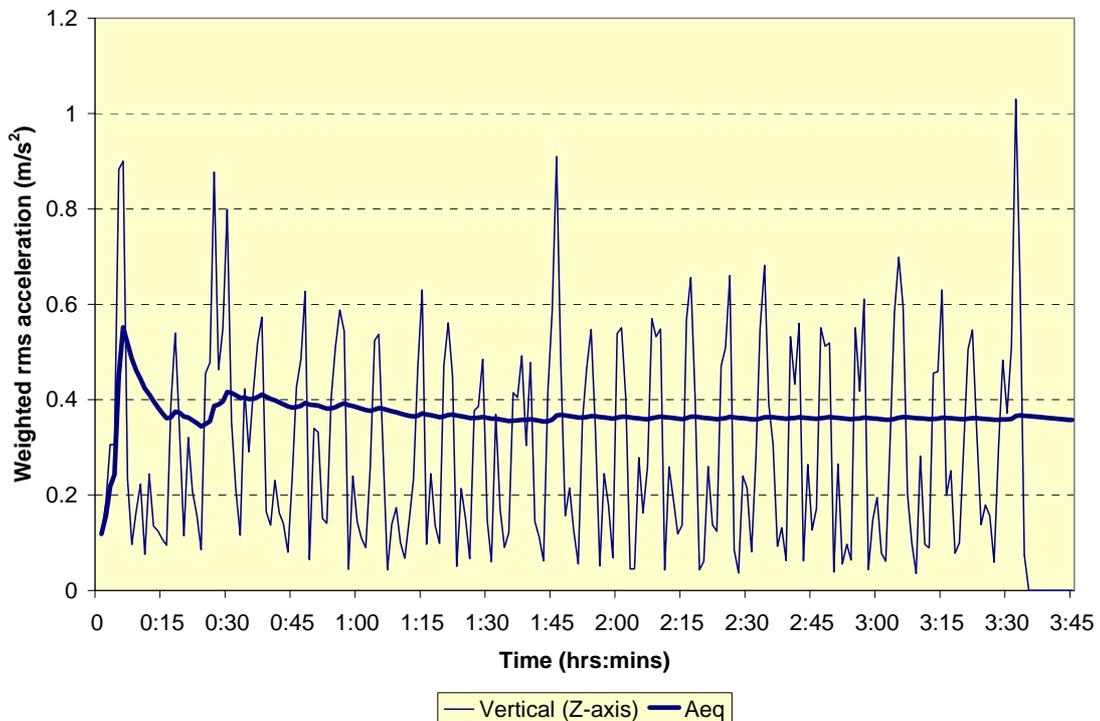
**Figure A1.14.2** CAT Rigid Dump Truck:- time history of weighted 1-minute rms seat accelerations (Z-axis) and equivalent continuous rms acceleration (Aeq)

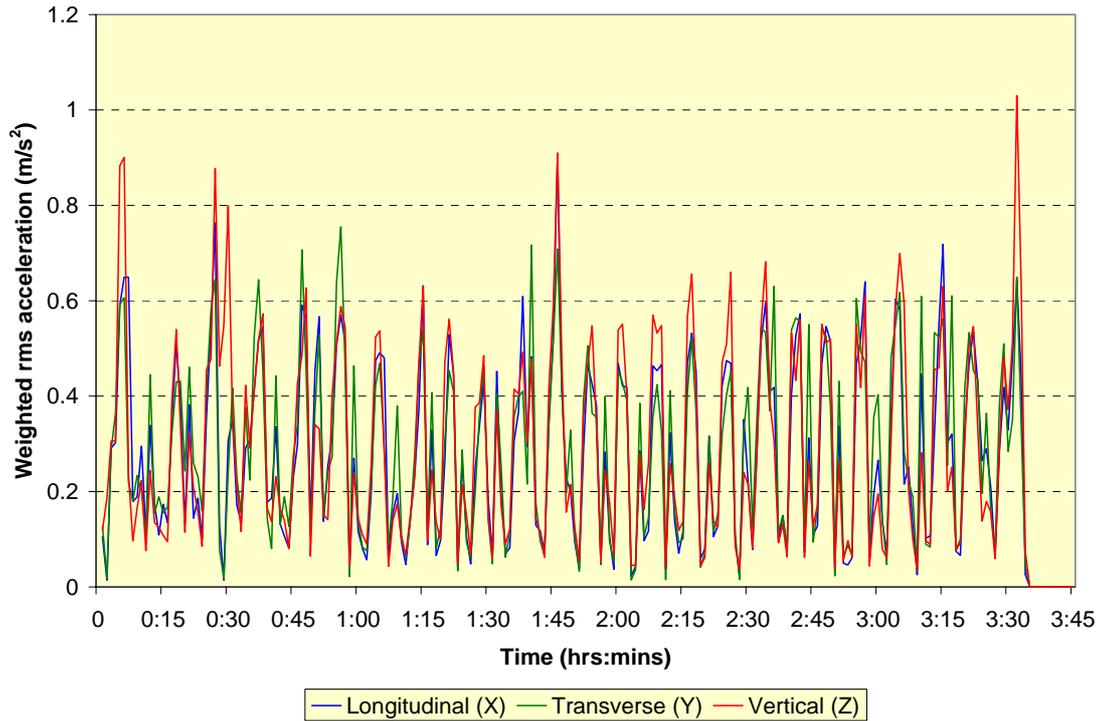
**Figure A1.14.3** CAT Rigid Dump Truck:- time histories of weighted 1-minute rms seat accelerations (X, Y and Z-axes)

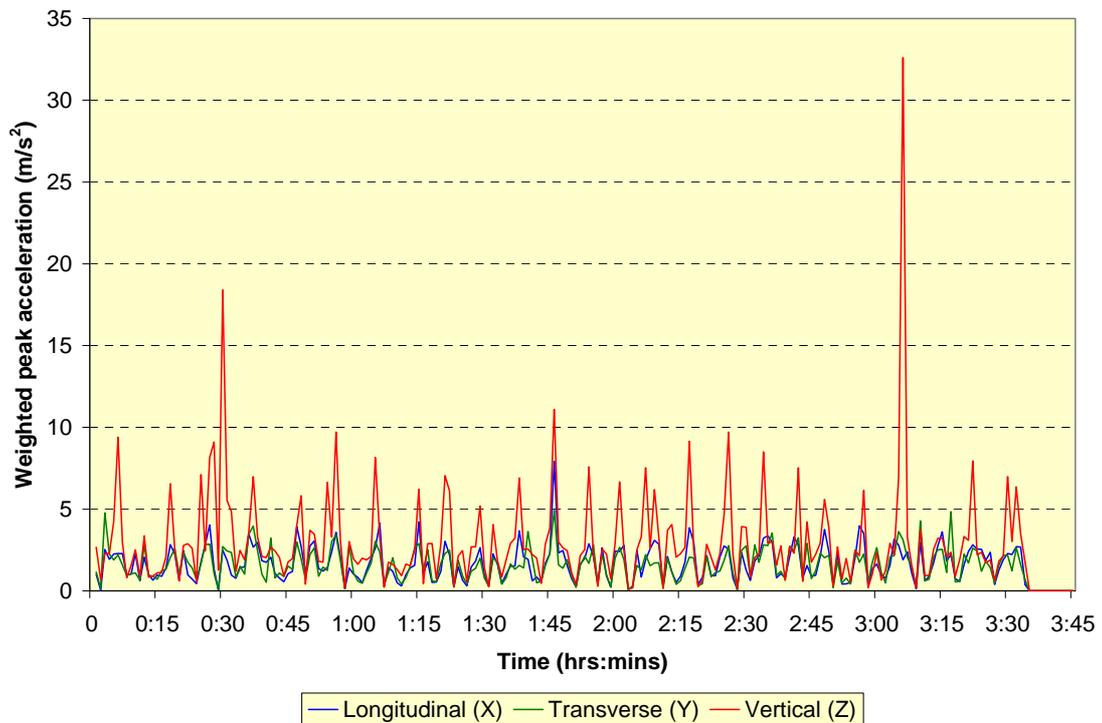
**Figure A1.14.4** CAT Rigid Dump Truck:- time histories of weighted 1-minute peak seat accelerations (X, Y and Z-axes)
