# **Whole-body vibration on construction, mining and quarrying machines**

Evaluation of emission and estimated  
exposure levels

Prepared by **Silsoe Research Institute**  
for the Health and Safety Executive 2005

**RESEARCH REPORT 400**

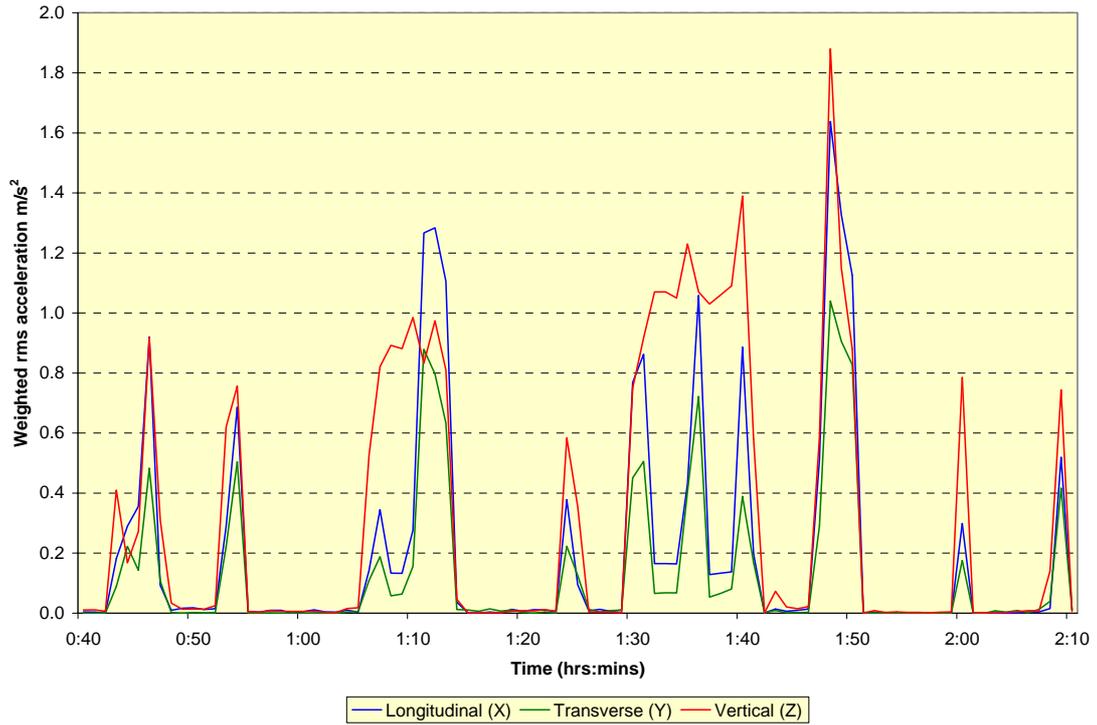
**Figure A1.15.3** CAT Skidsteer Loader:- time histories of weighted 1-minute rms seat accelerations (X, Y and Z-axes)

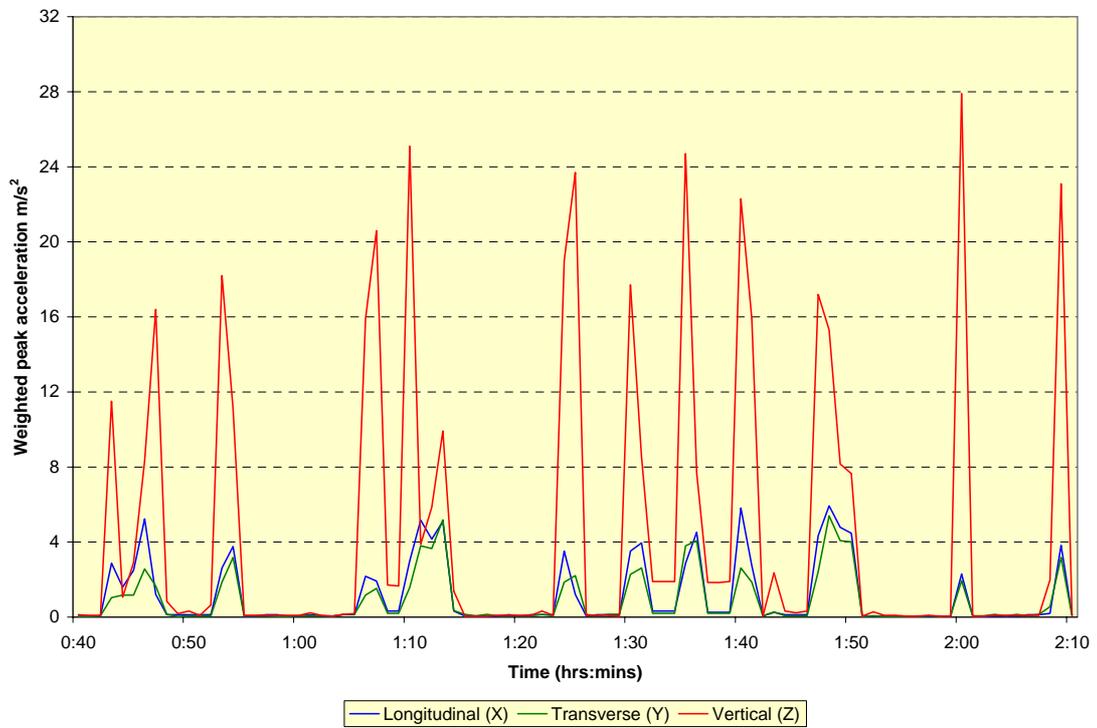
**Figure A1.15.4** CAT Skidsteer Loader:- time histories of weighted 1-minute peak seat accelerations (X, Y and Z-axes)

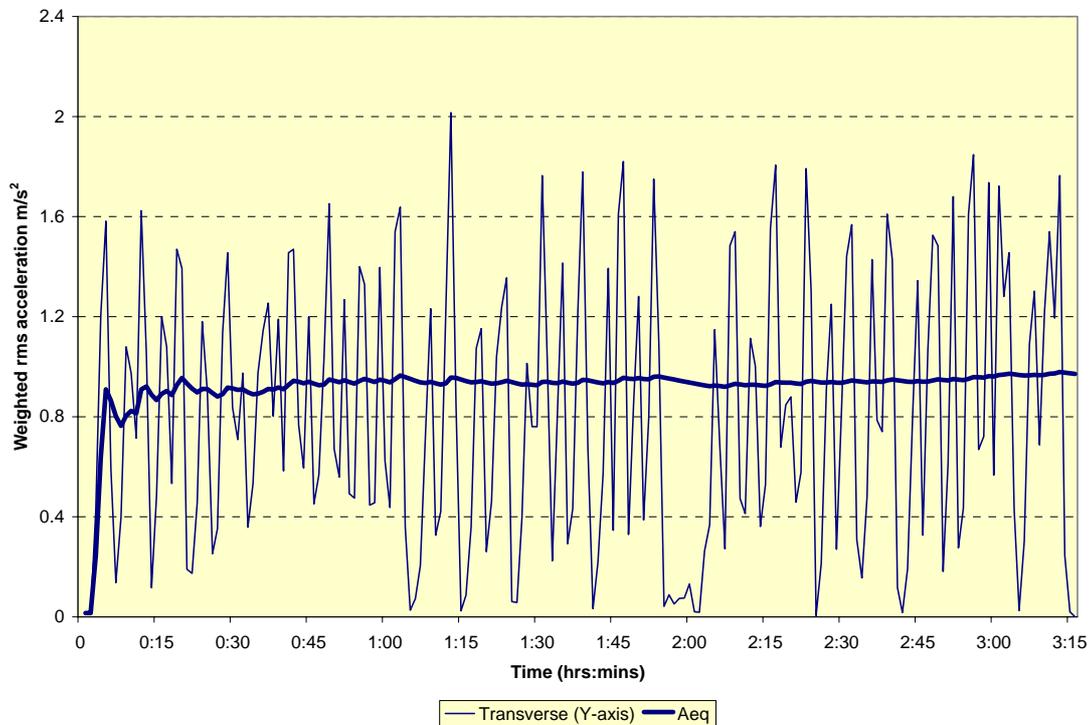
**Figure A1.16.3** CAT Wheeled Scraper:- time history of weighted 1-minute rms seat accelerations (Z-axis) and equivalent continuous rms acceleration (Aeq)

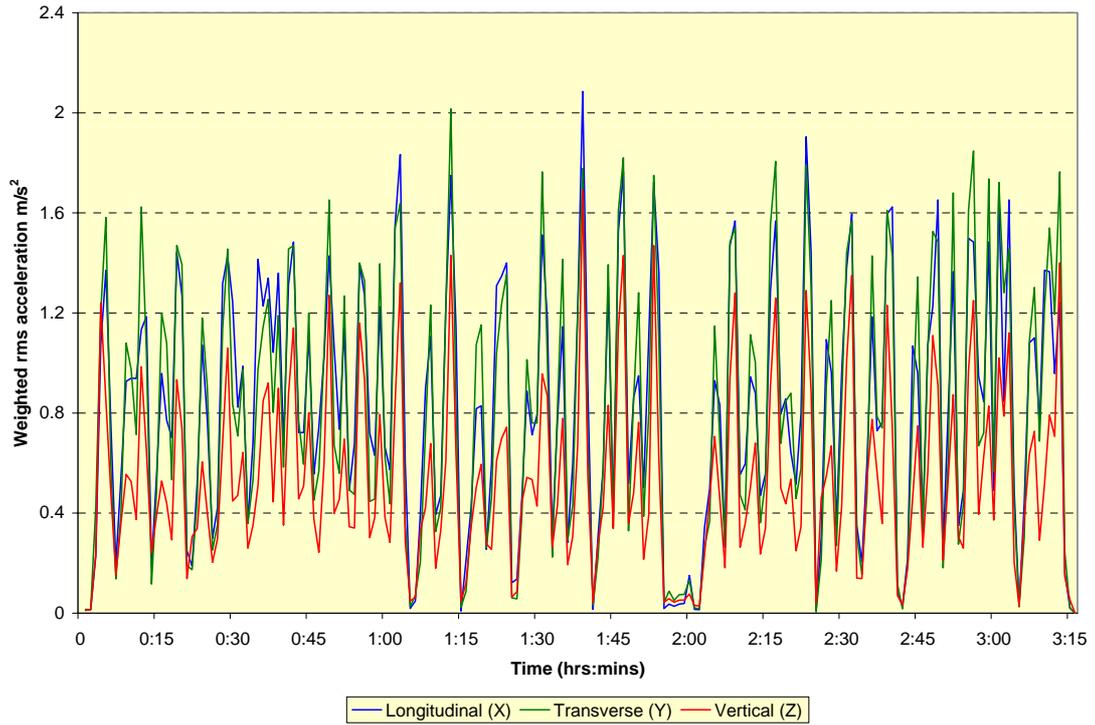
**Figure A1.16.4** CAT Wheeled Scraper:- time histories of weighted 1-minute rms seat accelerations (X, Y and Z-axes)

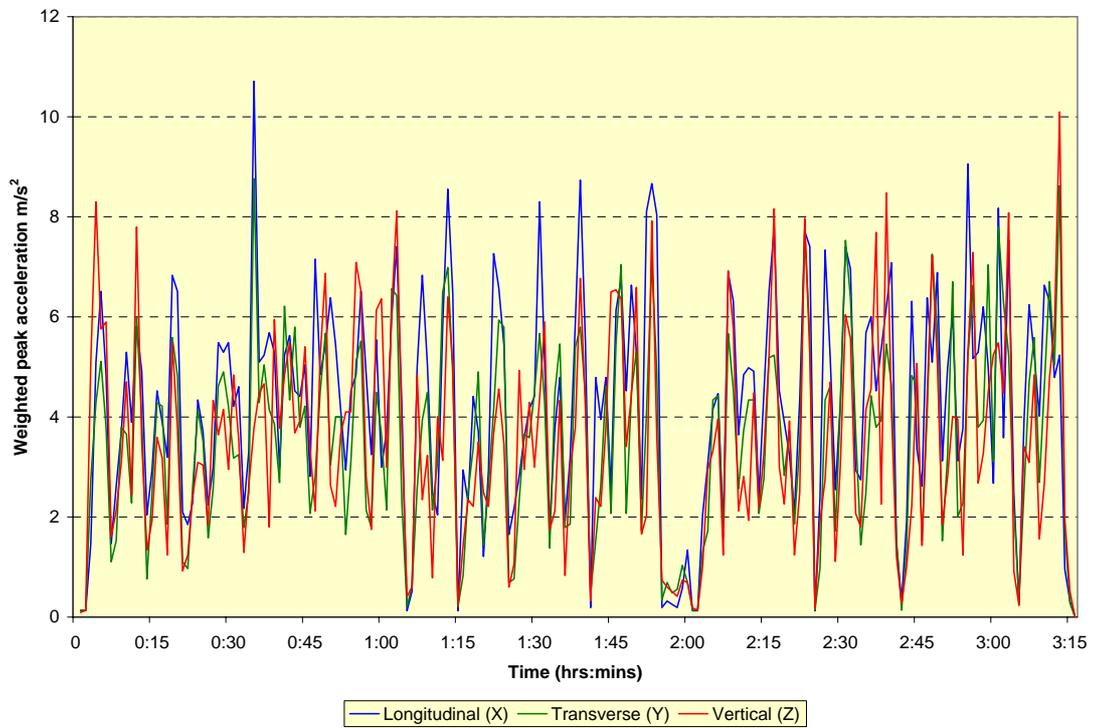
**Figure A1.16.5** CAT Wheeled Scraper:- time histories of weighted 1-minute peak seat accelerations (X, Y and Z-axes)
